PASCOAG UTILITY DISTRICT

CLEAN WATER INFRASTRUCTURE REPLACEMENT PLAN

Five (5) Year Update

May 11, 2022

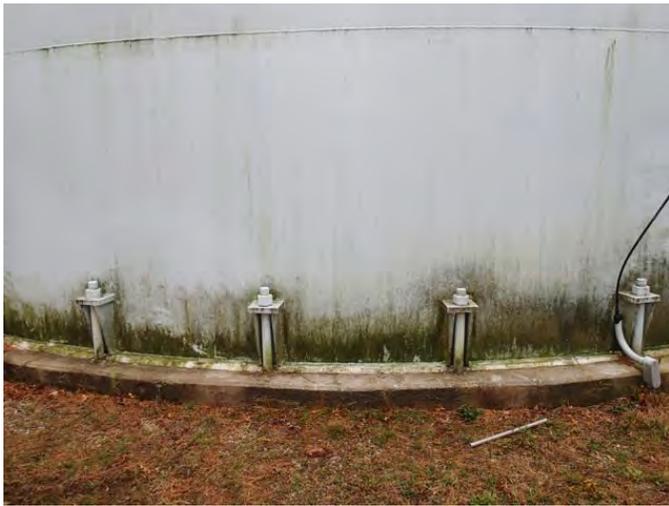
1 *Exterior Wall With Mild To Moderate Mildew*

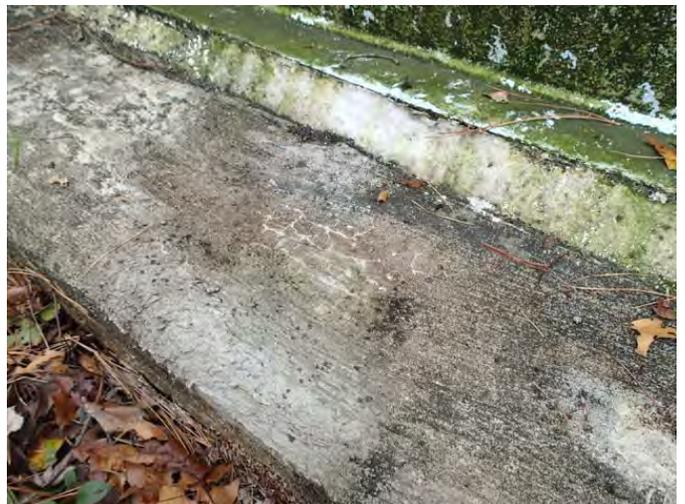
- The tank foundation is uncoated yet appeared mostly sound. Tight cracks were observed throughout less than 5% of the exposed surfaces. The cracks were sounded and appeared to be limited to the surface of the concrete and free of voids or spalls at this time. USI advised that these cracks should be monitored to ensure that concrete spall does not occur.

18 *Concrete Foundation With Tight Cracks*

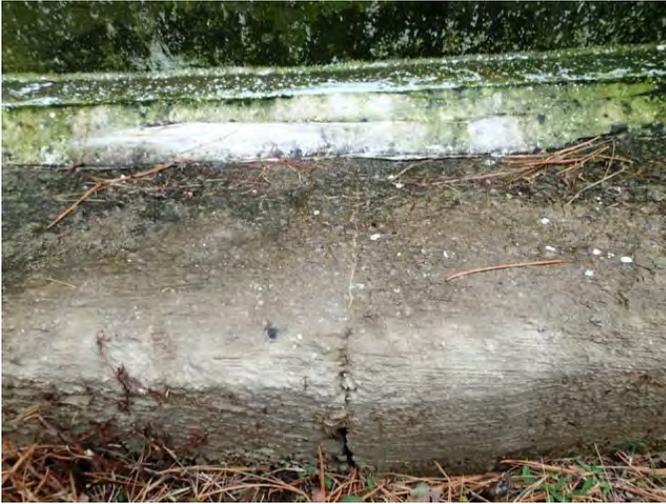
19 *Concrete Foundation With Tight Cracks*

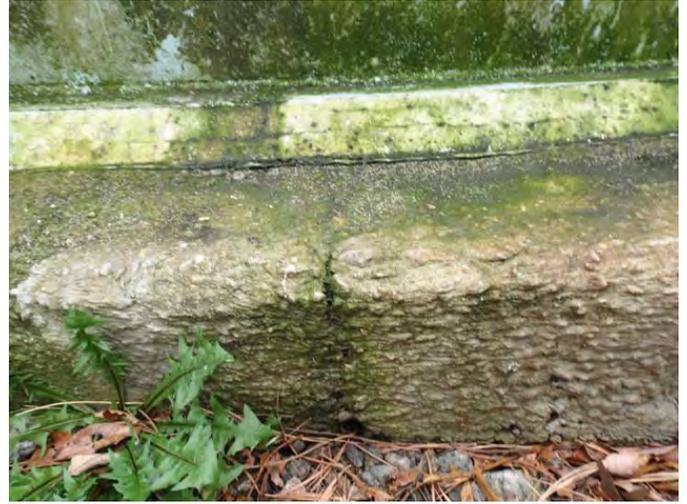
20 *Concrete Foundation With Tight Cracks*

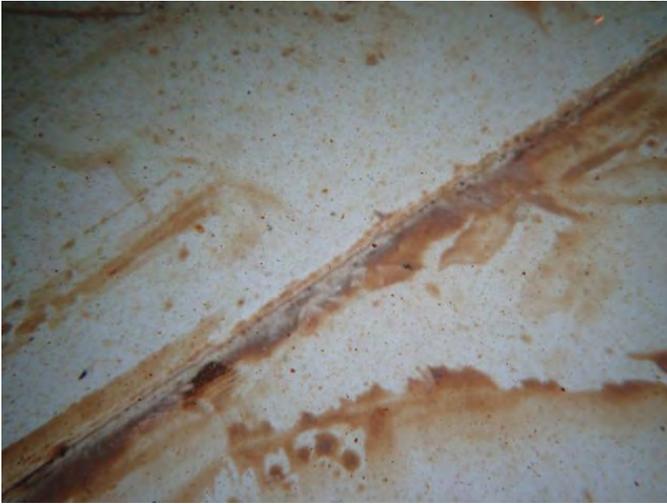
- A uniform layer of accumulated precipitate averaging 1.5” in depth, was found throughout the floor. All precipitate was vacuumed up during the cleaning process. A mild to moderate stain remained throughout the floor which was attributed to the precipitate. Mild staining was observed throughout the interior walls as well.

57 *Floor With Mild To Moderate Staining*

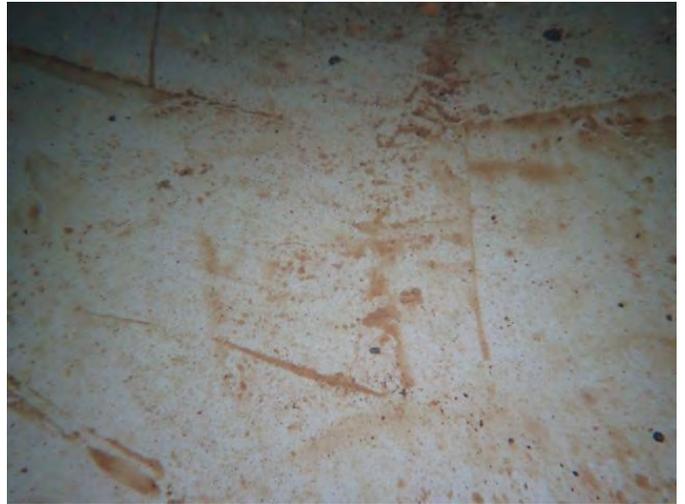
58 *Floor With Mild To Moderate Staining*

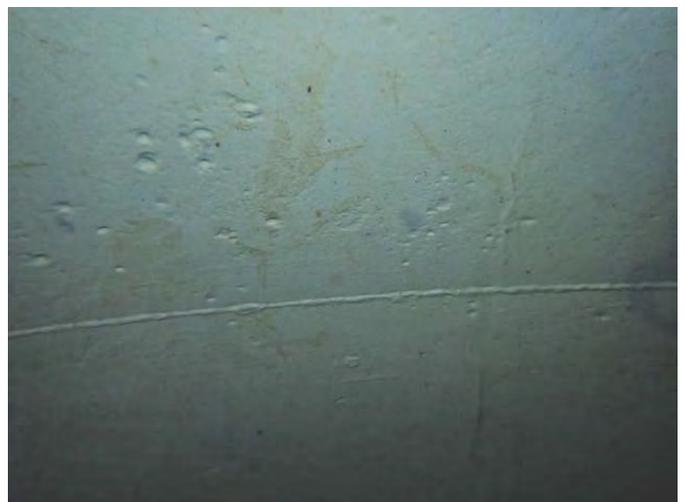
78 *Interior Wall With Mild Staining*

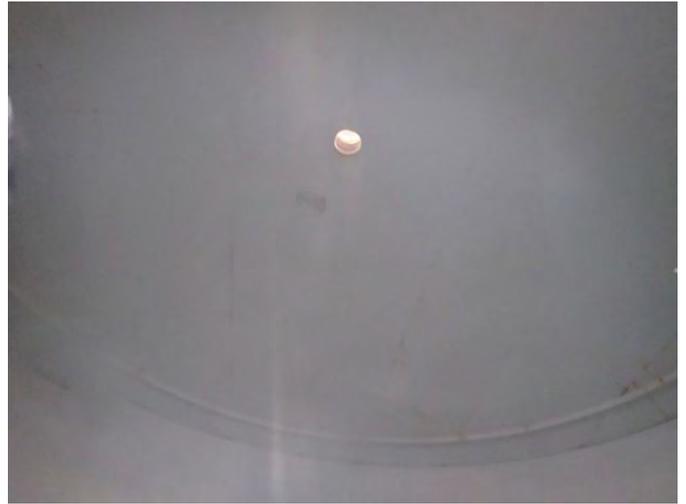
92 *Overhead With Mild Rust Staining*

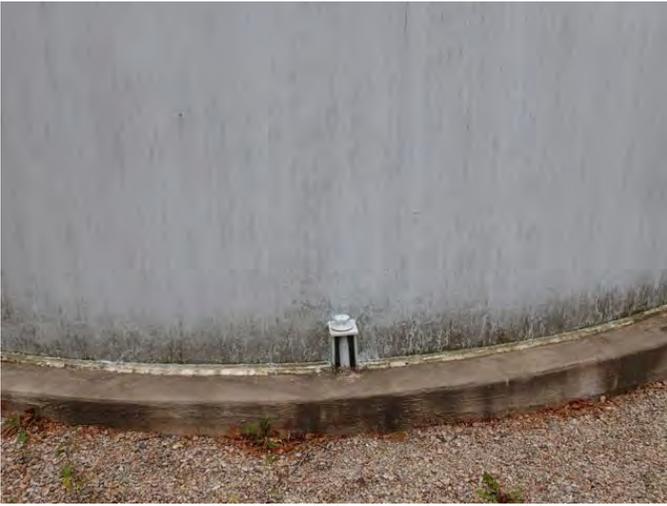
1 *Exterior Wall With Mild To Moderate Mildew*

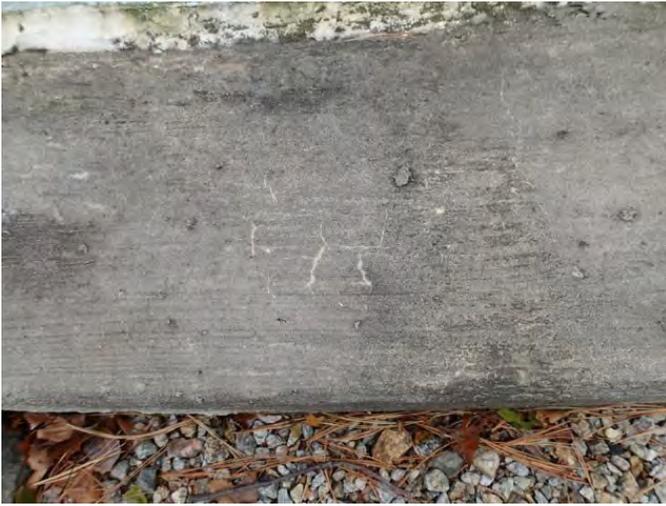
- The tank foundation is uncoated yet appeared mostly sound. Tight cracks were observed throughout less than 5% of the exposed surfaces. The cracks were sounded and appeared to be limited to the surface of the concrete and free of voids or spalls at this time. USI advised that these cracks should be monitored to ensure that concrete spall does not occur.

13 *Concrete Foundation With Tight Surface Cracks*

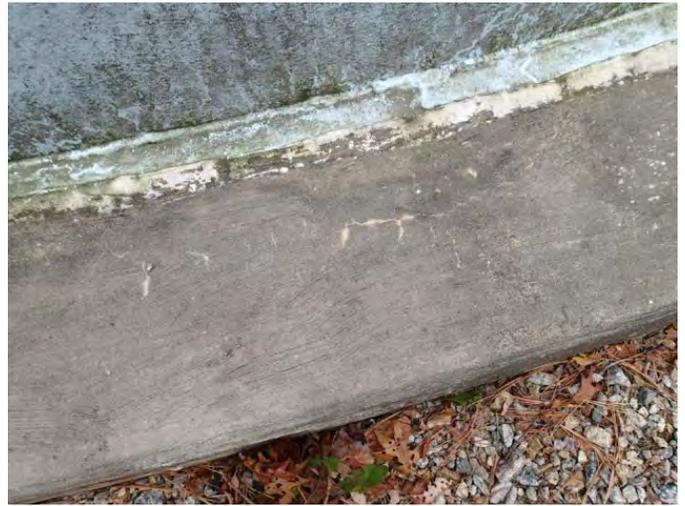
14 *Concrete Foundation With Tight Surface Cracks*

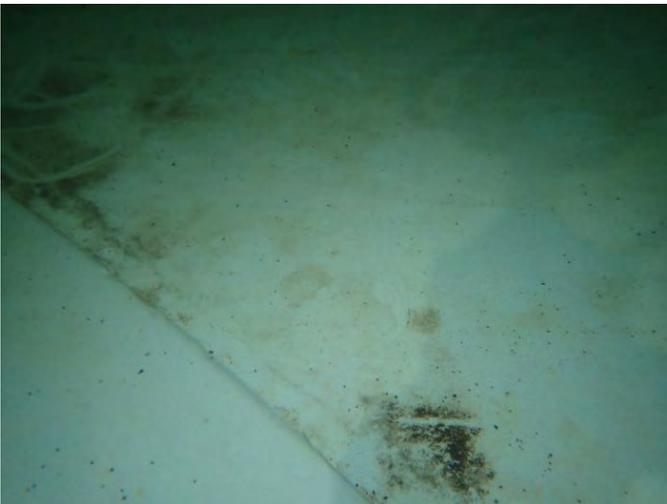
- The exterior access ladders are secure, and the coating system in good condition with a fall restraint system in place.
- A uniform layer of accumulated precipitate averaging 1" in depth, was found throughout the floor. All precipitate was vacuumed up during the cleaning process. A mild stain remained throughout the floor which was attributed to the precipitate. Mild staining was observed throughout the interior walls as well.

51 *Floor With Mild Staining*

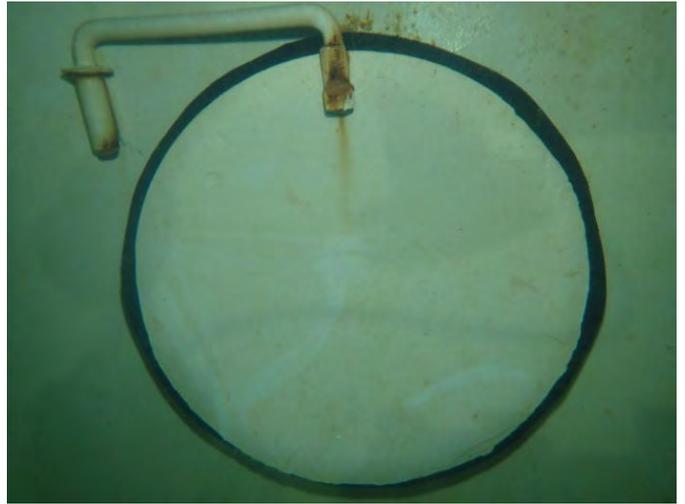
56 *Westernmost Manway Outer Circumference With Coating Loss And Mild Surface Corrosion*

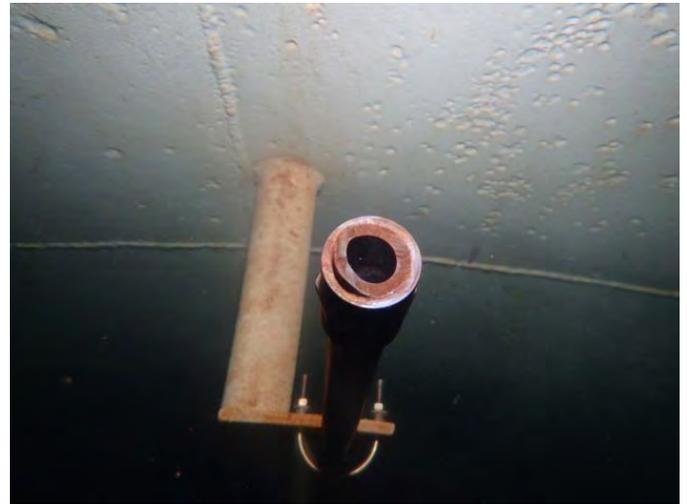
- The top 10' segment of the PVC sample piping support has failed, resulting in exposure of the steel surfaces at the site of the failed weld, with mild corrosion evident on the

76 *Failed Sample Pipe*

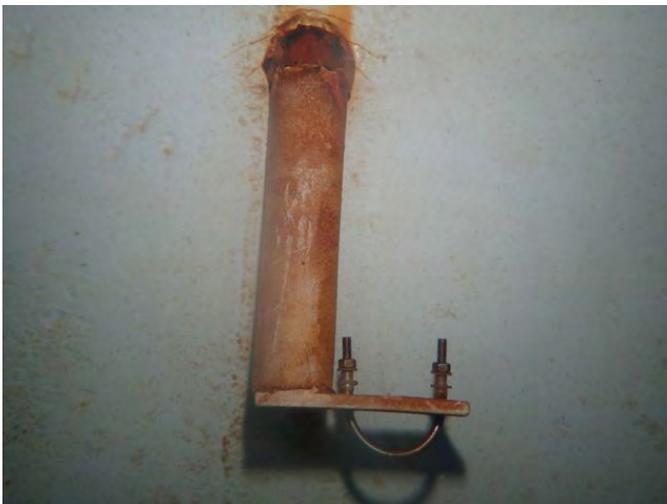
77 *Failed Sample Standoff Located 40' Above The Floor*

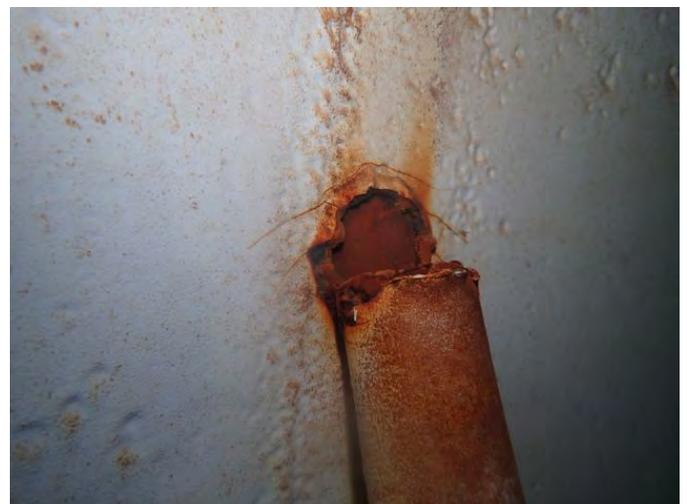
78 *Failed Sample Pipe Standoff Weld With Exposed Steel And Surface Corrosion*

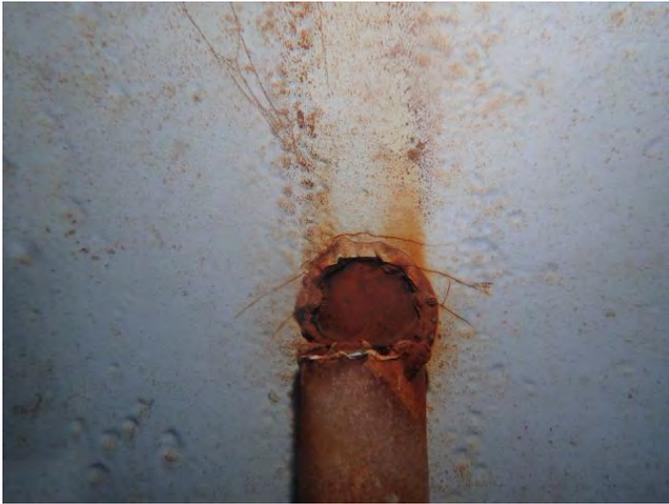
79 *Failed Sample Pipe Standoff Weld With Exposed Steel And Surface Corrosion*

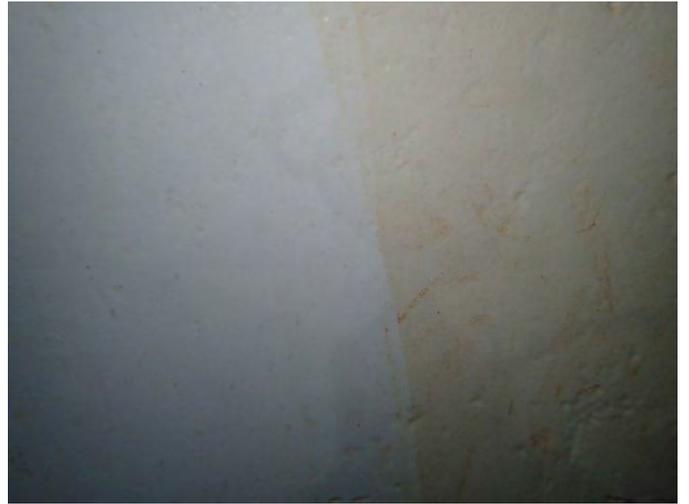
80 *Interior Wall With Mild Staining*

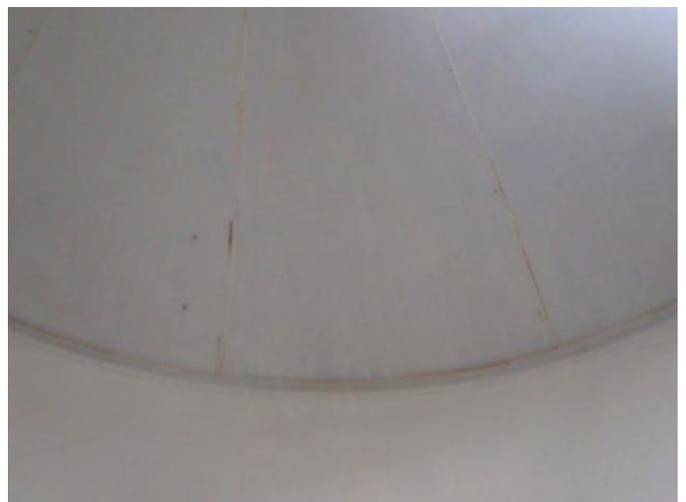
96 *Overhead With Mild Rust Staining*
