Smithfield, RI

# Clean Water Infrastructure Replacement Plan

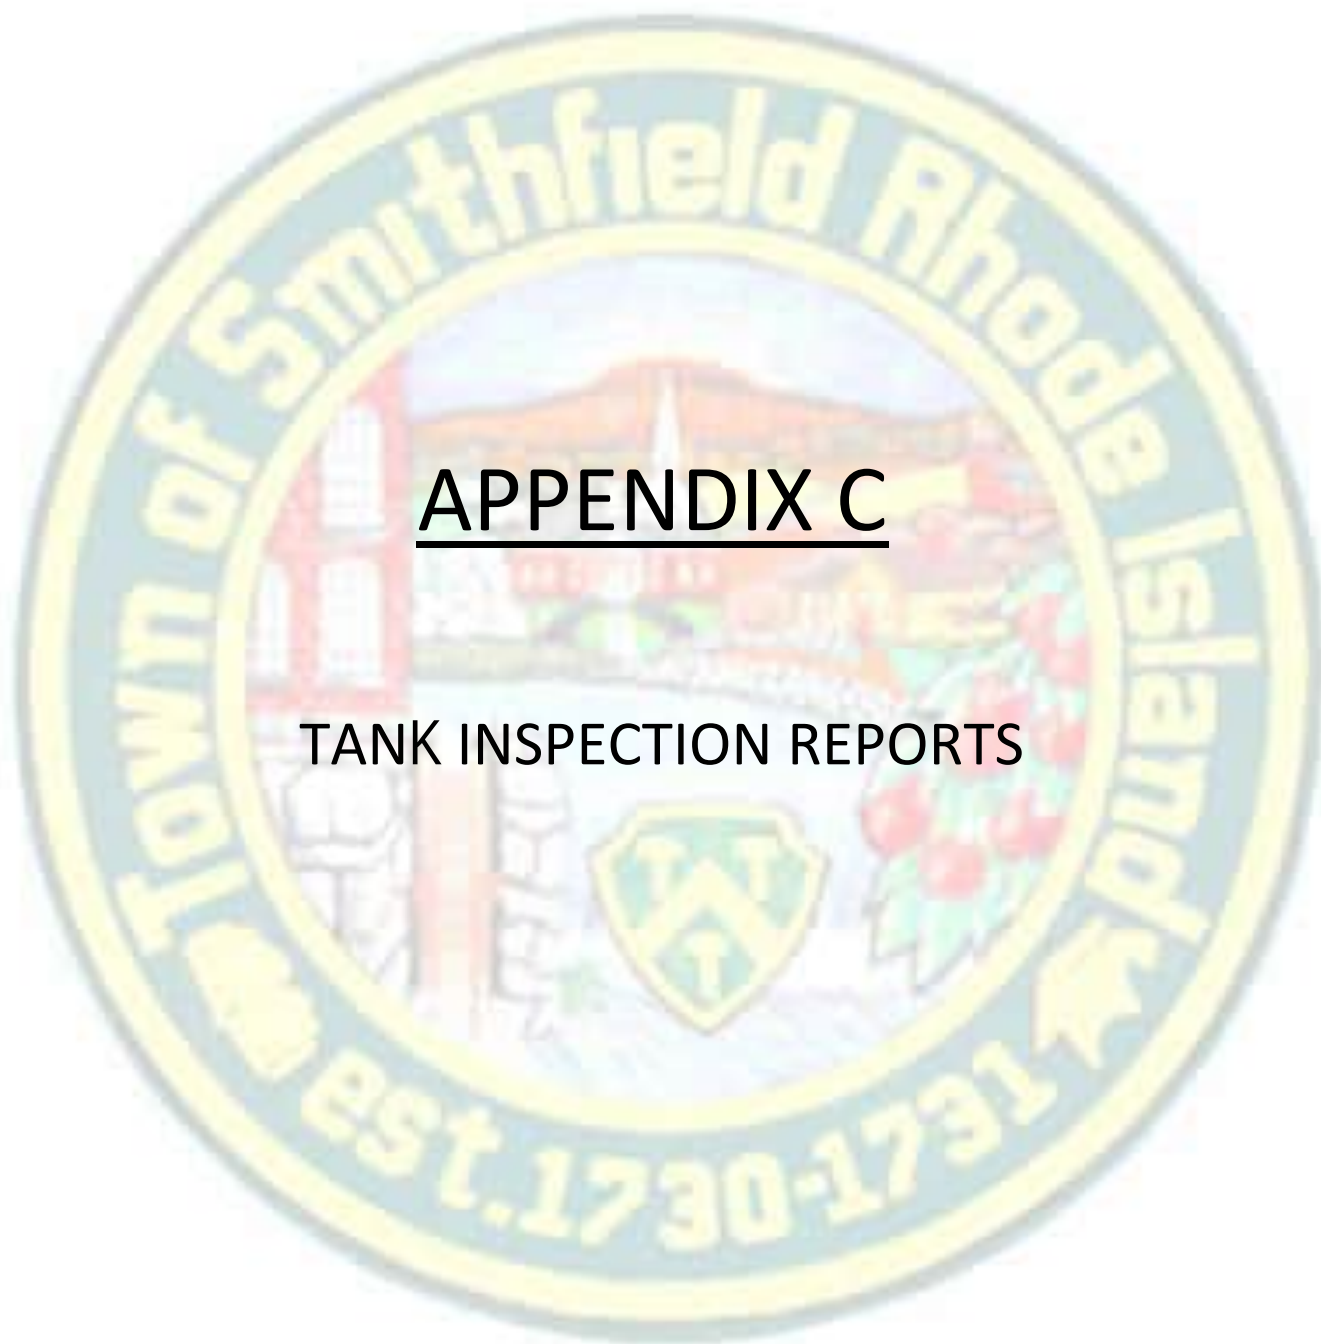
7) The Final Pipe Score is the sum of its Physical Rating and Location Rating. This dictates the pipe's ranking.

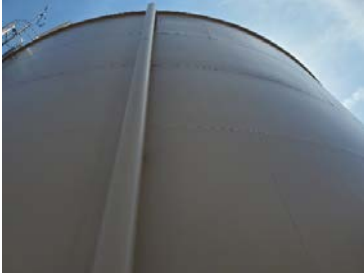
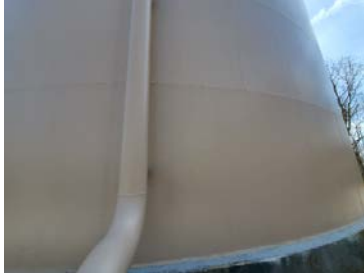
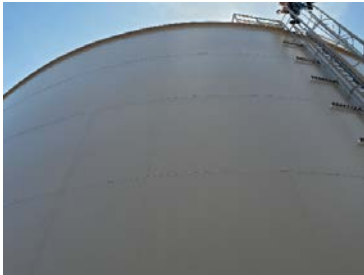
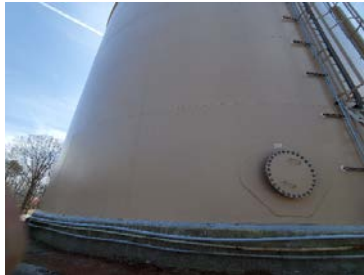
#### North Wall Exterior Aesthetics Photos

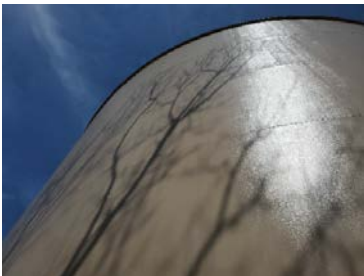
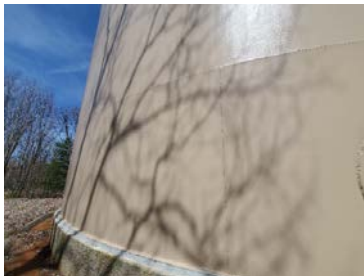
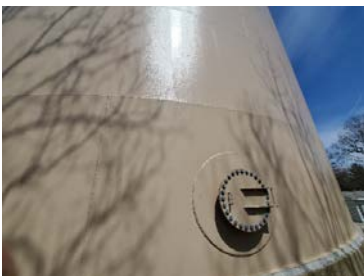
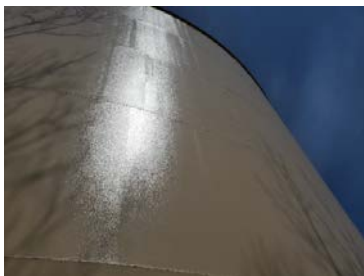
| EAST WALL | |

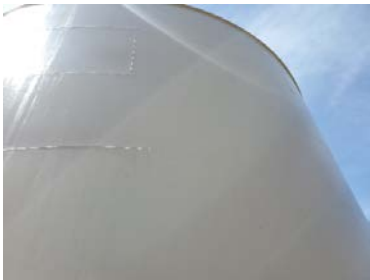
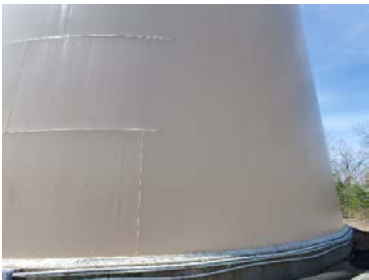
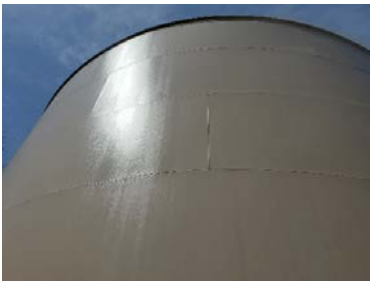
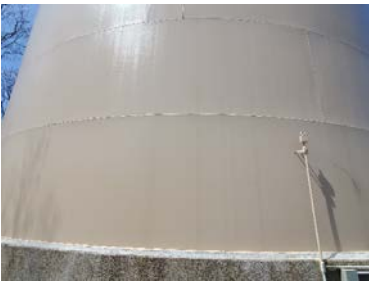
| WEST WALL | |

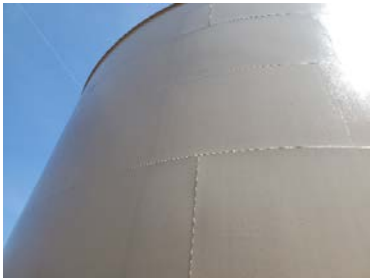
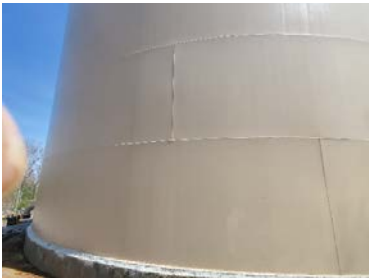
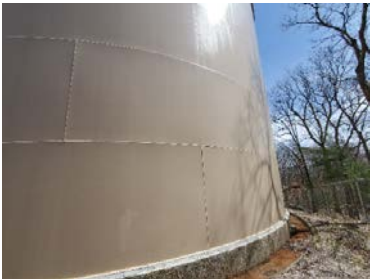
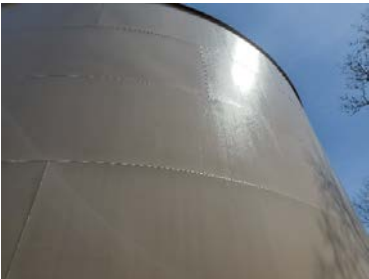
| <b>EXTERIOR WALL STRUCTURAL</b> |

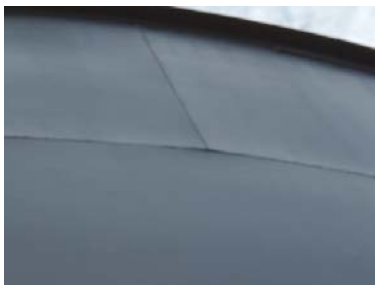
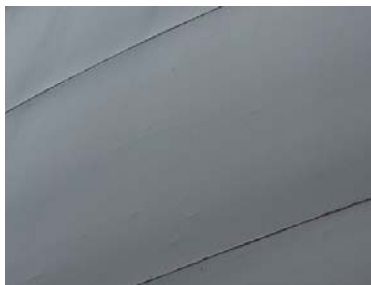
**MIDDLE SECTION NORTH WALL**

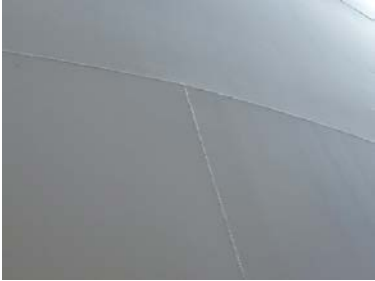
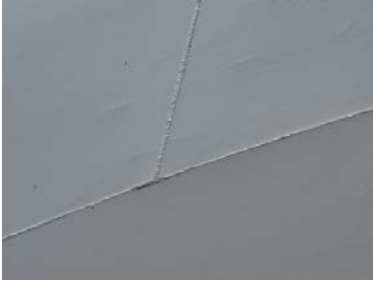
| LOWER SECTION NORTH WALL | |

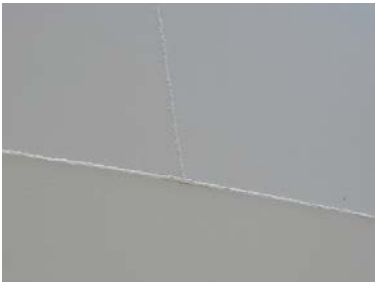
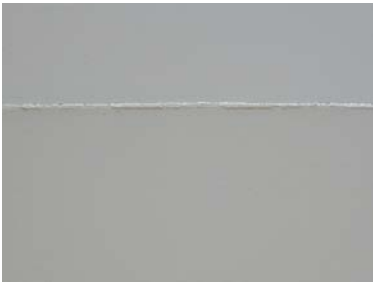
| UPPER SECTION SOUTH WALL | |

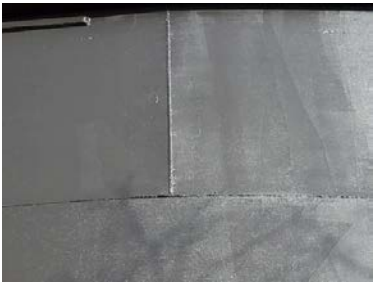
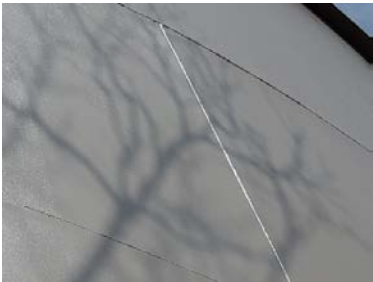
| MIDDLE SECTION SOUTH WALL | |

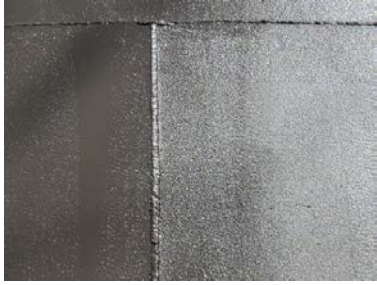
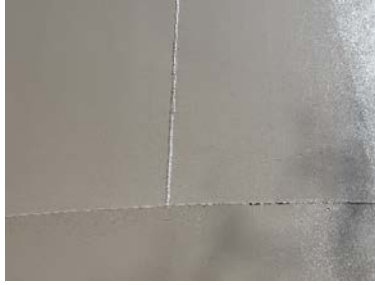
| LOWER SECTION SOUTH WALL | |

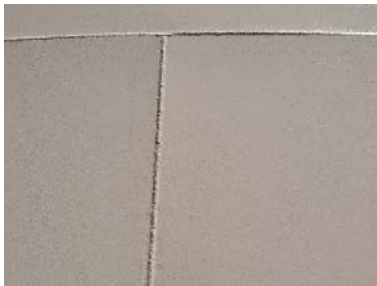
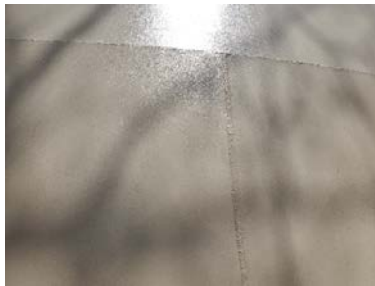
| UPPER SECTION EAST WALL | |

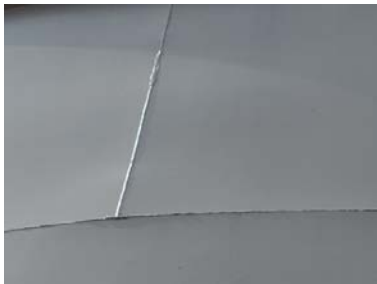
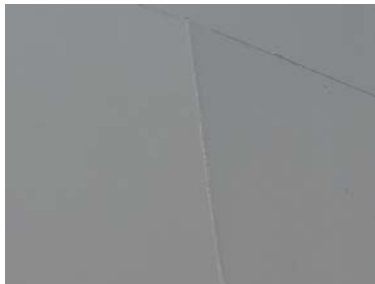
| MIDDLE SECTION EAST WALL | |

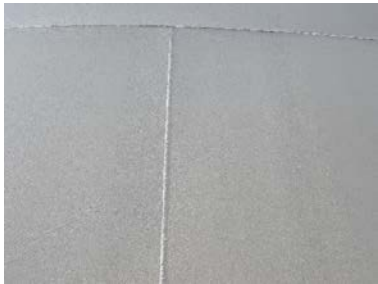
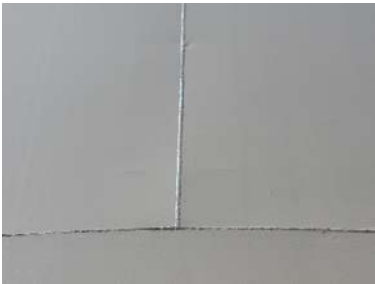
| LOWER SECTION EAST WALL | |

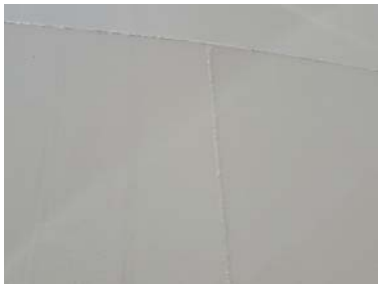
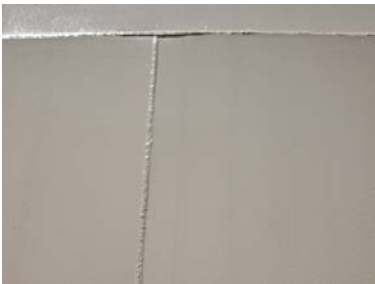
| UPPER SECTION WEST WALL | |

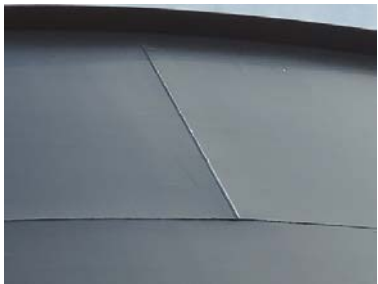
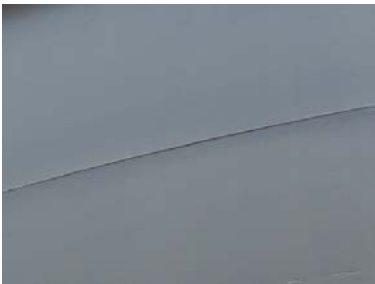
| MIDDLE SECTION WEST WALL | |

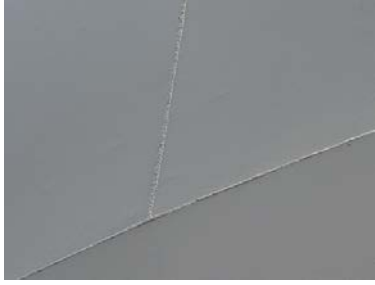
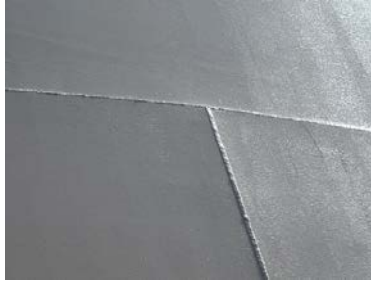
| <b>LOWER SECTION WEST WALL</b> | |

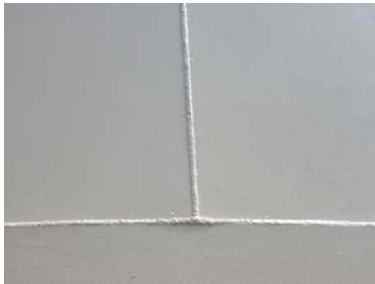
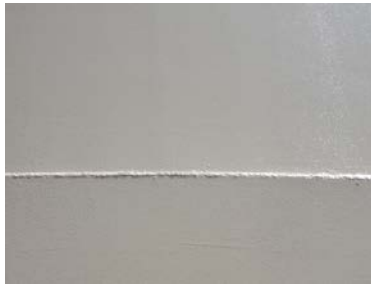
| <b>CATWALK</b> | |

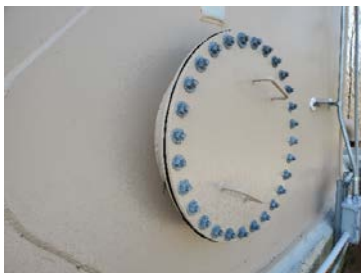
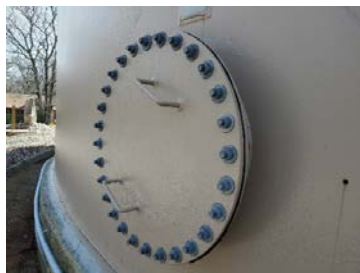
| EXTERIOR MANWAY #2 | |

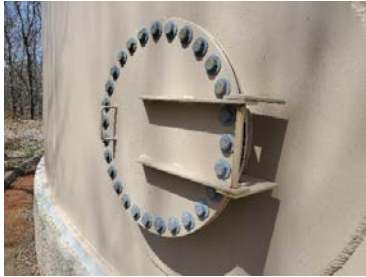
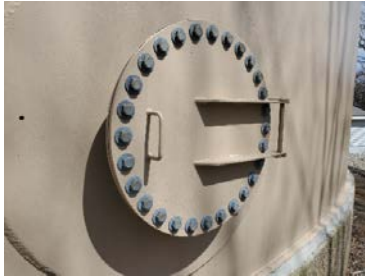
| EXTERIOR PIPING | |

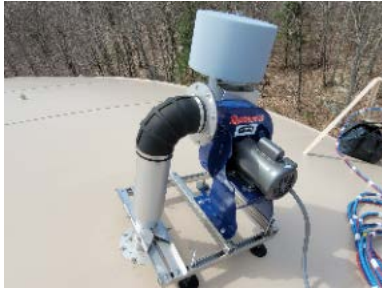
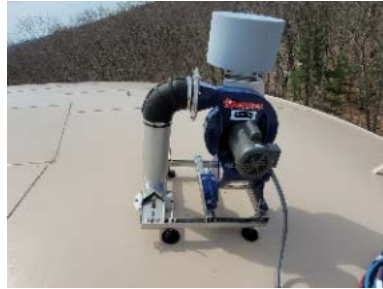
| EXTERIOR LADDER ACCESSIBILITY AND COMPLIANCE | |

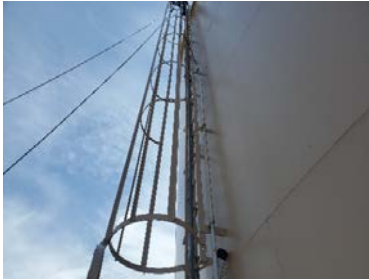
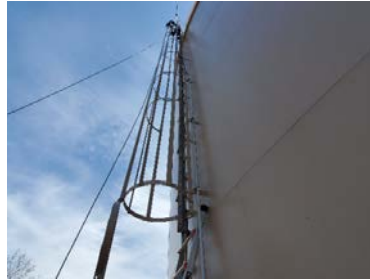
**EXPOSED FOUNDATION**

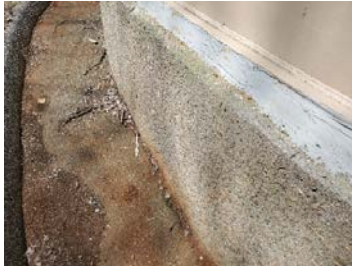
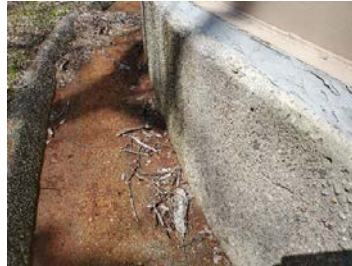
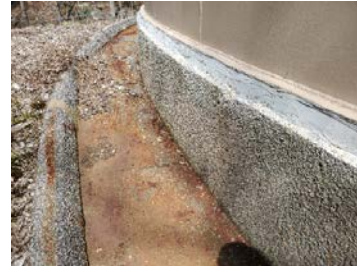
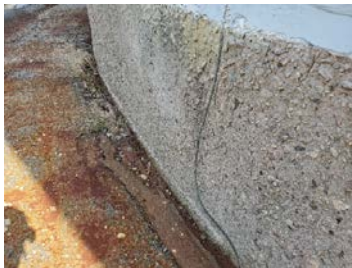
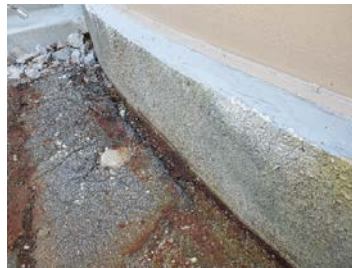
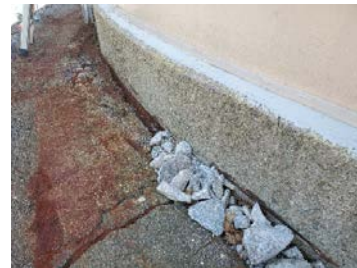
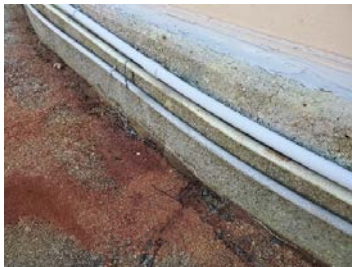
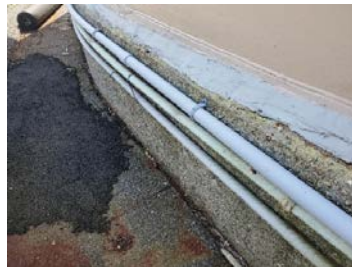
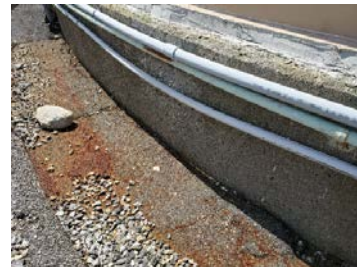
**Exposed Foundation Photos**

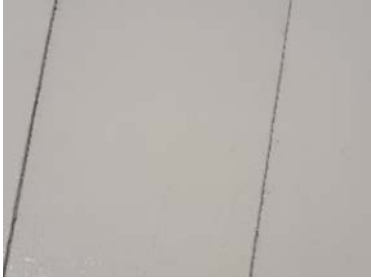
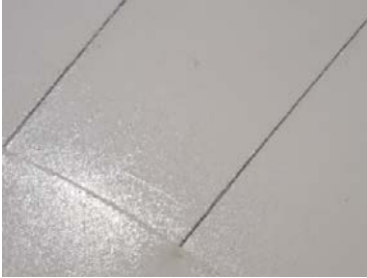
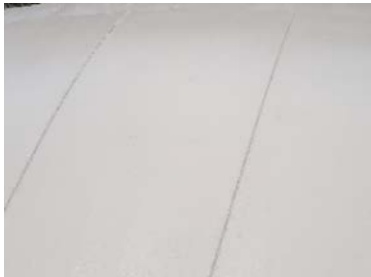
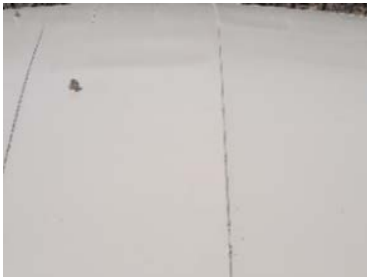
#### SOUTH ROOF QUADRANT AESTHETICS

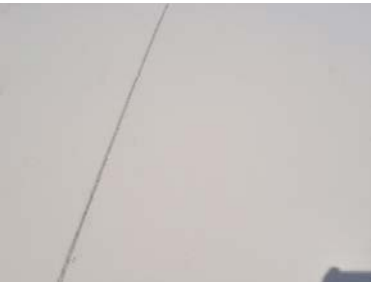
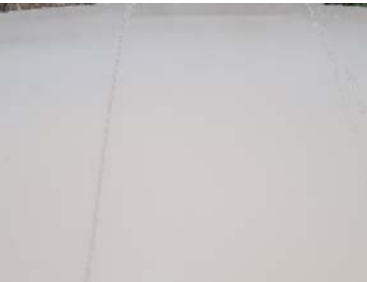
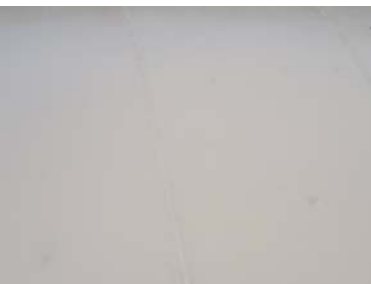
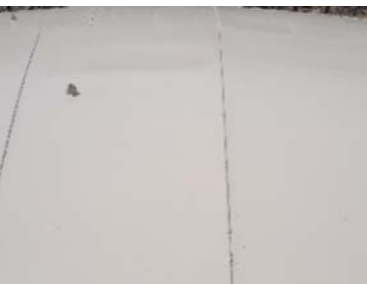
| EAST ROOF QUADRANT AESTHETICS | |

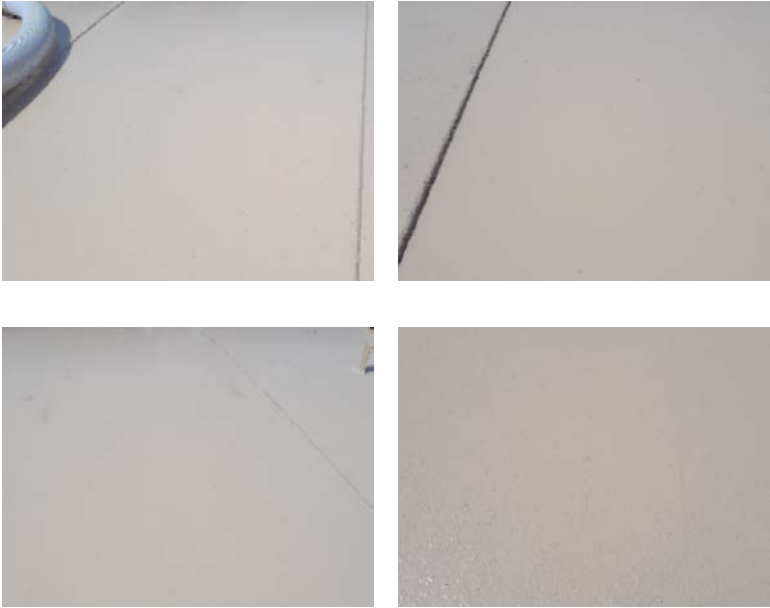
| WEST ROOF QUADRANT AESTHETICS | |

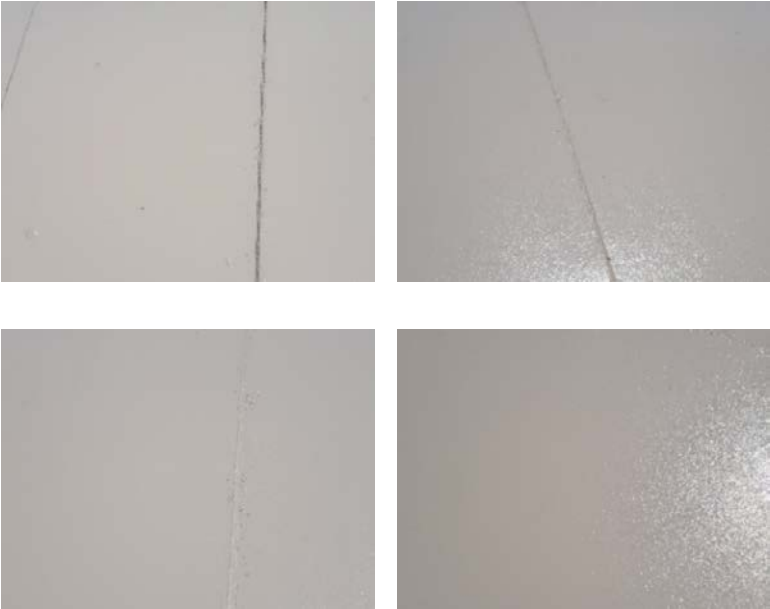
**EXTERIOR ROOF STRUCTURAL****NORTH ROOF STRUCTURAL**

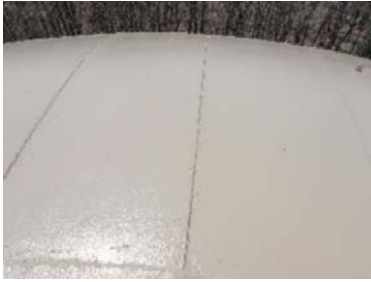
North Quadrant- Photo of welds

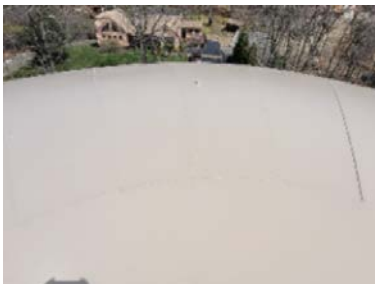
South Quadrant- Photo of welds

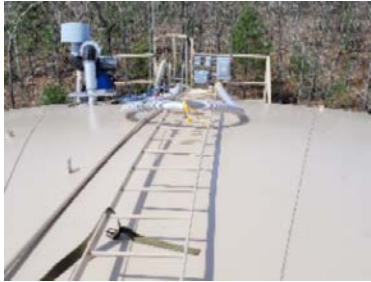
East Quadrant- Photo of welds

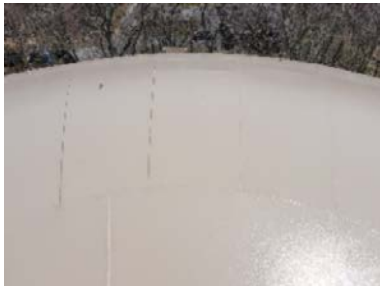
East Quadrant- Photo of welds

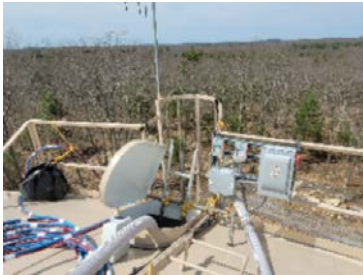
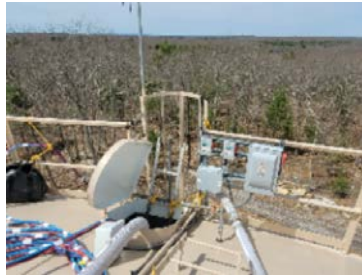
Safety Railing Photos

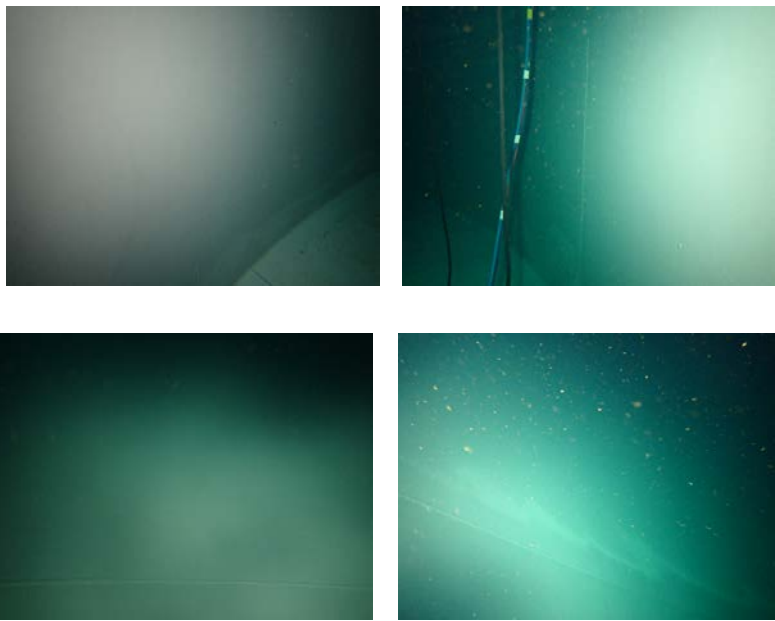
INTERIOR WALLS AESTHETICS

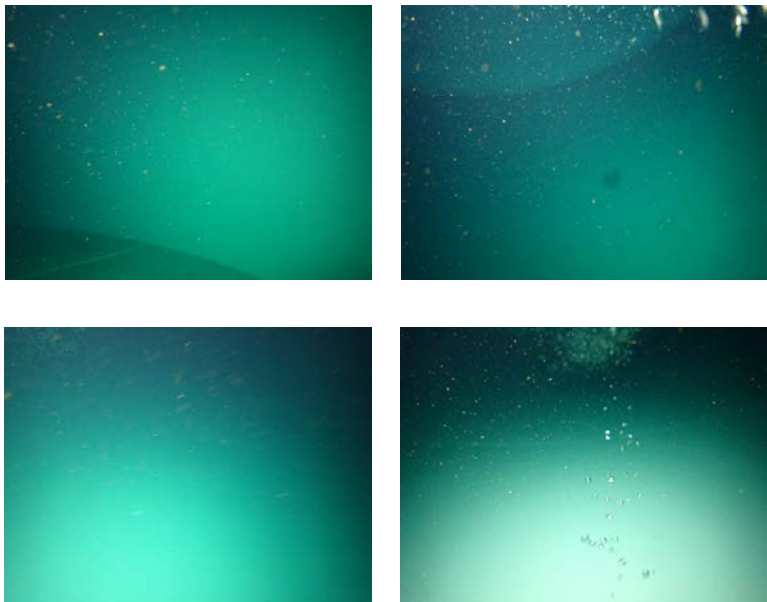
INTERIOR WALLS AESTHETICS

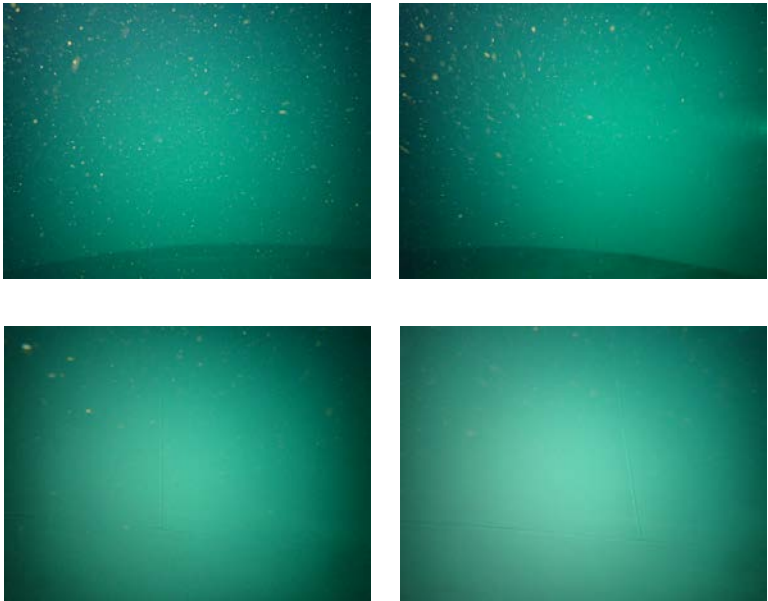
INTERIOR WALLS AESTHETICS

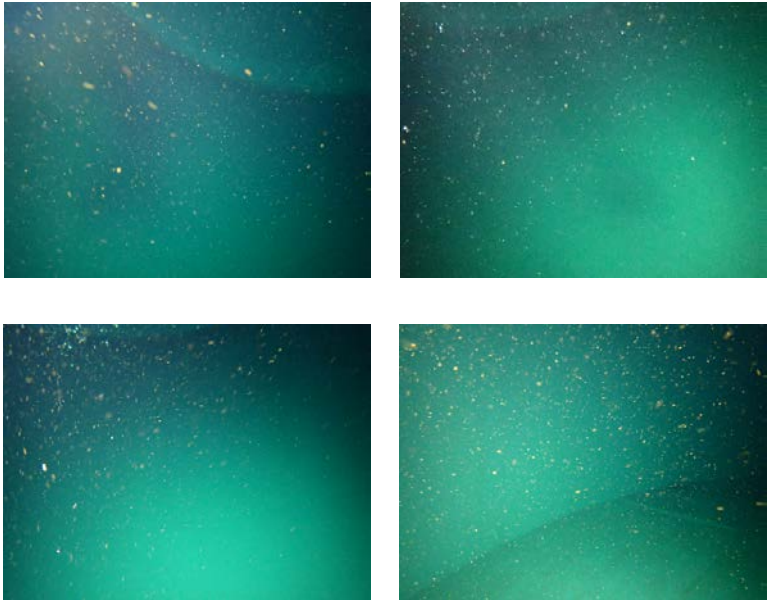
INTERIOR WALLS STRUCTURAL

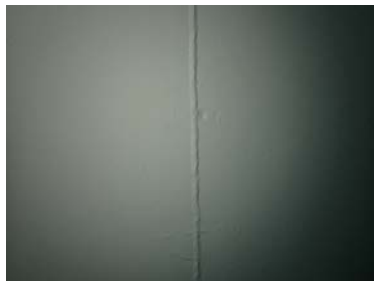
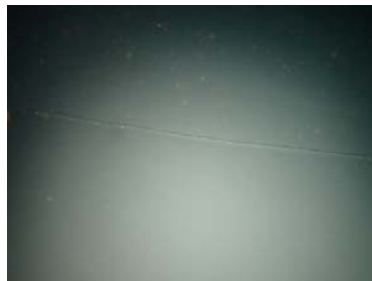
| MIDDLE SECTION NORTH WALL | |

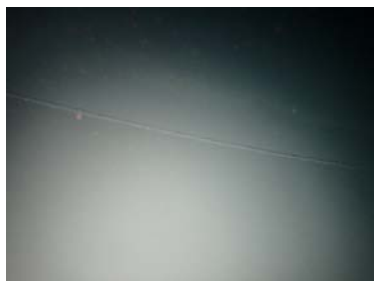
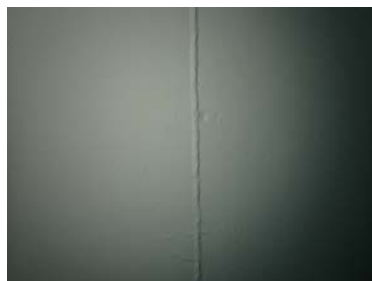
| LOWER SECTION NORTH WALL | |

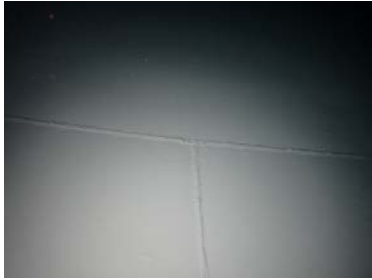
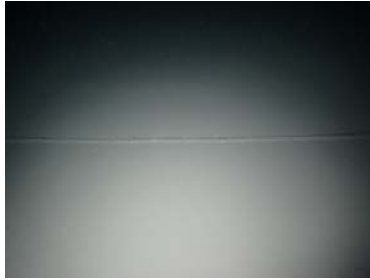
| UPPER SECTION SOUTH WALL | |

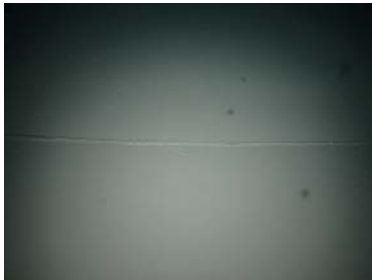
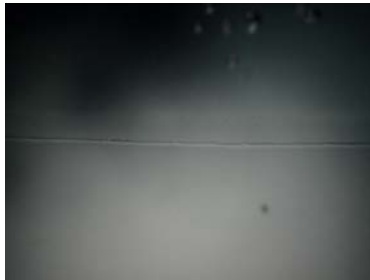
| MIDDLE SECTION SOUTH WALL | |

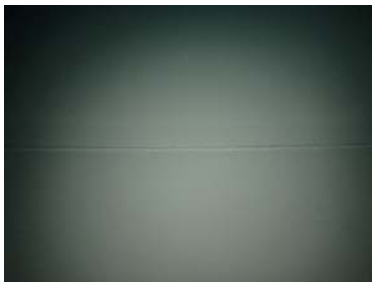
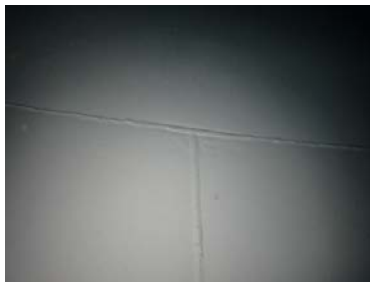
| LOWER SECTION SOUTH WALL | |

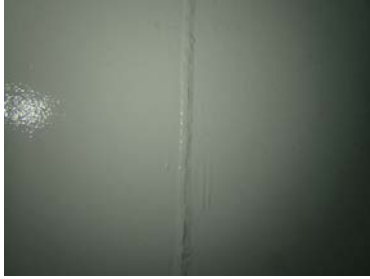
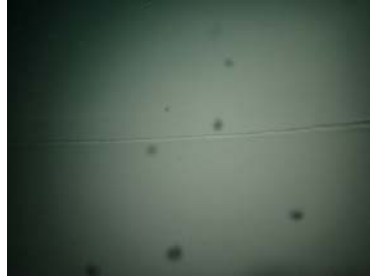
**UPPER SECTION EAST WALL**

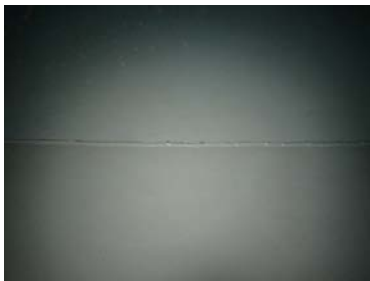
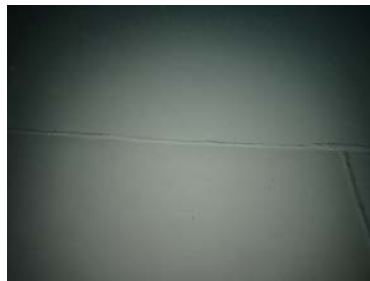
**MIDDLE SECTION EAST WALL**

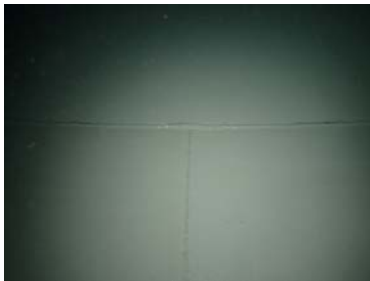
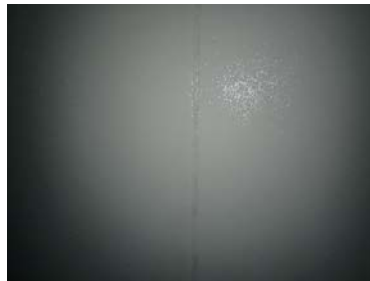
**LOWER SECTION EAST WALL**

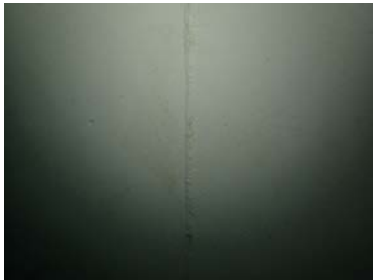
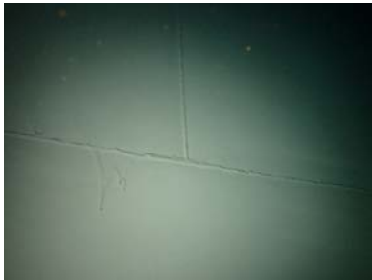
| UPPER SECTION WEST WALL | |

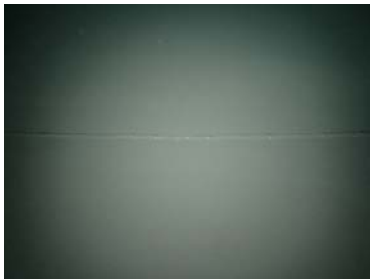
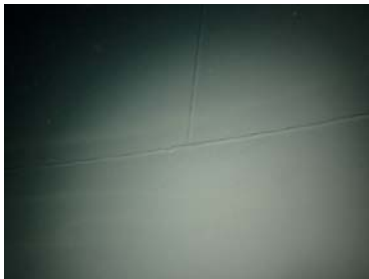
| MIDDLE SECTION WEST WALL | |

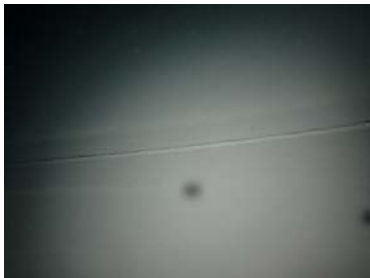
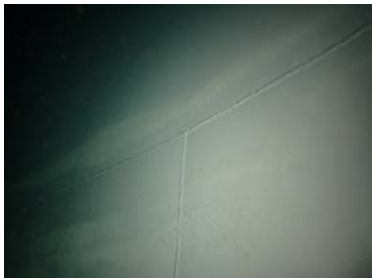
| LOWER SECTION WEST WALL | |

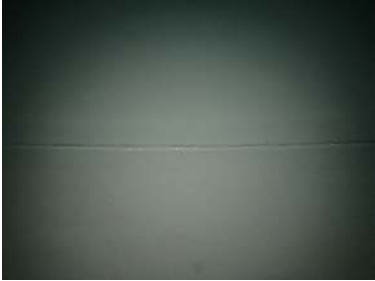
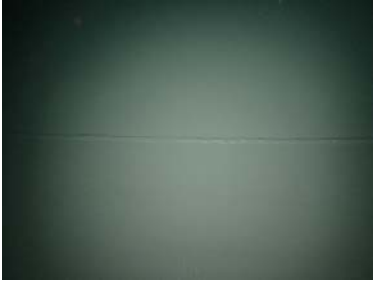
INTERIOR FLOOR NORTH QUADRANT AESTHETICS

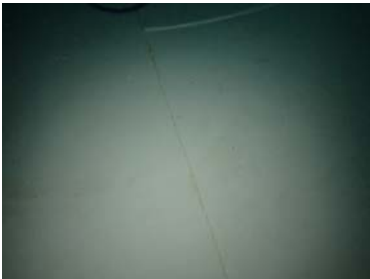
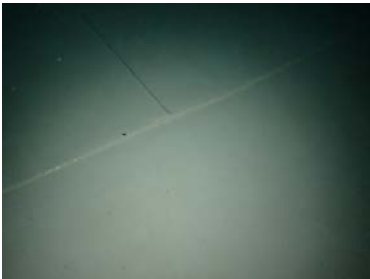
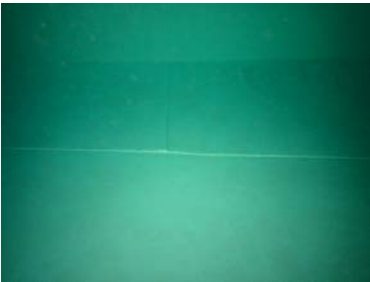
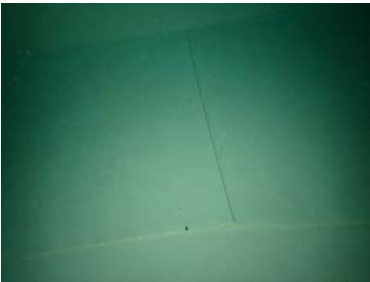
INTERIOR FLOOR SOUTH QUADRANT AESTHETICS

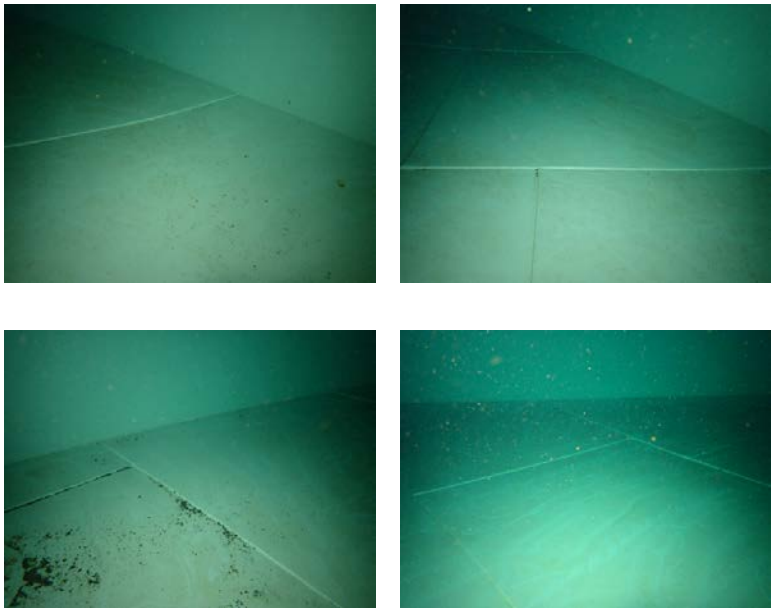
INTERIOR FLOOR EAST QUADRANT AESTHETICS

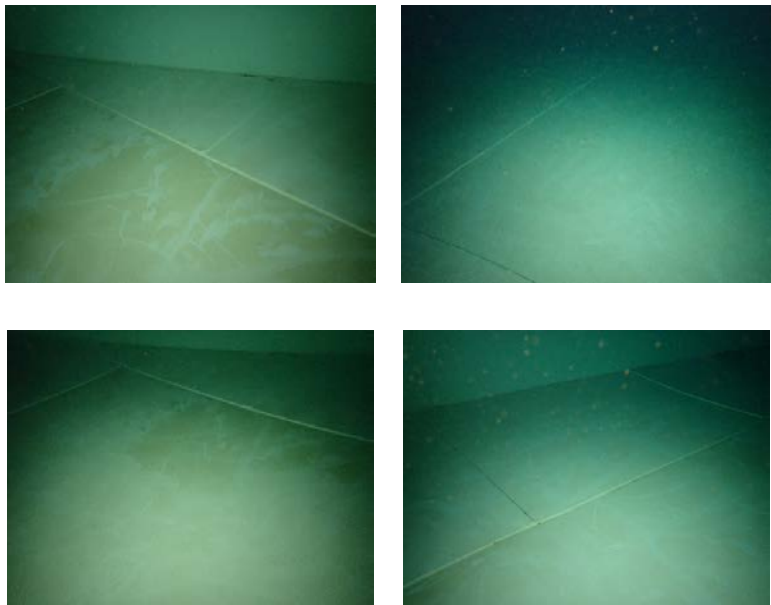
## INTERIOR FLOOR WEST QUADRANT AESTHETICS

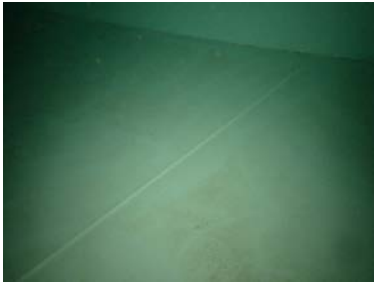
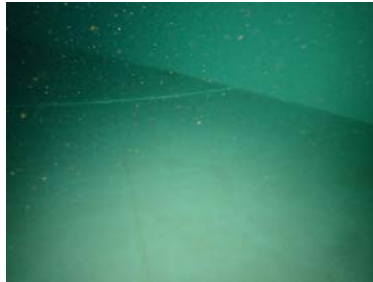
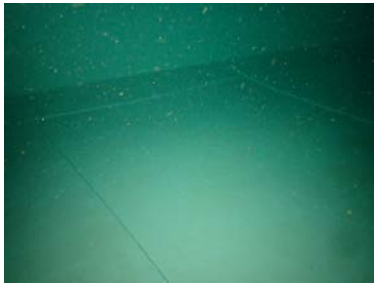
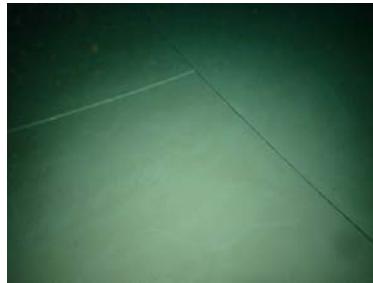
## INTERIOR FLOORS STRUCTURAL

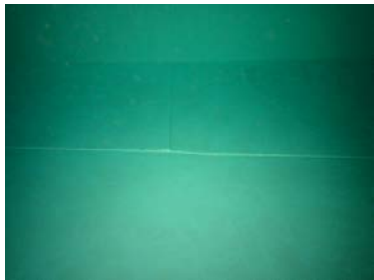
North Quadrant- Photo of welds

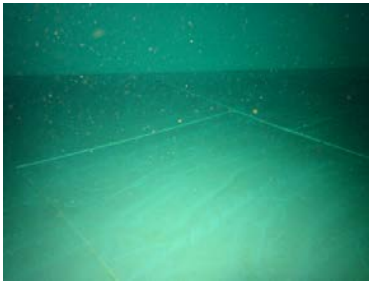
South Quadrant- Photo of welds

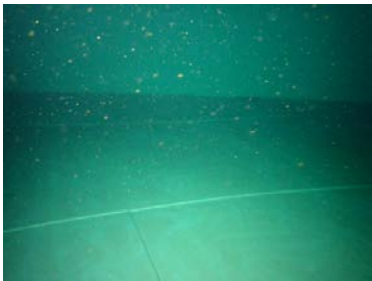
East Quadrant- Photo of welds

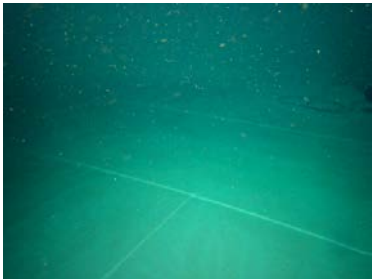
West Quadrant- Photo of welds

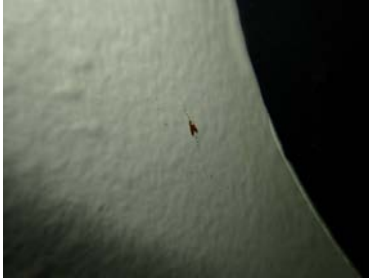
Interior Manway #1 Photo of corrosion

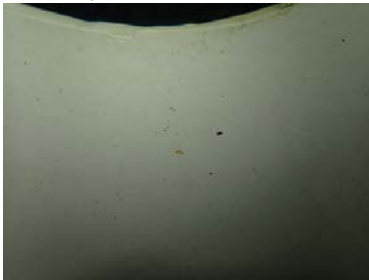
Interior Manway Photos

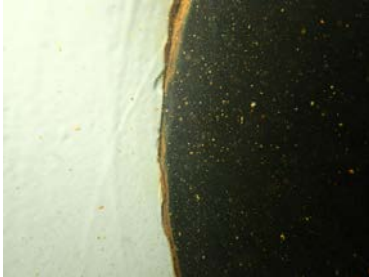
Interior Manway #2 Photo of corrosion

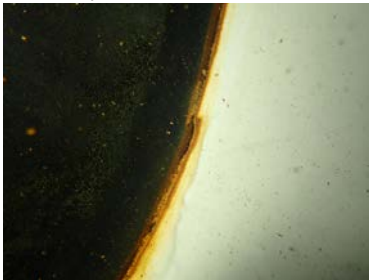
Interior Manway #2 Photos

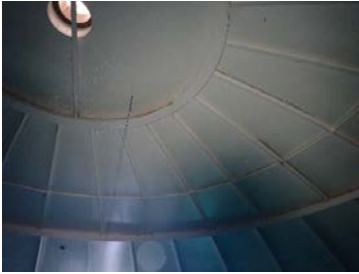
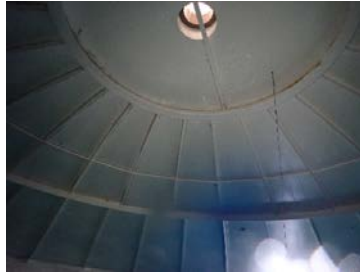
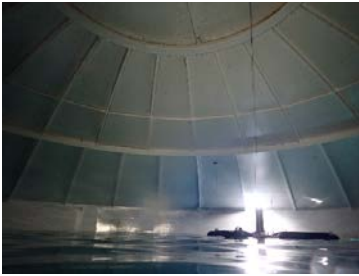
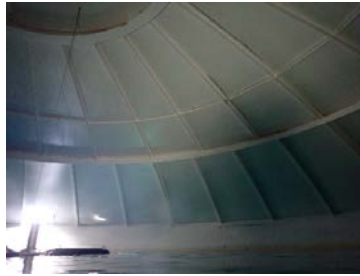
#### SOUTH OVERHEAD AESTHETICS QUADRANT

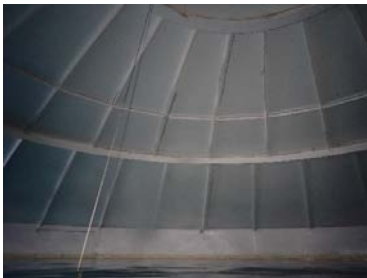
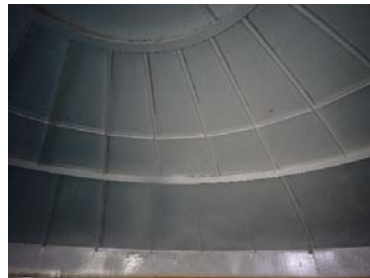
#### South Overhead Aesthetics Photos

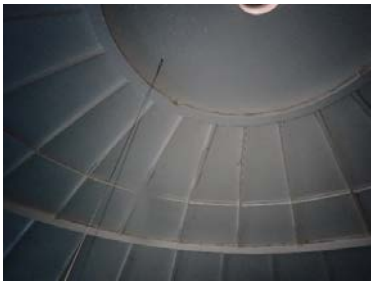
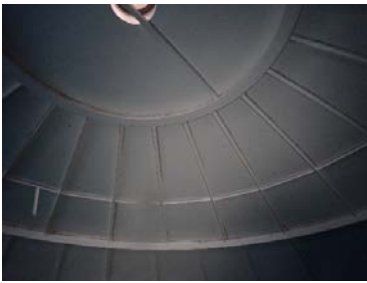
| EAST OVERHEAD AESTHETICS QUADRANT | |

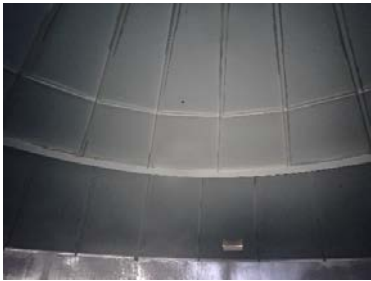
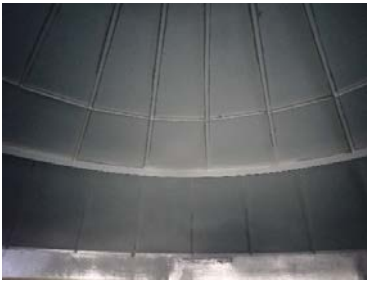
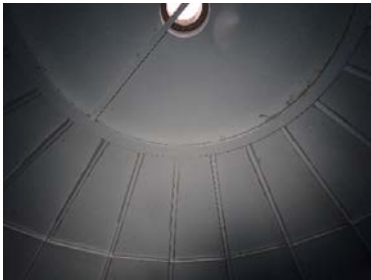
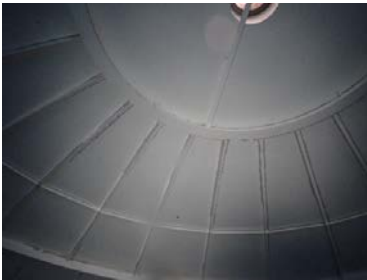
| WEST OVERHEAD AESTHETICS QUADRANT | |

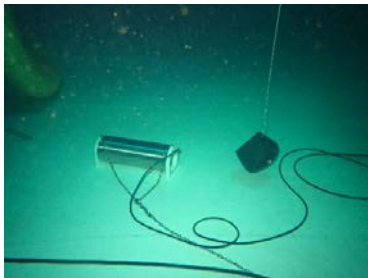
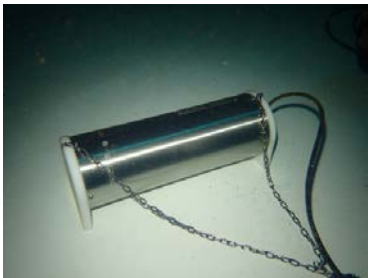
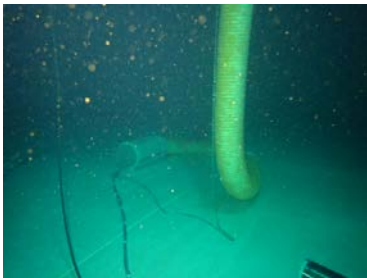
SITE SECURITY UPON COMPLETION

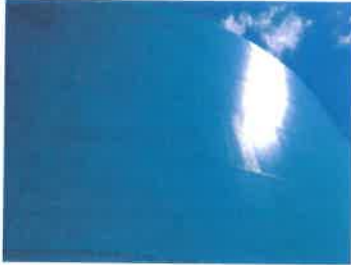
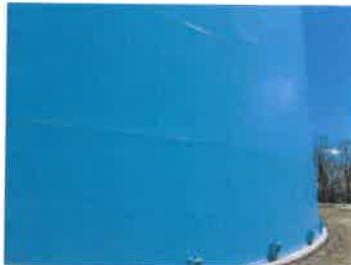
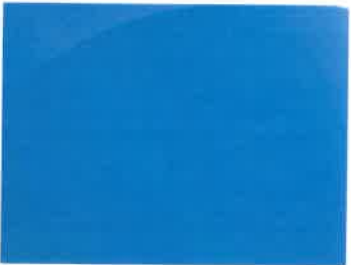
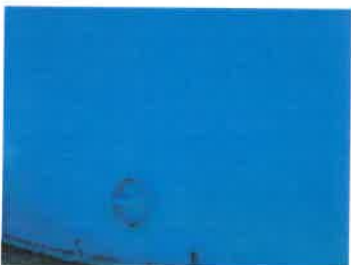
| SOUTH WALL | |

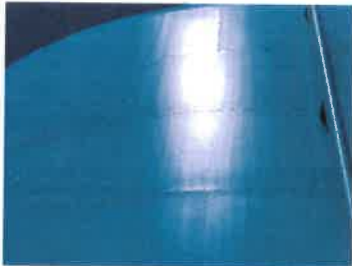
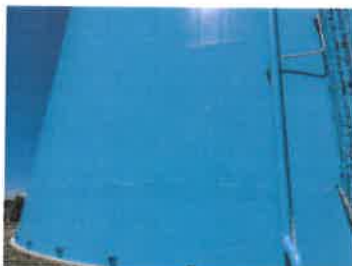
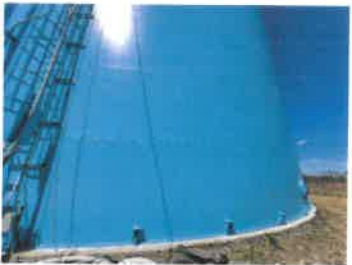
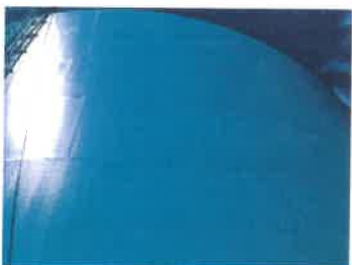
| EAST WALL | |

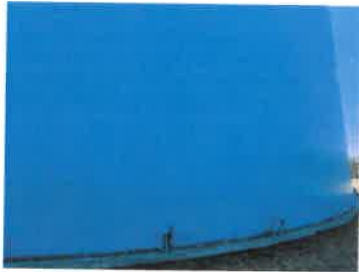
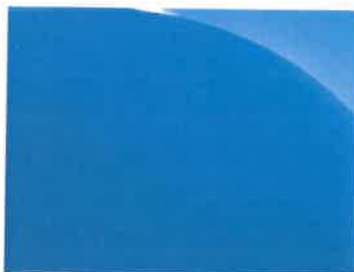
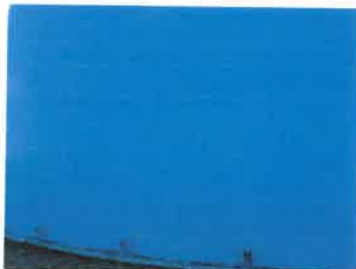
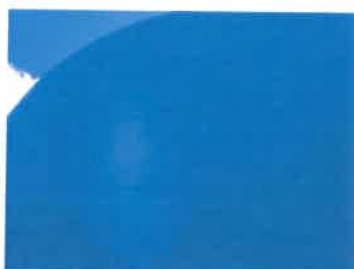
| WEST WALL | |

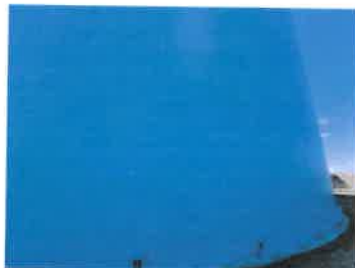
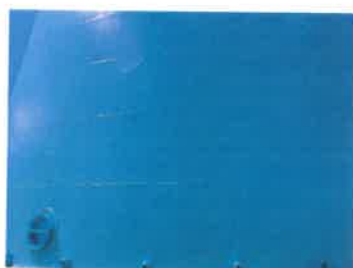
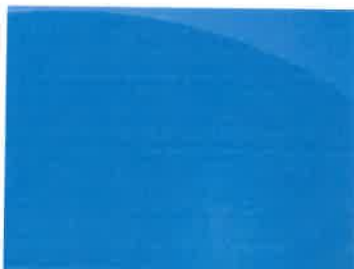
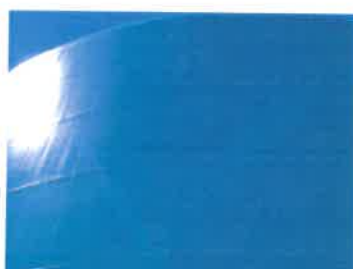
**EXTERIOR WALL STRUCTURAL****UPPER SECTION NORTH WALL**

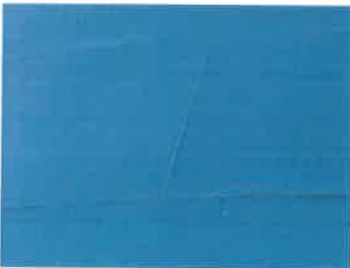
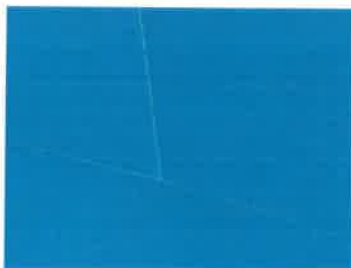
**MIDDLE SECTION NORTH WALL**

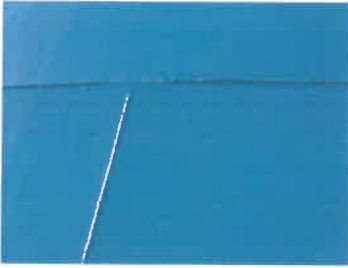
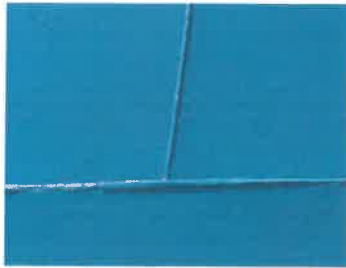
| <b>LOWER SECTION NORTH WALL</b> | |

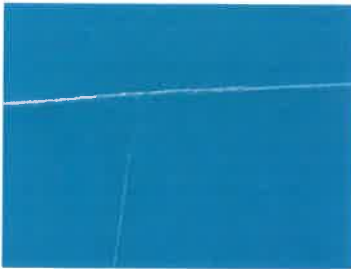
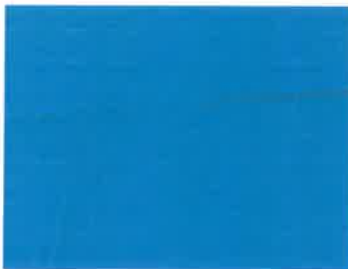
| <b>UPPER SECTION SOUTH WALL</b> | |

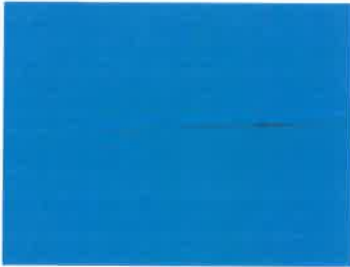
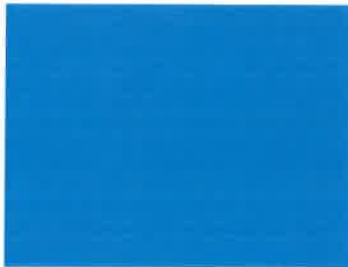
| <b>MIDDLE SECTION SOUTH WALL</b> | |

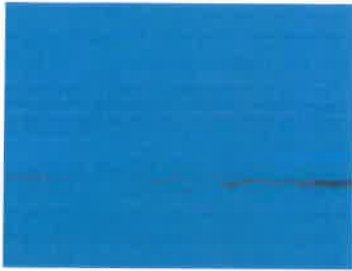
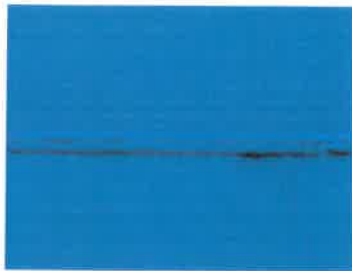
| LOWER SECTION SOUTH WALL | |

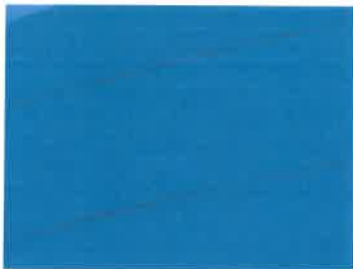
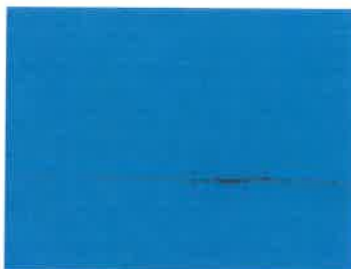
| UPPER SECTION EAST WALL | |

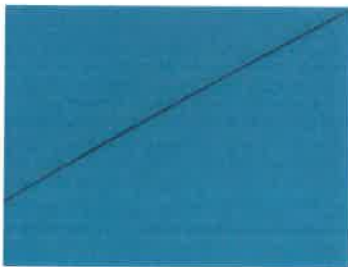
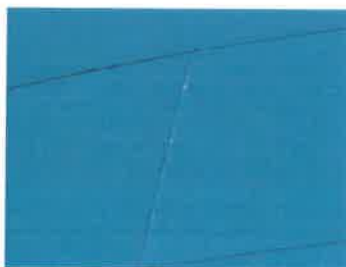
| MIDDLE SECTION EAST WALL | |

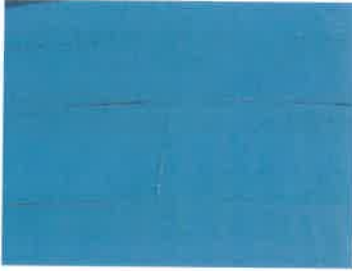
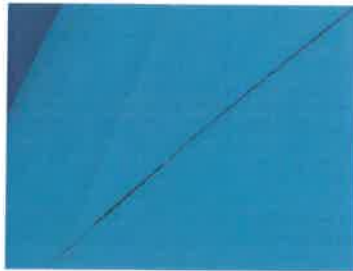
**LOWER SECTION EAST WALL**

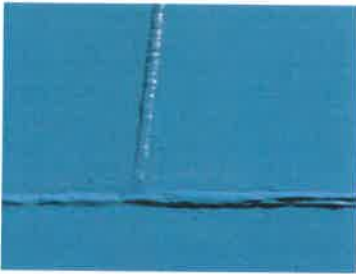
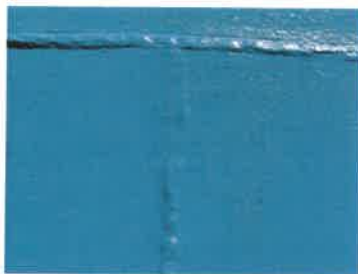
**UPPER SECTION WEST WALL**

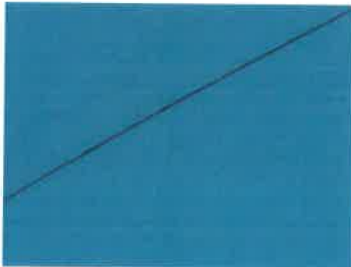
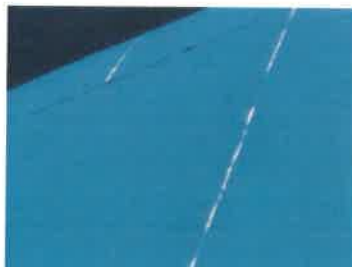
**MIDDLE SECTION WEST WALL**

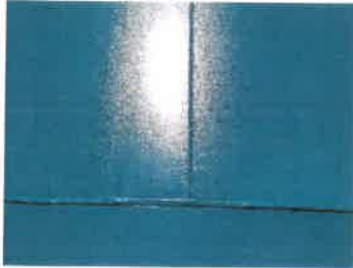
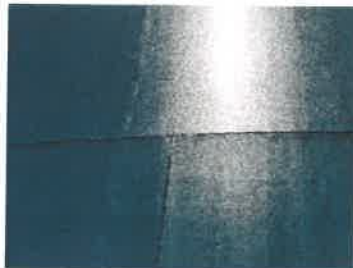
**LOWER SECTION WEST WALL**

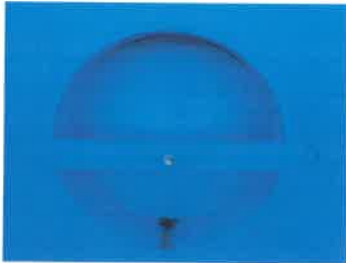
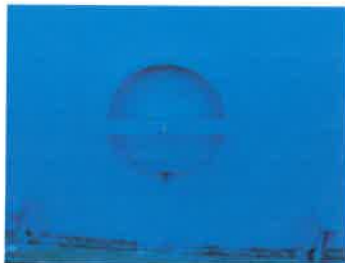
| EXTERIOR PIPING | |

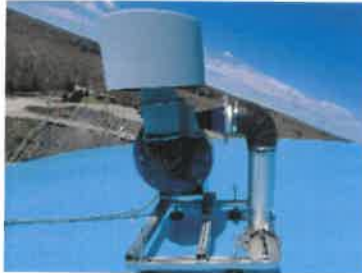
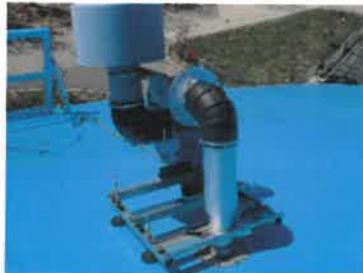
| EXTERIOR LADDER ACCESSIBILITY AND COMPLIANCE | |
