Smithfield, RI

# Clean Water Infrastructure Replacement Plan

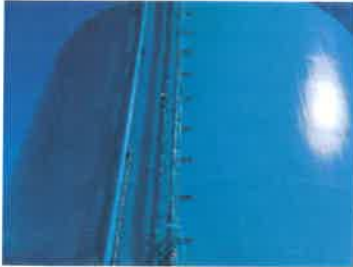
**EXPOSED FOUNDATION**

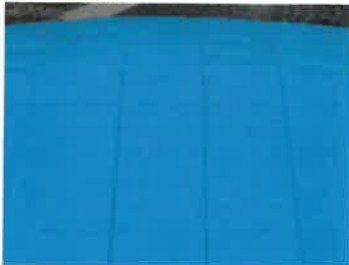
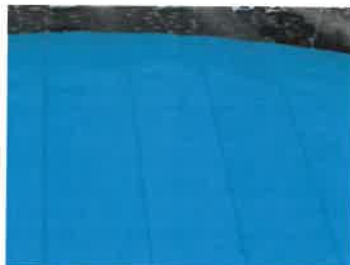
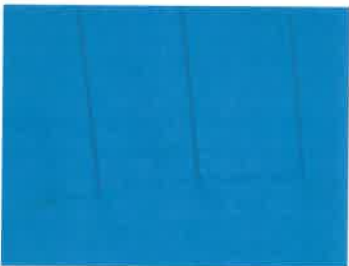
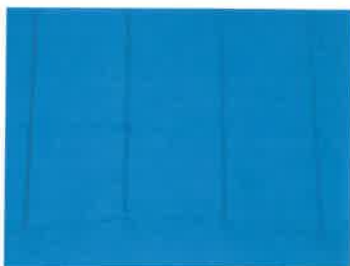
#### SOUTH ROOF QUADRANT AESTHETICS

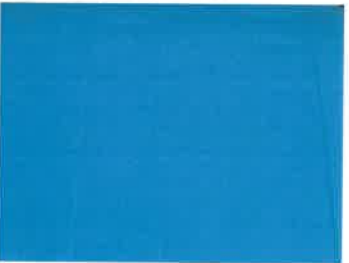
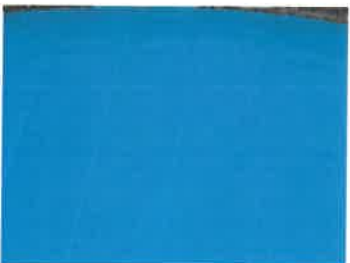
South Roof Quadrant Aesthetic Photos

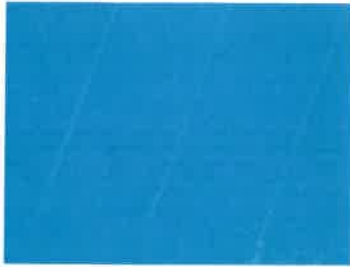
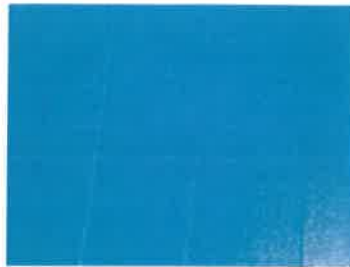
| EAST ROOF QUADRANT AESTHETICS | |

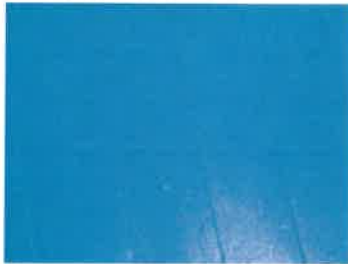
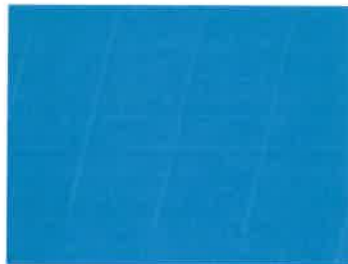
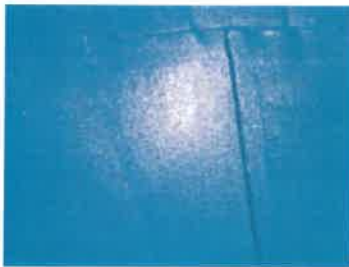
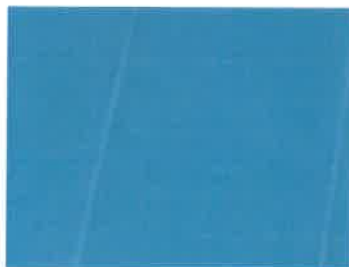
| WEST ROOF QUADRANT AESTHETICS | |

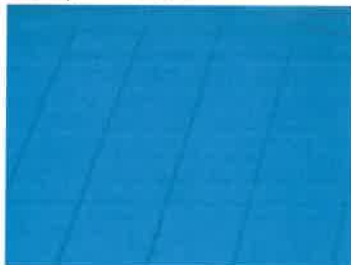
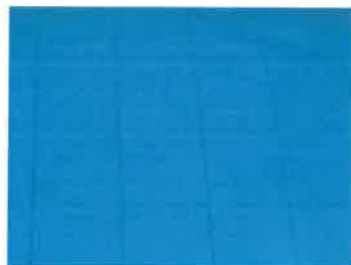
West Roof Quadrant Aesthetics Photos

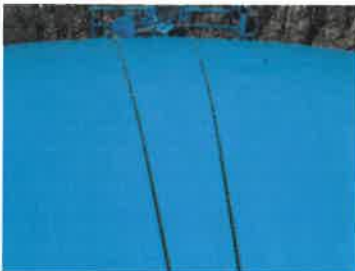
East Quadrant- Photo of welds

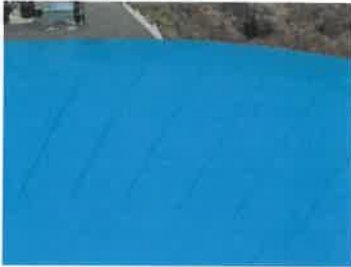
West Quadrant- Photo of welds

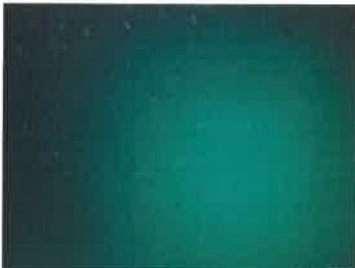
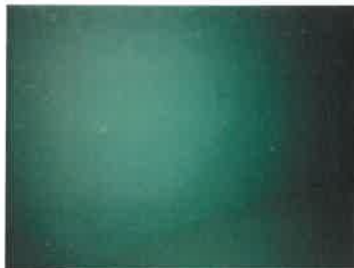
North Wall Aesthetics Photos

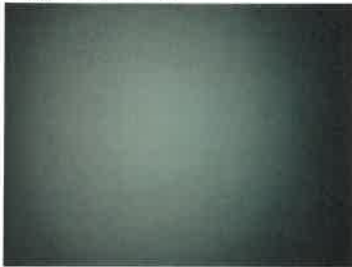
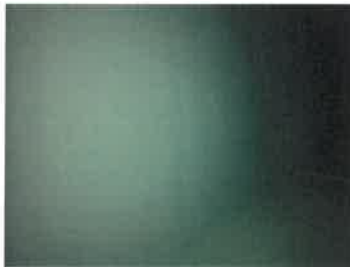
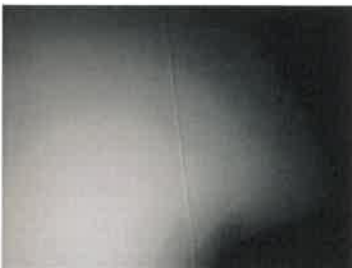
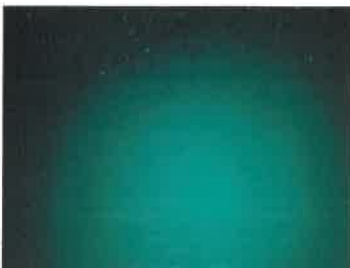
# **INTERIOR WALLS AESTHETICS**

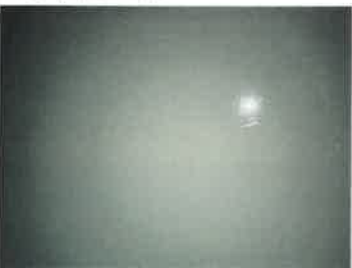
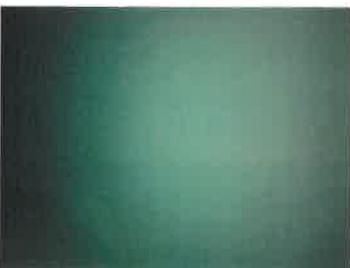
## **East Wall Aesthetics Photos**

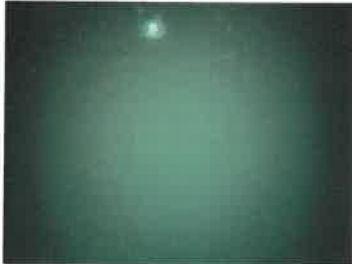
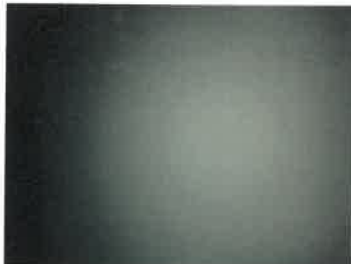
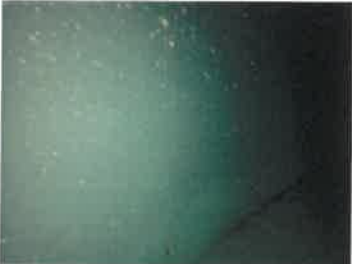
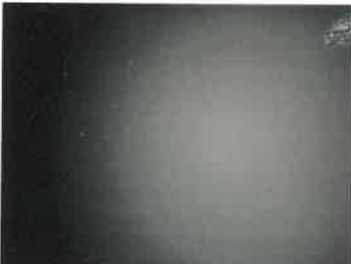
#### INTERIOR WALLS STRUCTURAL

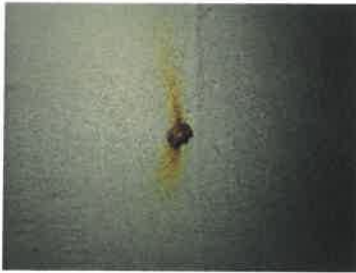
Overall photo of entire quadrant

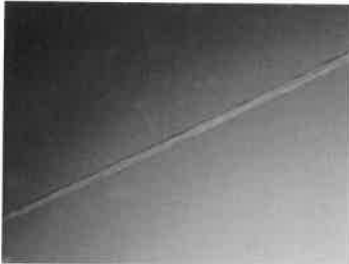
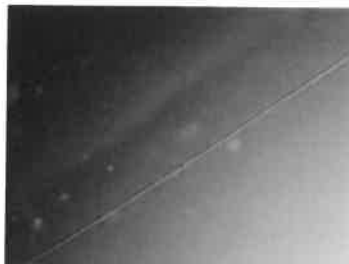
### MIDDLE SECTION NORTH WALL

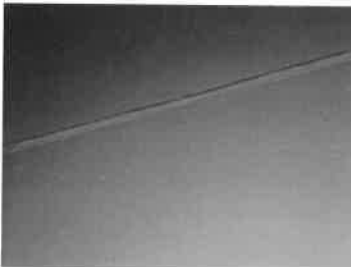
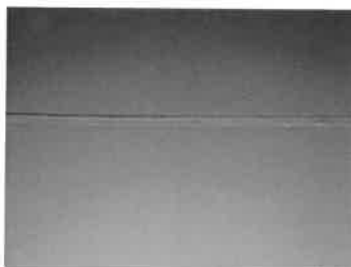
### LOWER SECTION NORTH WALL

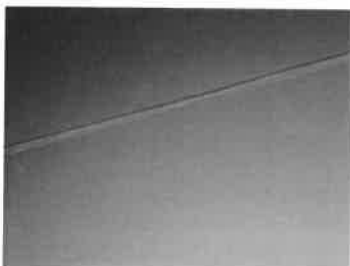
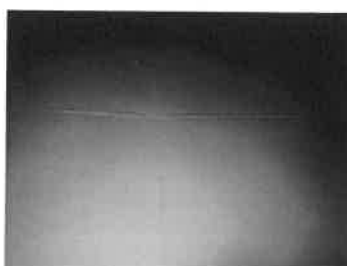
### UPPER SECTION SOUTH WALL

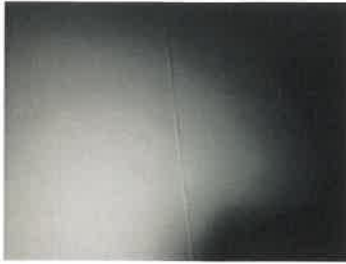
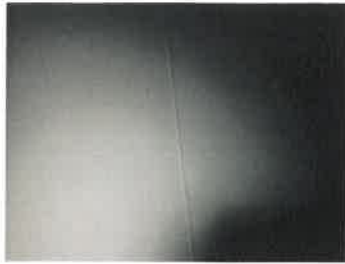
#### MIDDLE SECTION SOUTH WALL

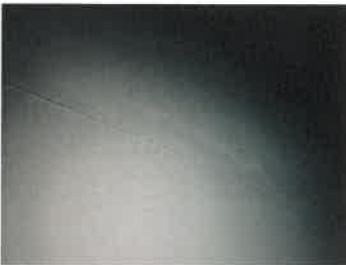
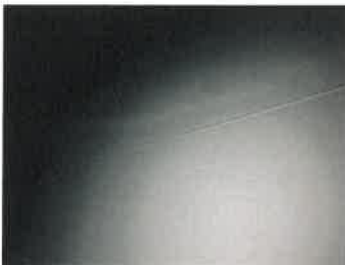
#### LOWER SECTION SOUTH WALL

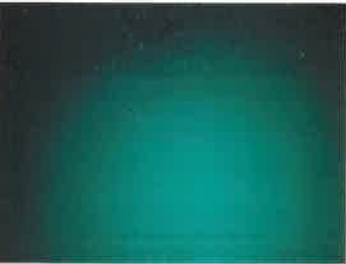
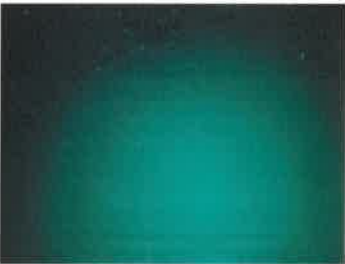
#### UPPER SECTION EAST WALL

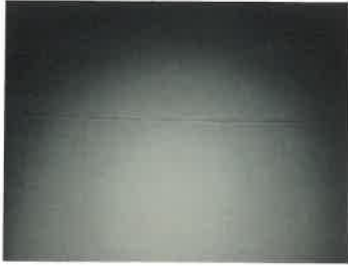
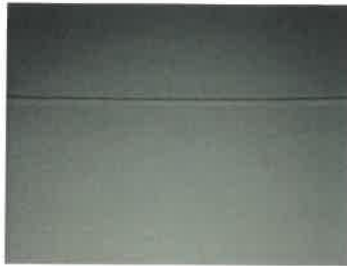
**MIDDLE SECTION EAST WALL**

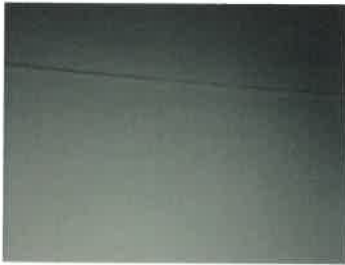
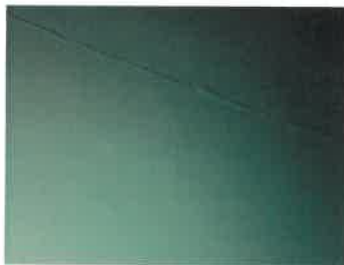
**LOWER SECTION EAST WALL**

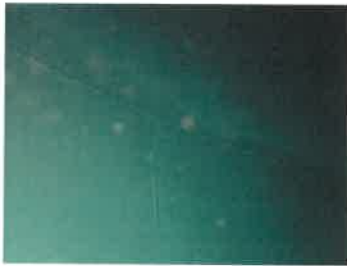
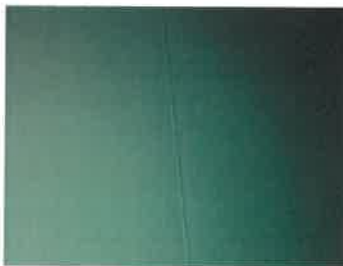
**UPPER SECTION WEST WALL**

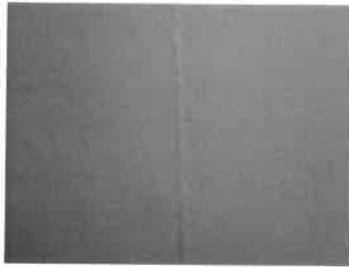
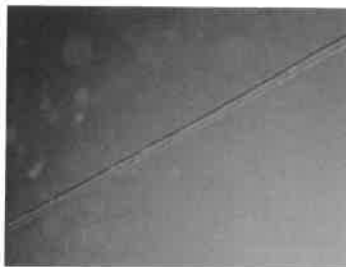
#### MIDDLE SECTION WEST WALL

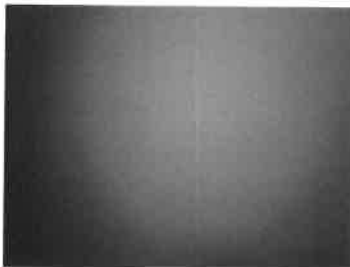
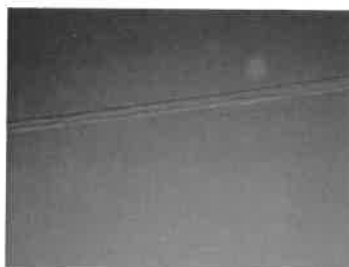
#### LOWER SECTION WEST WALL

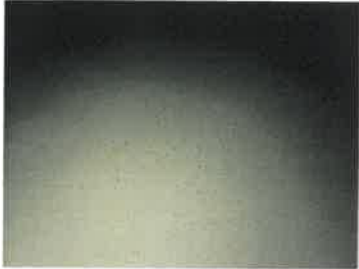
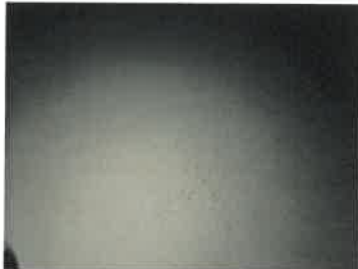
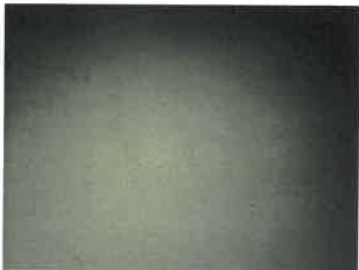
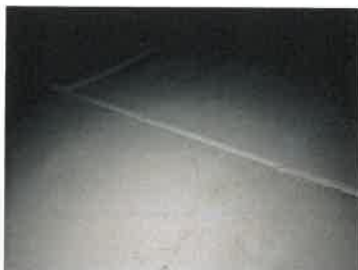
**INTERIOR FLOOR EAST QUADRANT AESTHETICS****INTERIOR AESTHETICS EAST FLOOR**

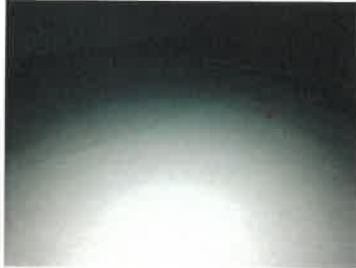
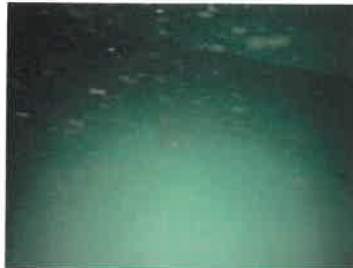
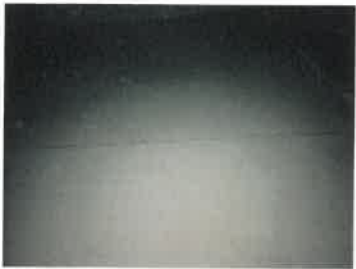
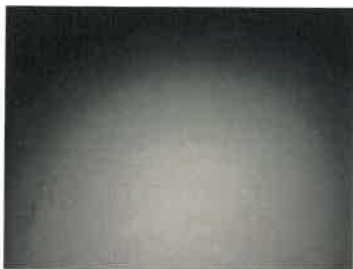
**INTERIOR FLOOR WEST QUADRANT AESTHETICS****INTERIOR AESTHETICS WEST FLOOR**

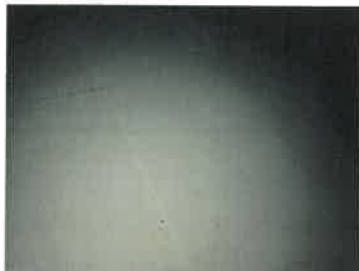
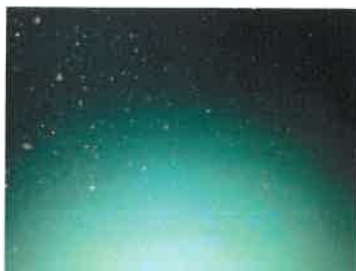
**West Floor Aesthetic Photos**

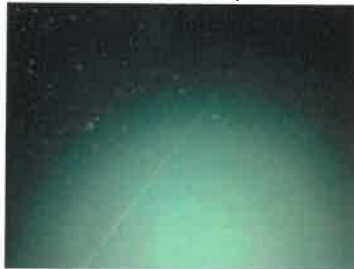
##### North Quadrant- Photo of welds

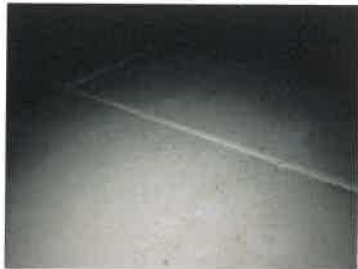
South Quadrant- Photo of welds

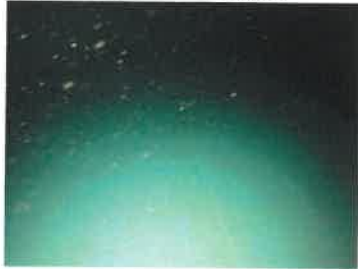
**West Quadrant- Photo of welds**

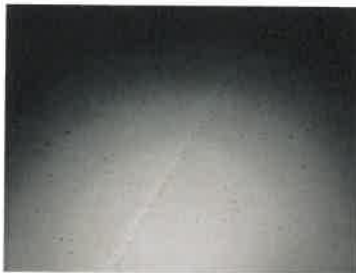
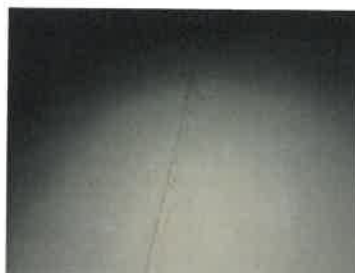
**CLEANING****SEDIMENT REMOVAL**

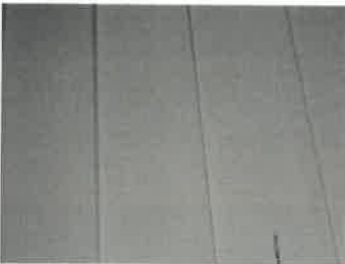
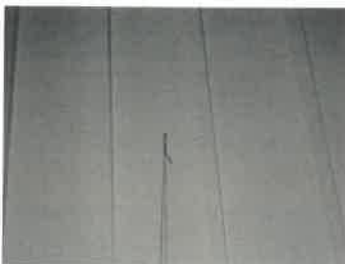
| SOUTH OVERHEAD AESTHETICS QUADRANT | |

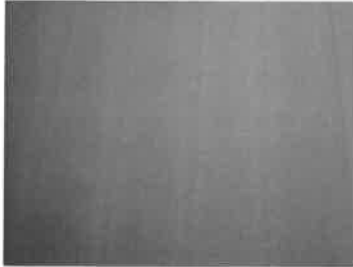
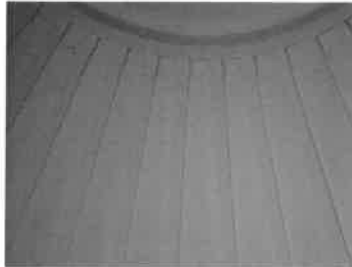
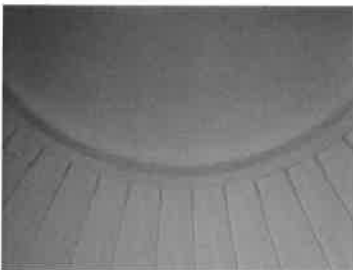
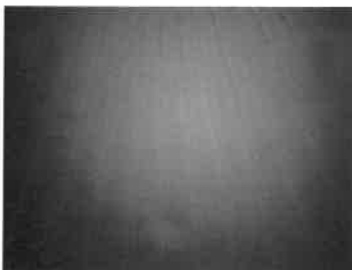
| EAST OVERHEAD AESTHETICS QUADRANT | |

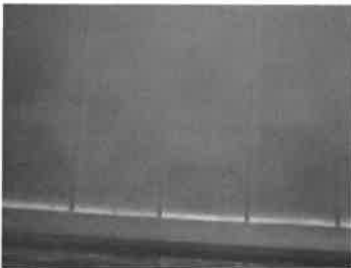
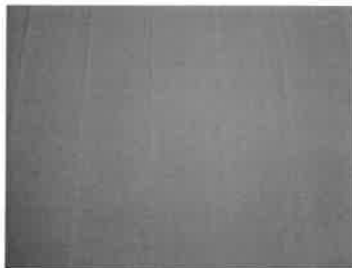
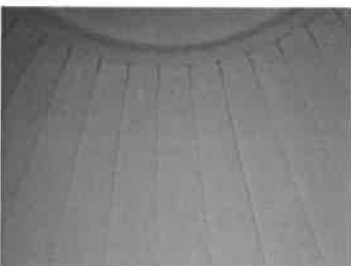
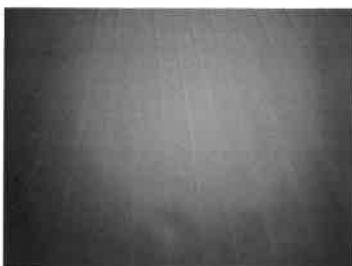
| WEST OVERHEAD AESTHETICS QUADRANT | |

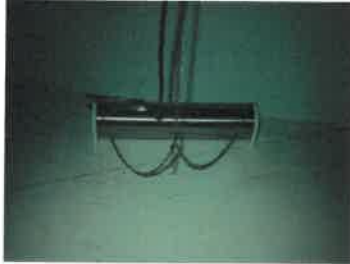
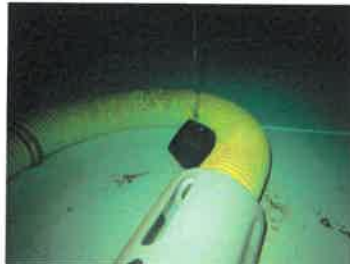
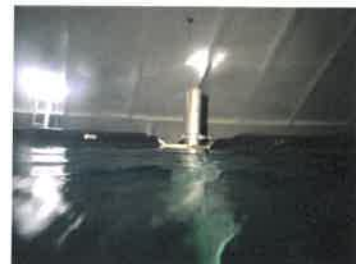
## SITE SECURITY UPON COMPLETION

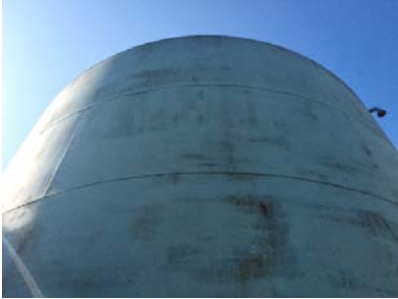
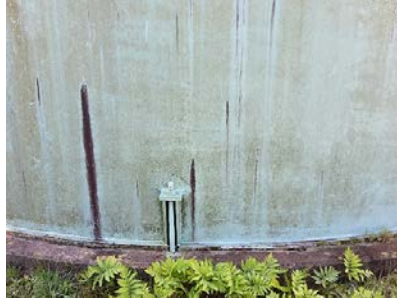
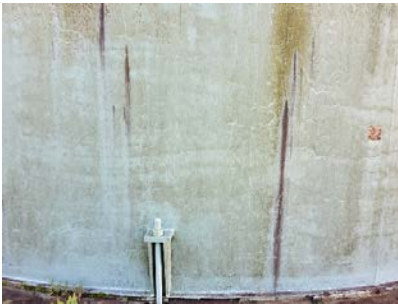
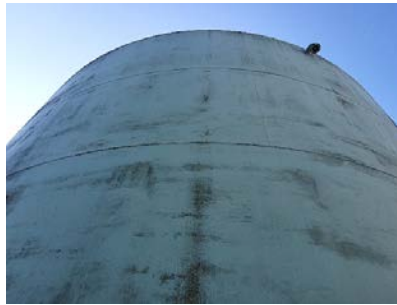
#### North Wall Exterior Aesthetics Photos

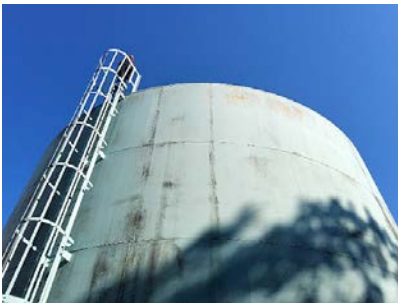
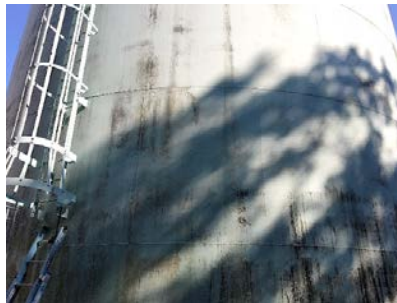
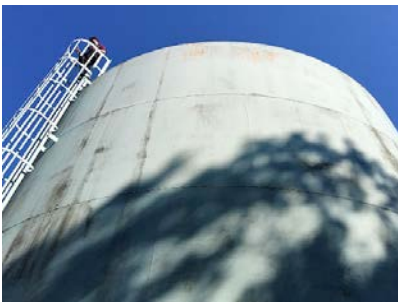
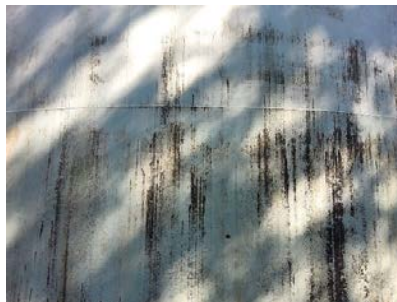
| EAST WALL | |

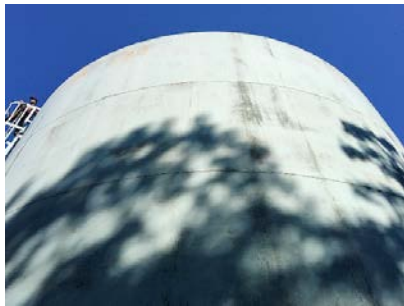
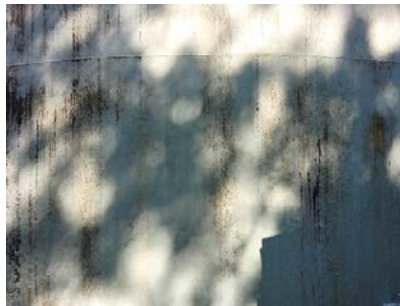
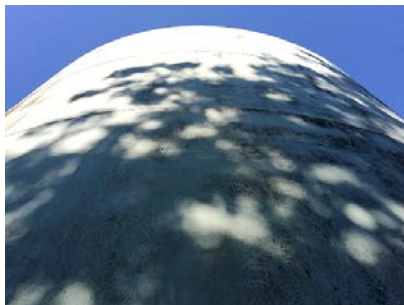
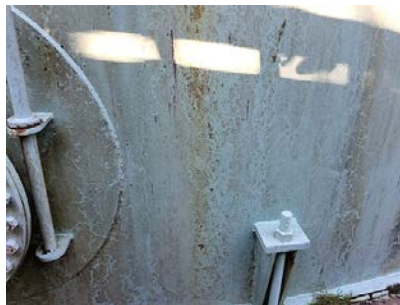
| WEST WALL | |

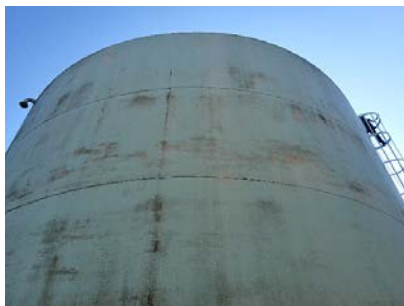
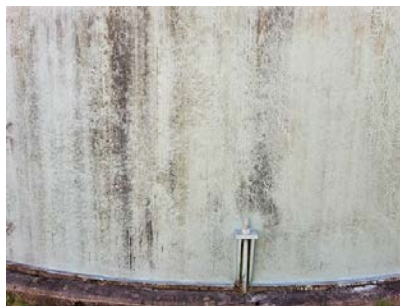
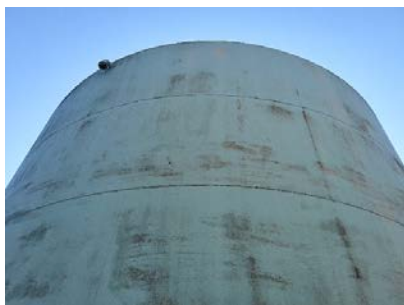
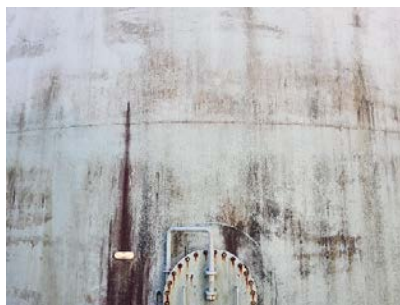
**EXTERIOR WALL STRUCTURAL**

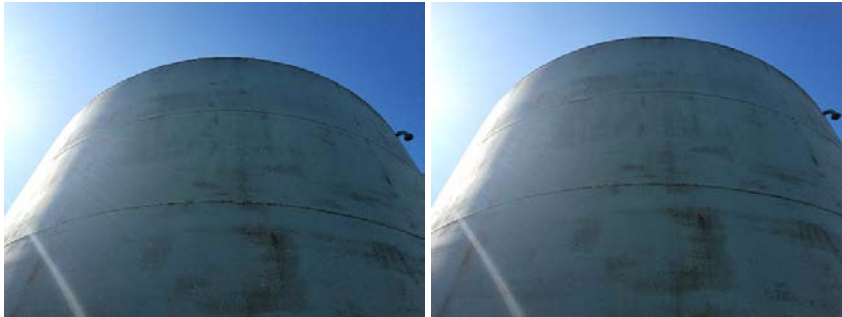
| MIDDLE SECTION NORTH WALL | |

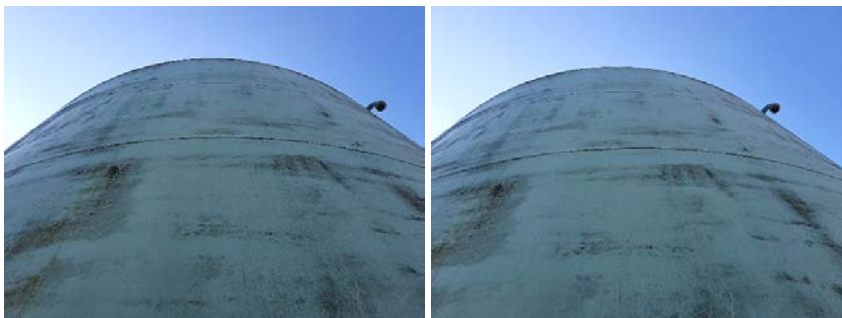
| LOWER SECTION NORTH WALL | |

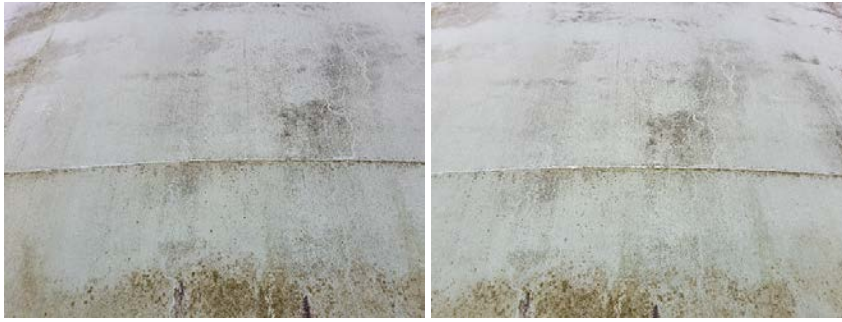
**UPPER SECTION SOUTH WALL**

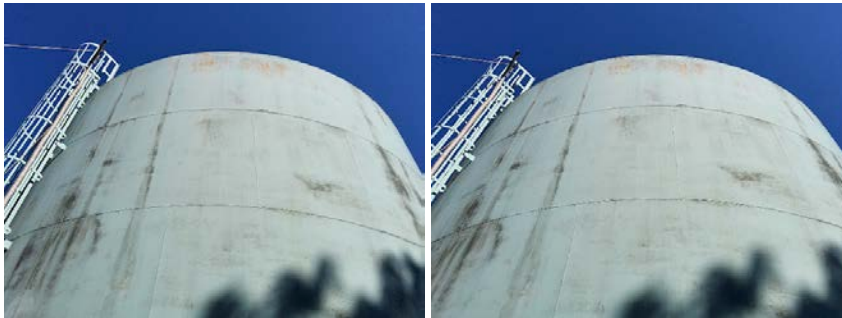
**MIDDLE SECTION SOUTH WALL**

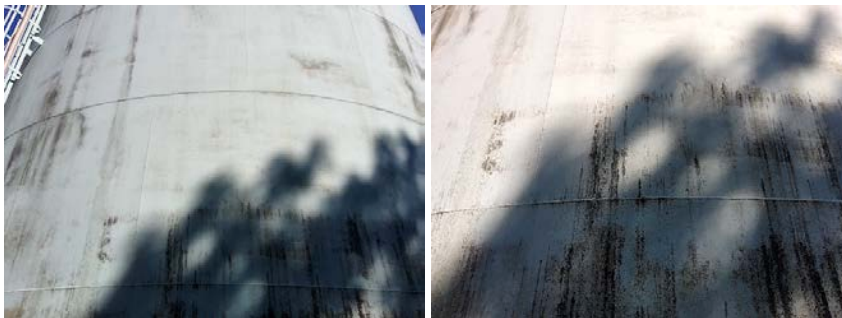
**LOWER SECTION SOUTH WALL**

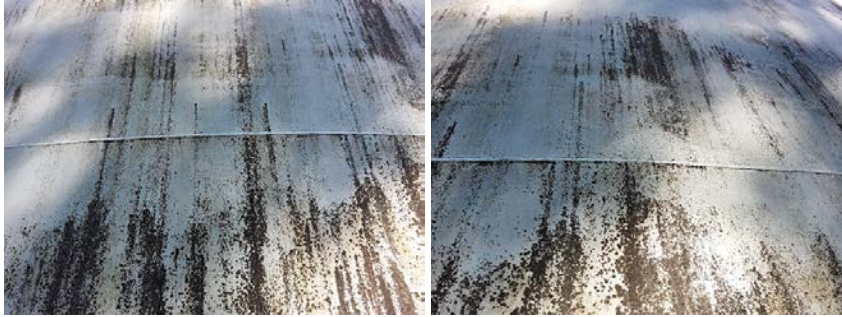
#### UPPER SECTION EAST WALL

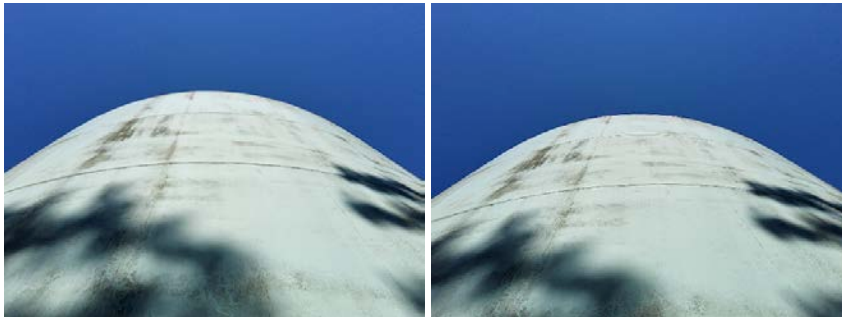
#### MIDDLE SECTION EAST WALL

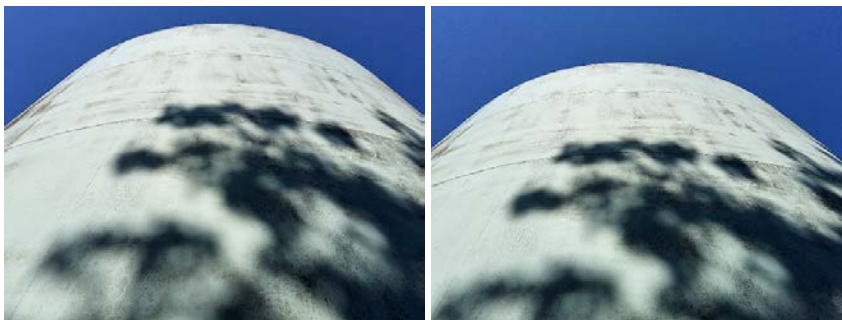
#### LOWER SECTION EAST WALL

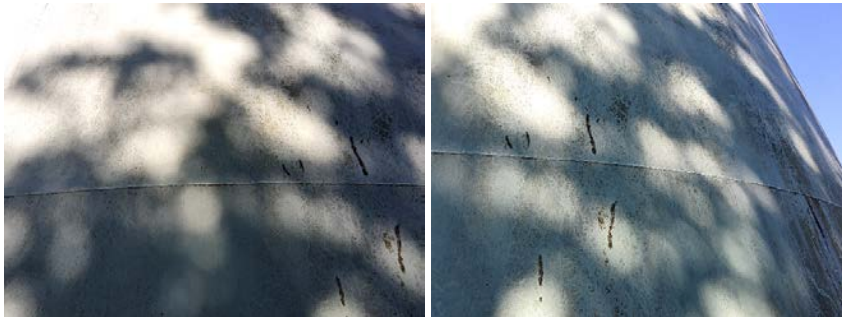
**UPPER SECTION WEST WALL**

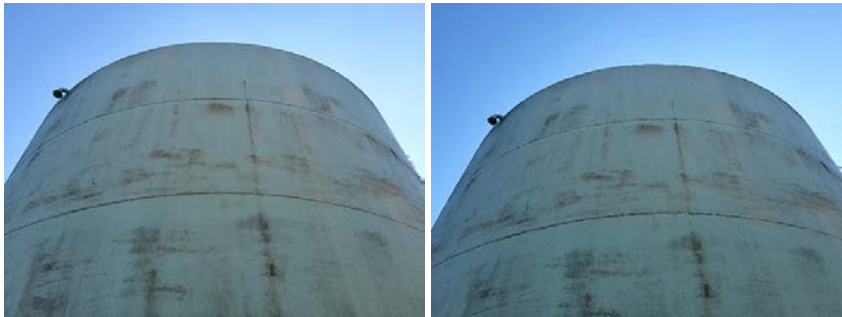
**MIDDLE SECTION WEST WALL**

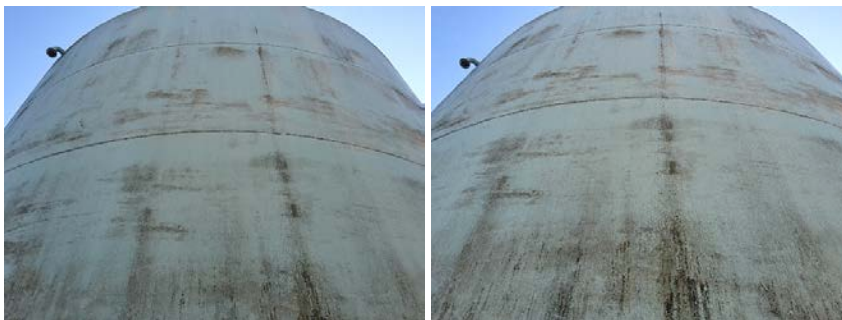
**LOWER SECTION WEST WALL**

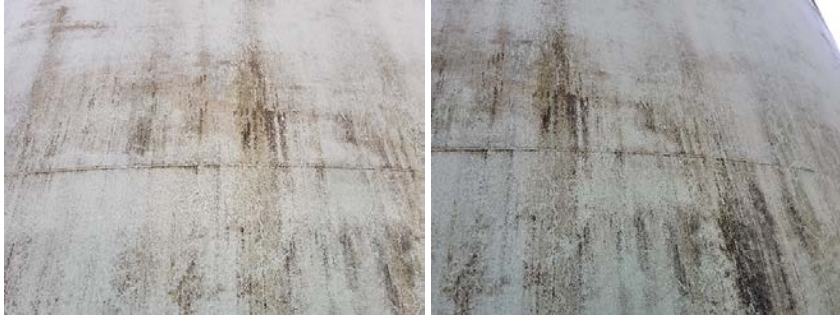
## GROUND LEVEL ULTRA SONIC / DRY FILM THICKNESS MEASUREMENTS

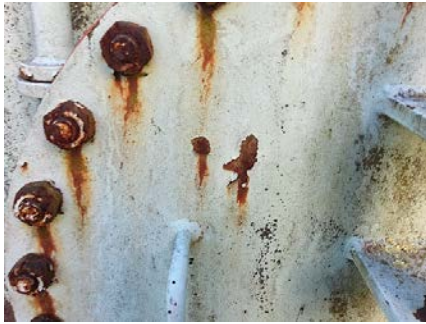
Photo of metal exposure

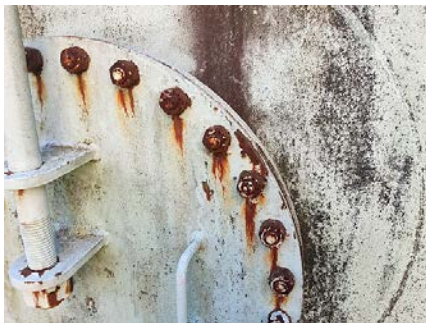
Exterior Manway 1 Photos

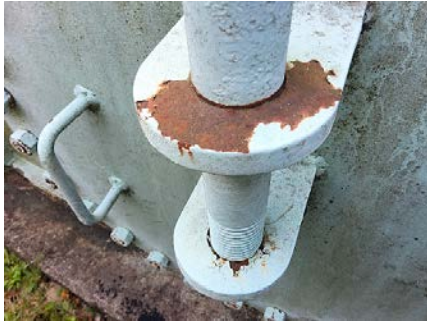
Photo of metal exposure

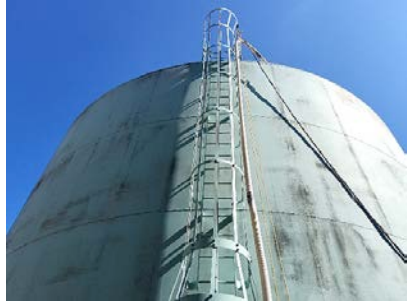
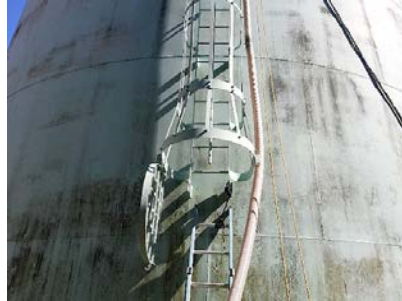
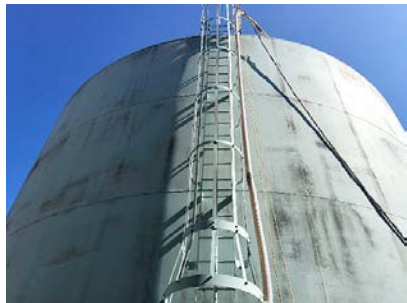
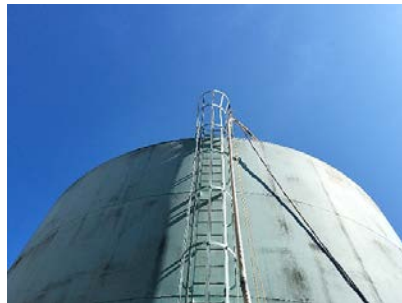
## EXPOSED FOUNDATION

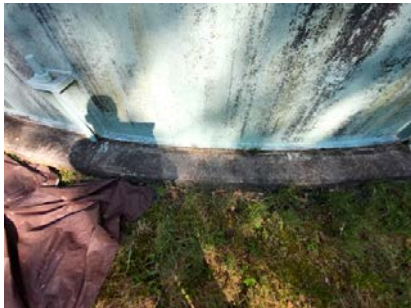
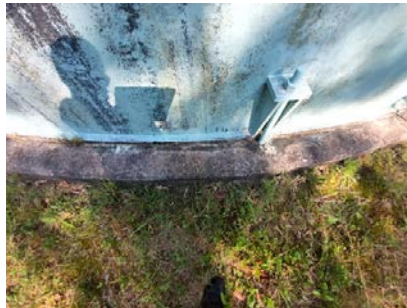
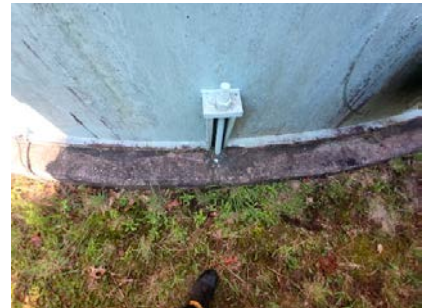
Exposed Foundation Photos

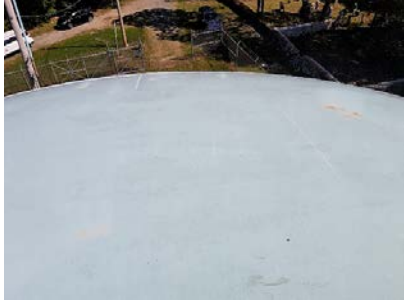
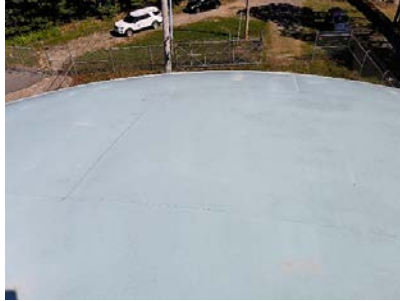
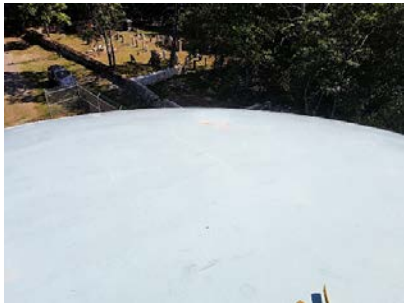
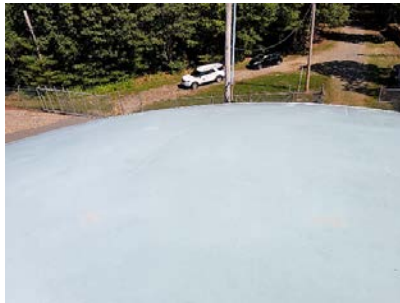
#### SOUTH ROOF QUADRANT AESTHETICS

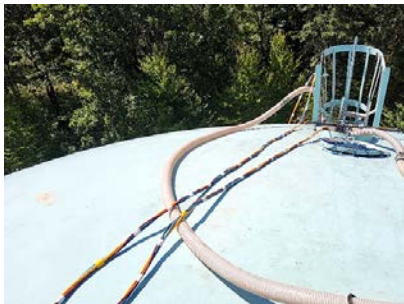
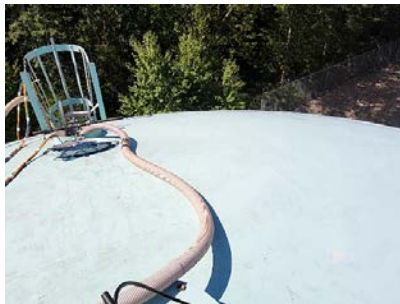
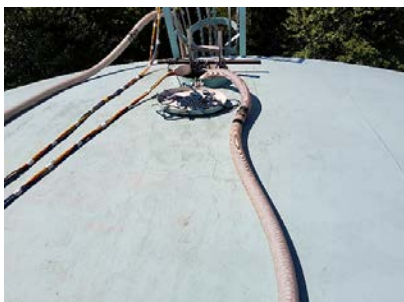
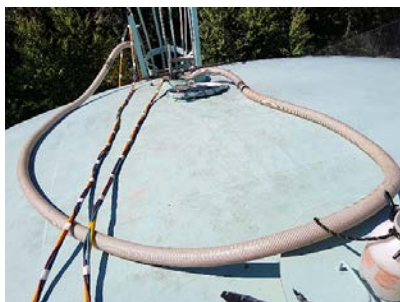
| EAST ROOF QUADRANT AESTHETICS | |

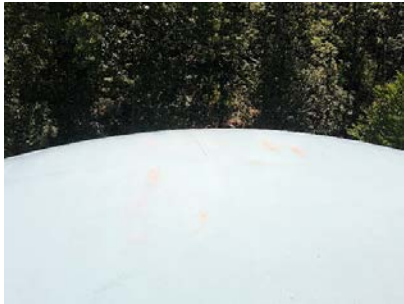
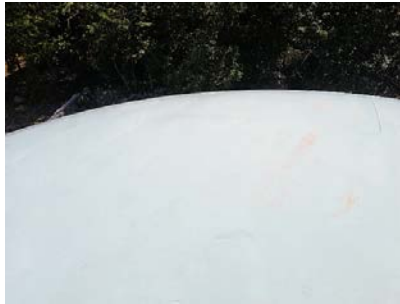
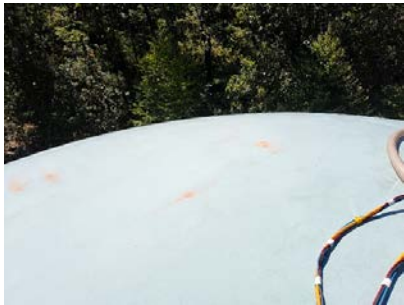
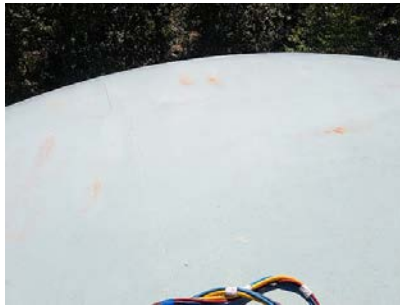
| WEST ROOF QUADRANT AESTHETICS | |

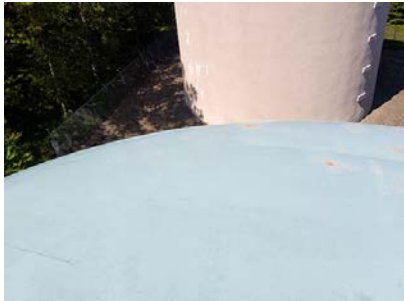
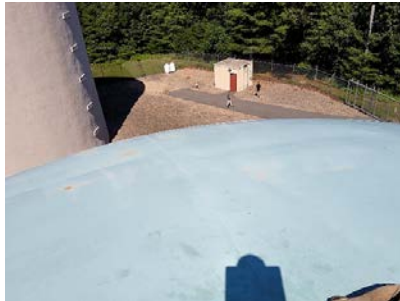
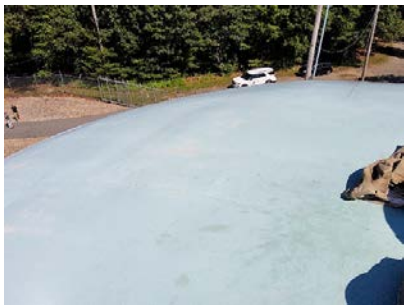
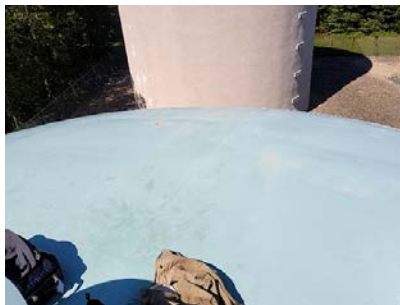
**EXTERIOR ROOF STRUCTURAL****NORTH ROOF STRUCTURAL**

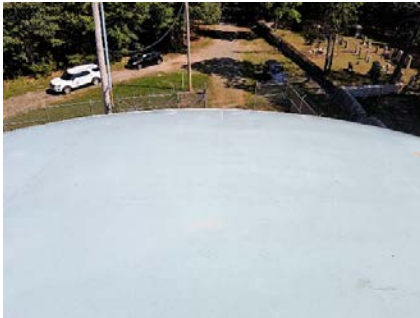
North Quadrant- Photo of welds

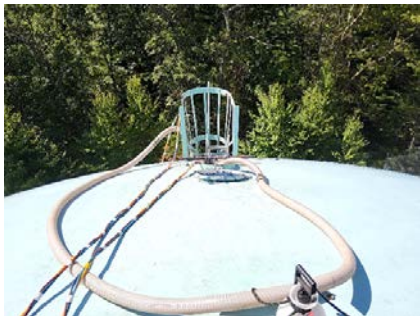
**South Quadrant- Photo of welds**

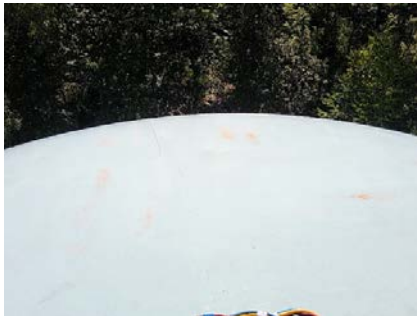
**East Quadrant- Photo of welds**

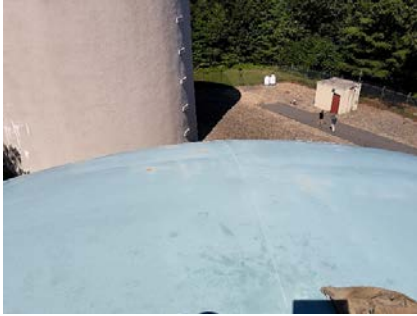
West Quadrant- Photo of welds

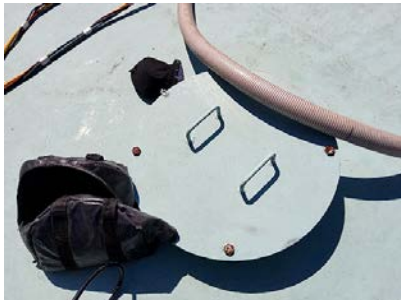
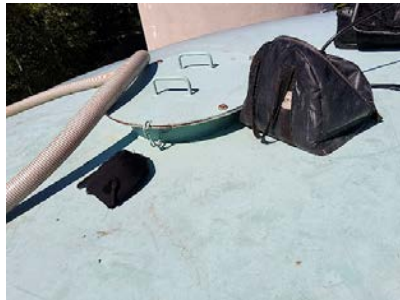
#### Hatch #2 Photos

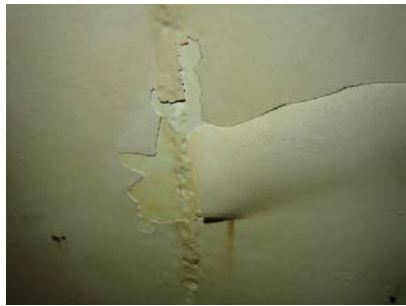
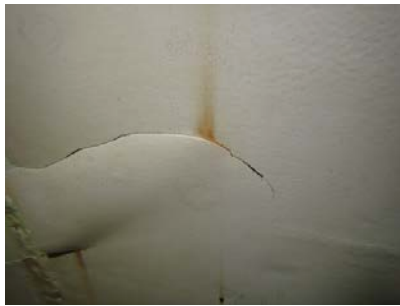
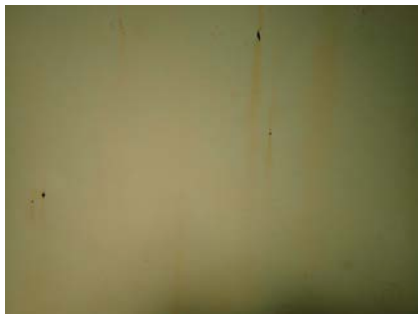
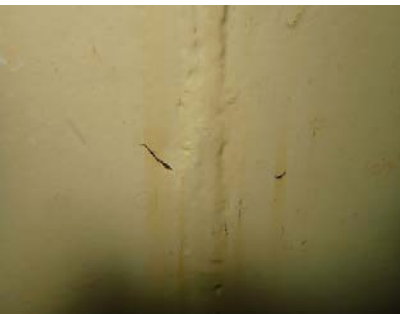
### INTERIOR WALLS AESTHETICS

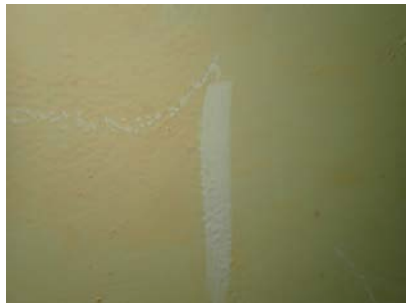
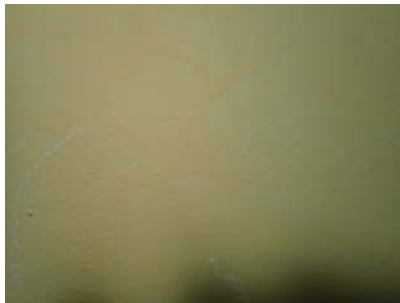
#### South Wall Aesthetics Photos

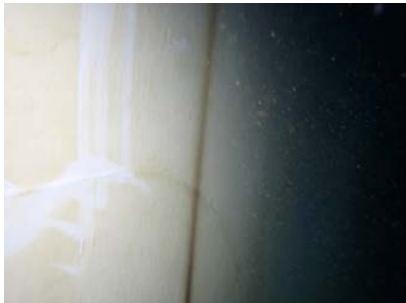
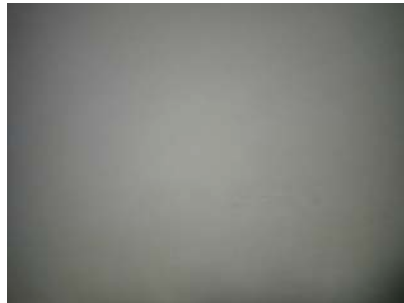
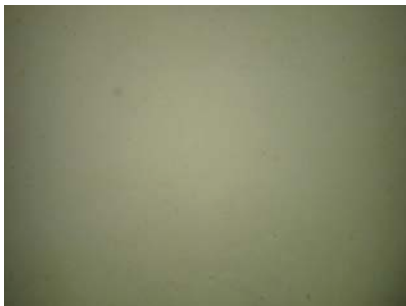
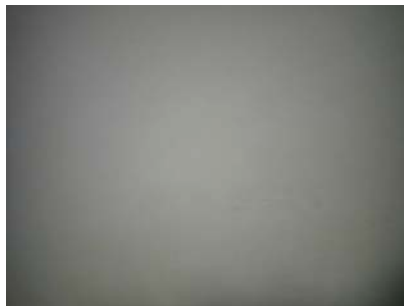
| <b>INTERIOR WALLS AESTHETICS</b> |

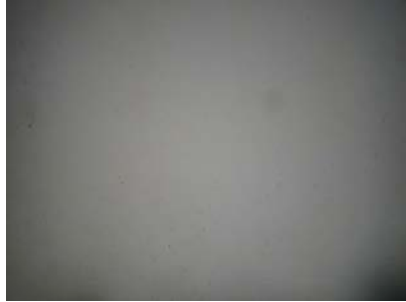
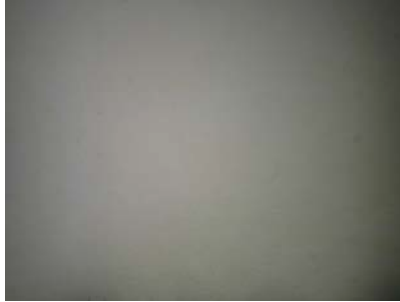
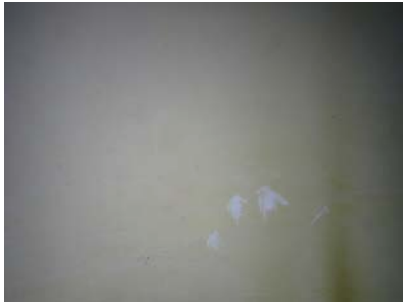
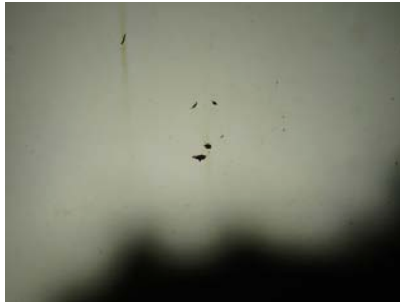
### INTERIOR WALLS STRUCTURAL

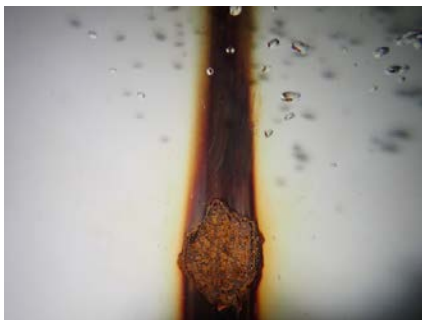
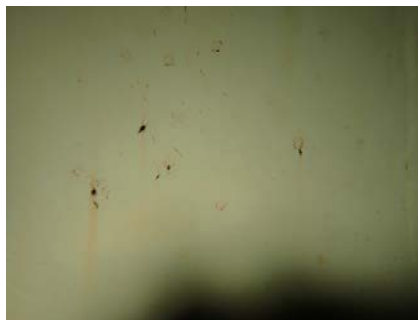
Interior Lower North Wall Section- Photo of corrosion

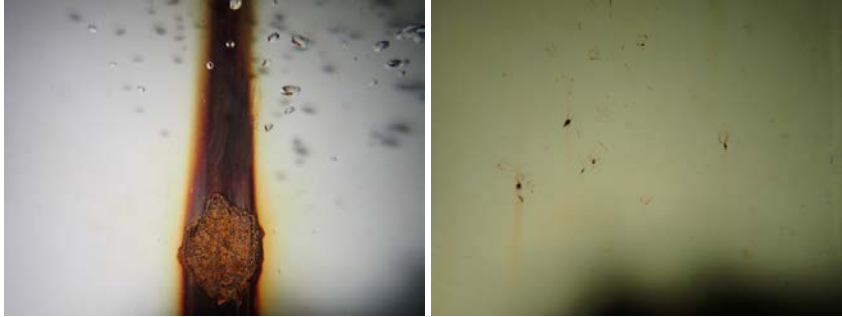
Overall photo of entire quadrant

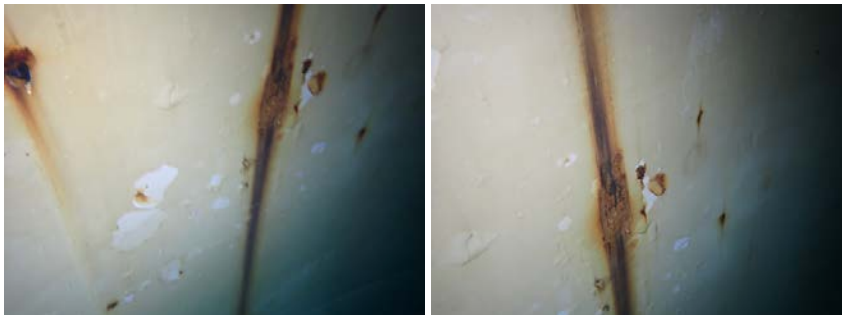
Interior Middle South Wall Section- Photo of corrosion

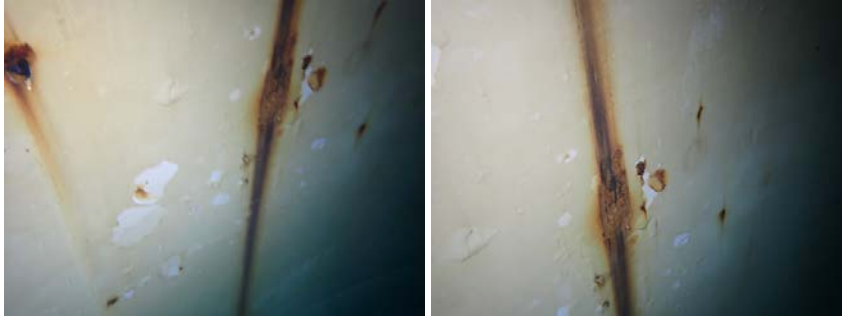
**LOWER SECTION SOUTH WALL**

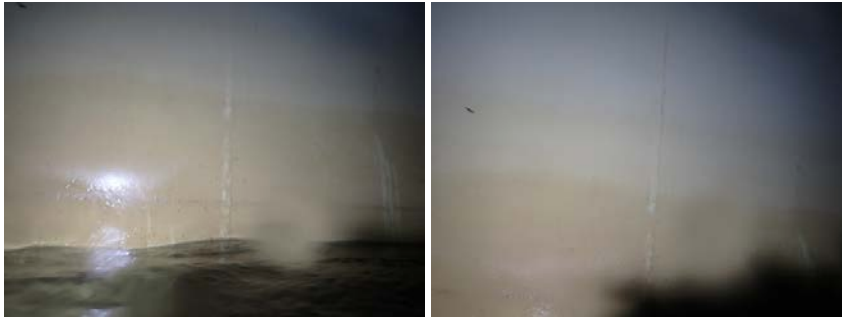
#### MIDDLE SECTION NORTH WALL

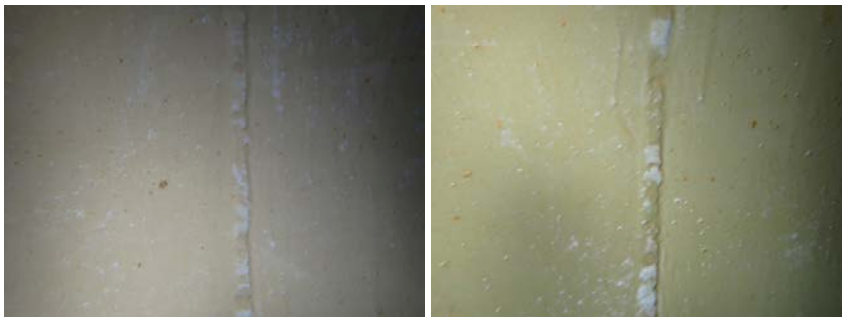
#### LOWER SECTION NORTH WALL

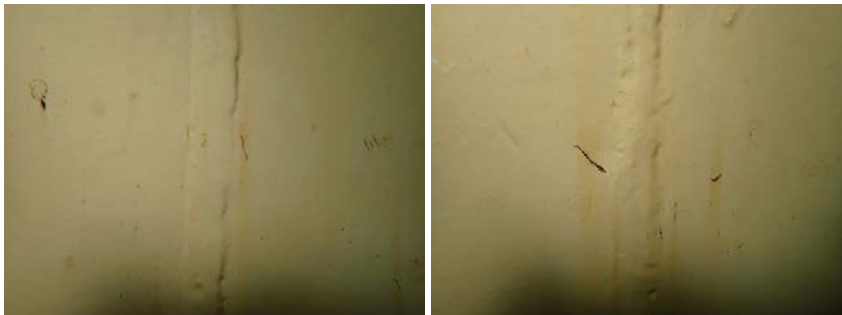
#### UPPER SECTION SOUTH WALL

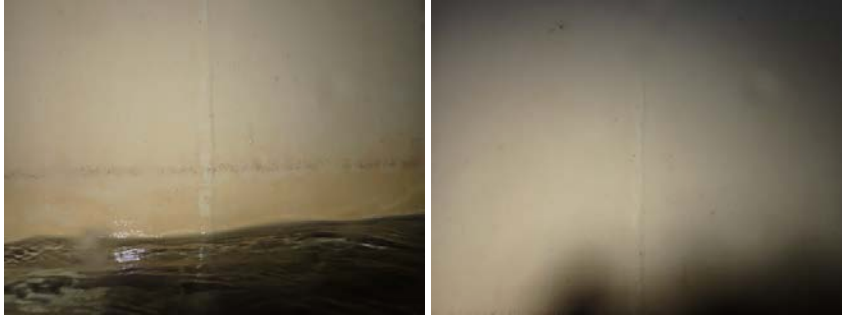
#### MIDDLE SECTION SOUTH WALL

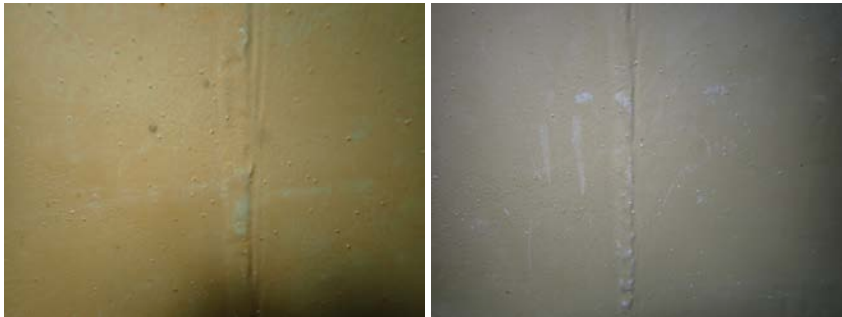
#### LOWER SECTION SOUTH WALL

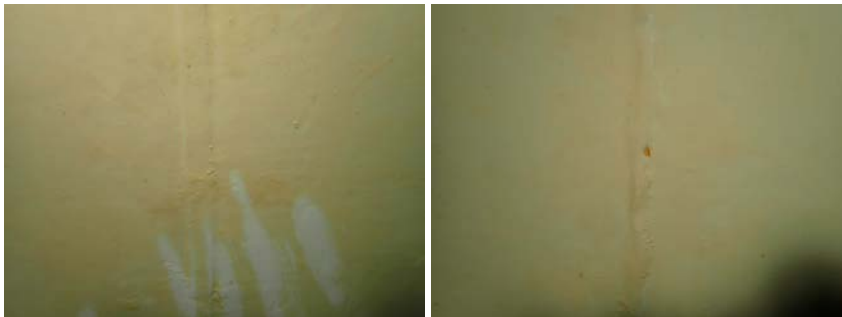
#### UPPER SECTION EAST WALL

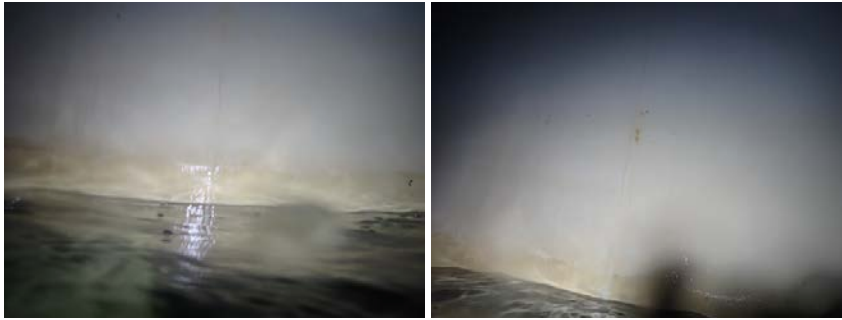
#### MIDDLE SECTION EAST WALL

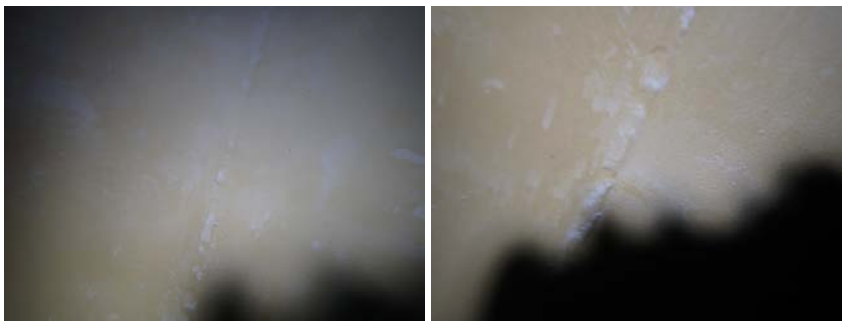
#### LOWER SECTION EAST WALL

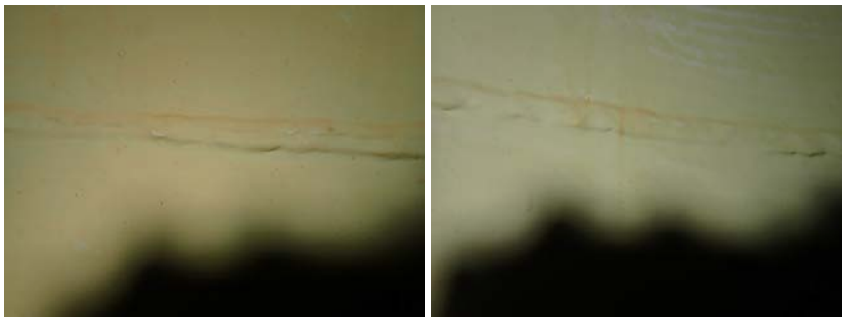
#### UPPER SECTION WEST WALL

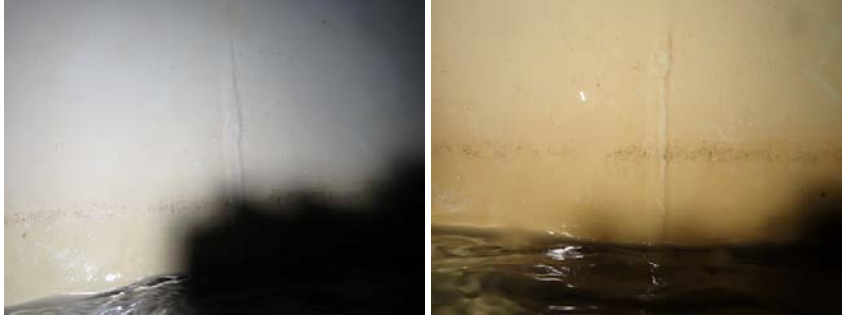
#### MIDDLE SECTION WEST WALL

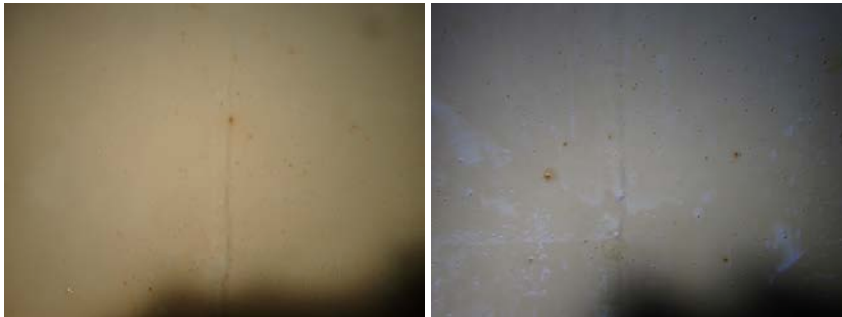
#### LOWER SECTION WEST WALL
