Smithfield, RI

# Clean Water Infrastructure Replacement Plan

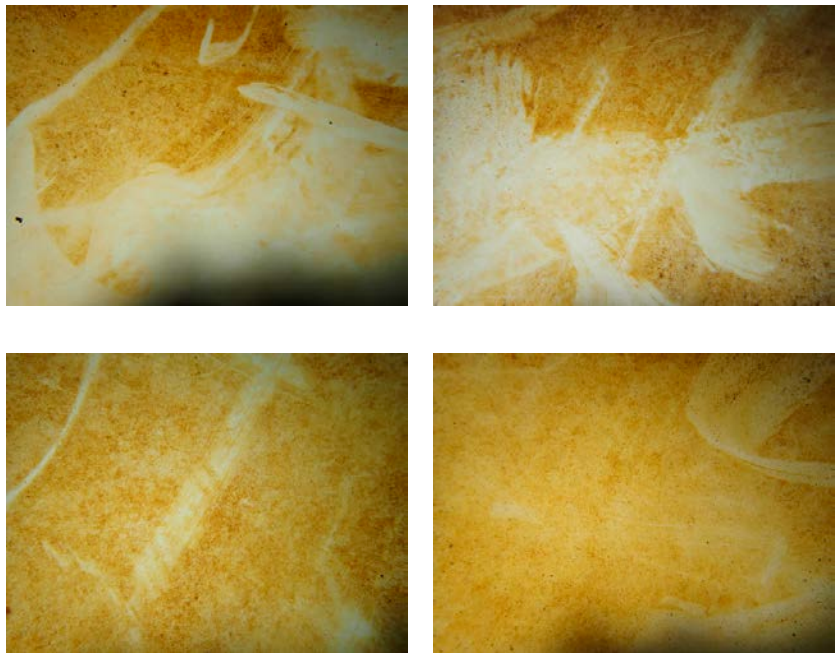
INTERIOR FLOOR SOUTH QUADRANT AESTHETICS

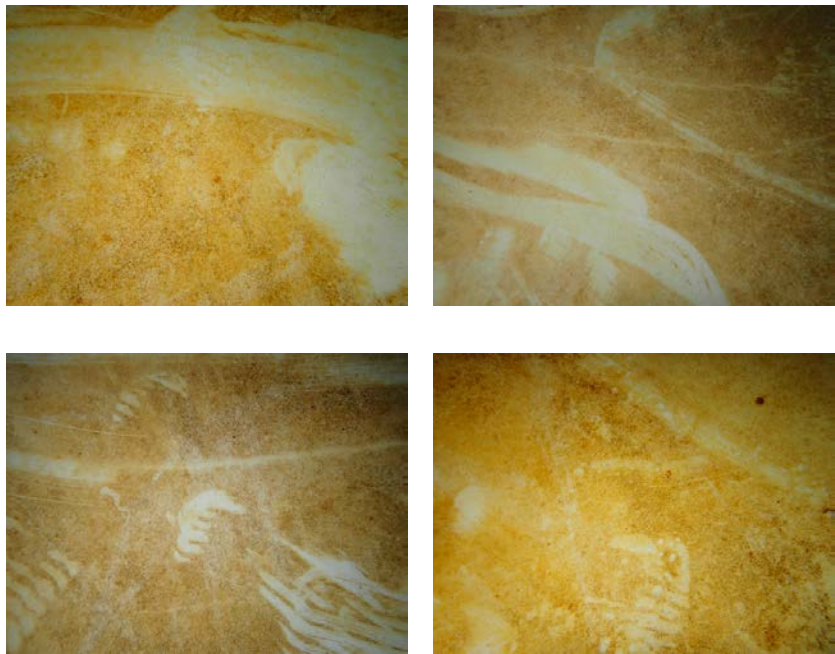
**INTERIOR FLOOR EAST QUADRANT AESTHETICS****INTERIOR AESTHETICS EAST FLOOR**

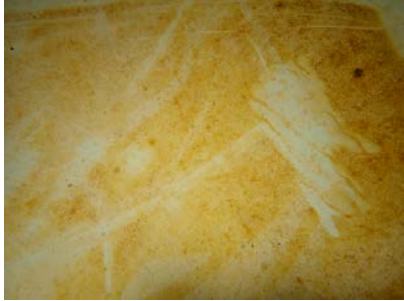
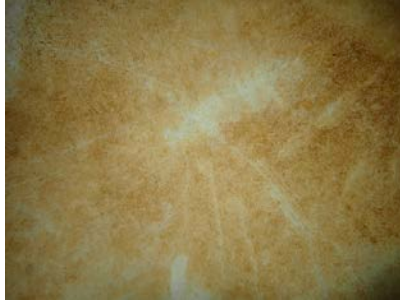
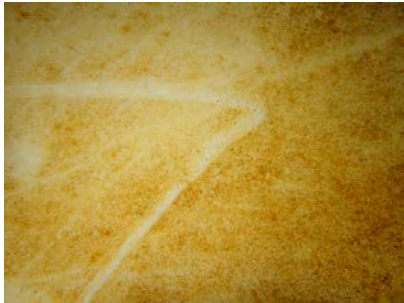
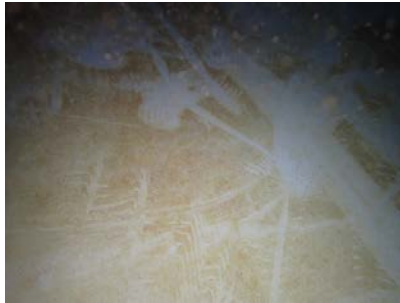
**INTERIOR FLOOR WEST QUADRANT AESTHETICS****INTERIOR AESTHETICS WEST FLOOR**

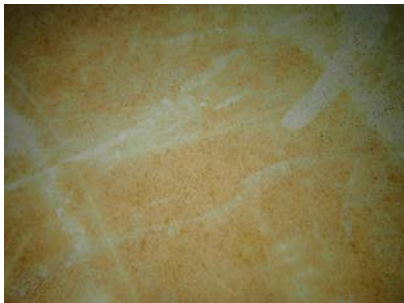
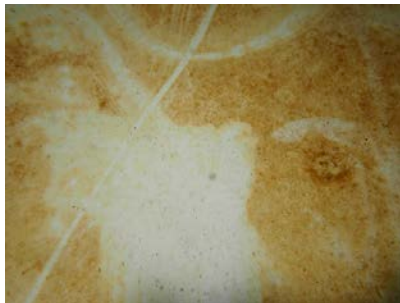
**West Floor Aesthetic Photos**

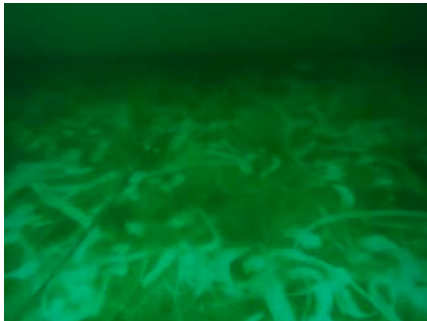
### North Quadrant- Photo of weld deficiencies

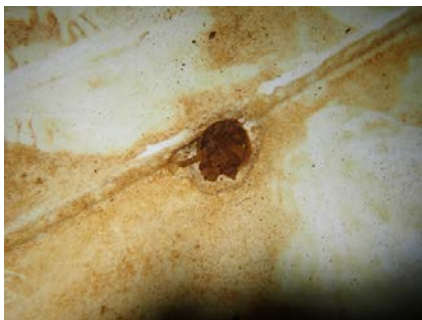
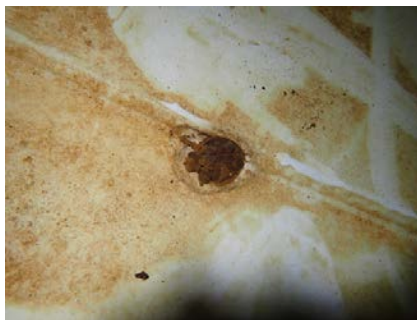
## INTERIOR FLOORS STRUCTURAL

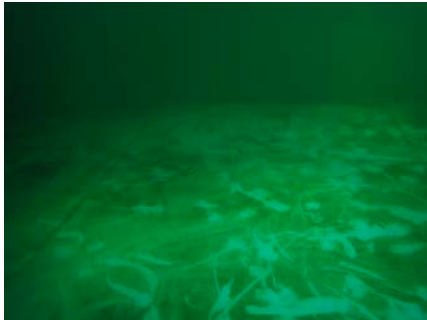
#### Photos of exposed steel

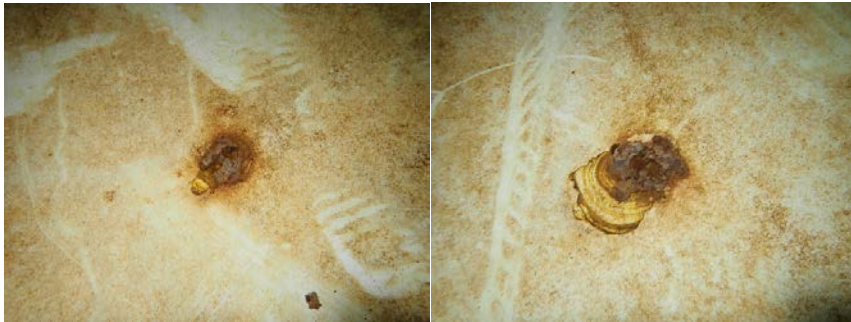
#### Photo of corrosion

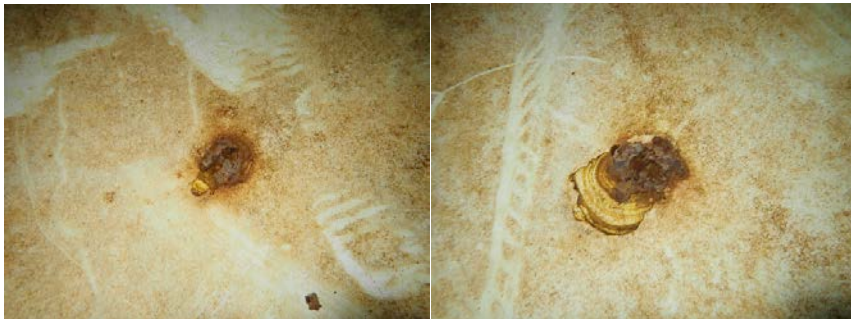
South Quadrant- Photo of weld deficiencies

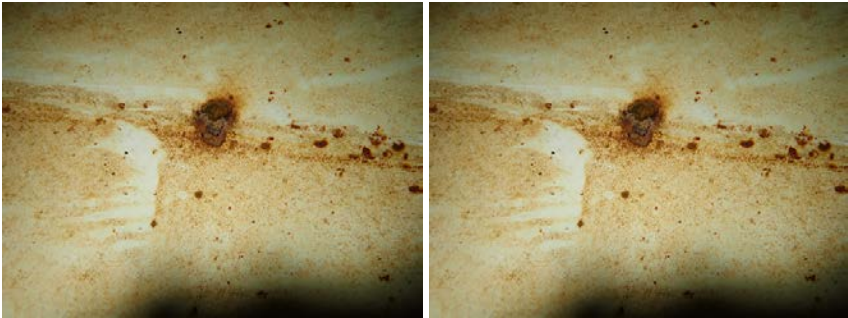
INTERIOR FLOORS STRUCTURAL

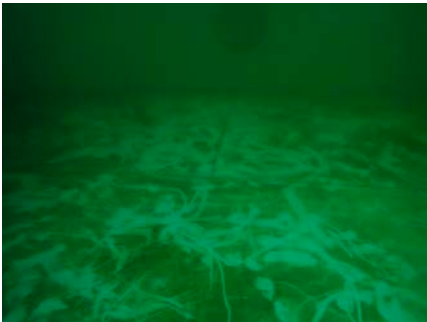
East Quadrant- Photo of weld deficiencies

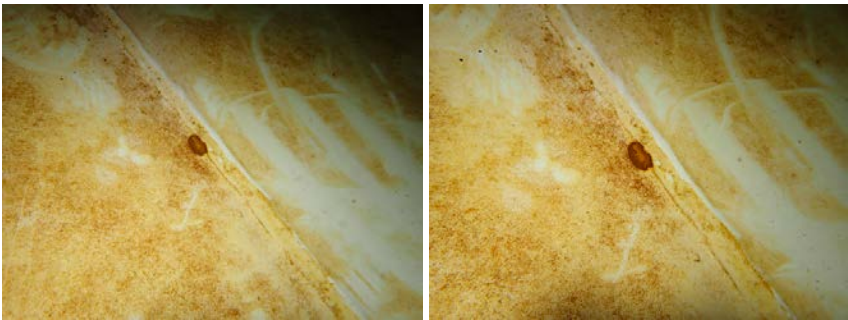
## INTERIOR FLOORS STRUCTURAL

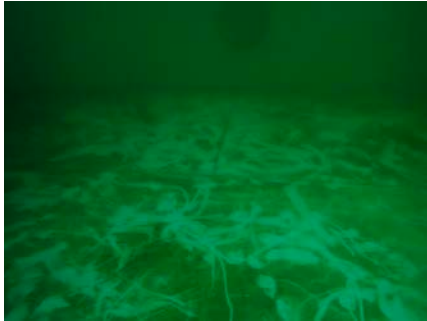
#### Photos of exposed steel

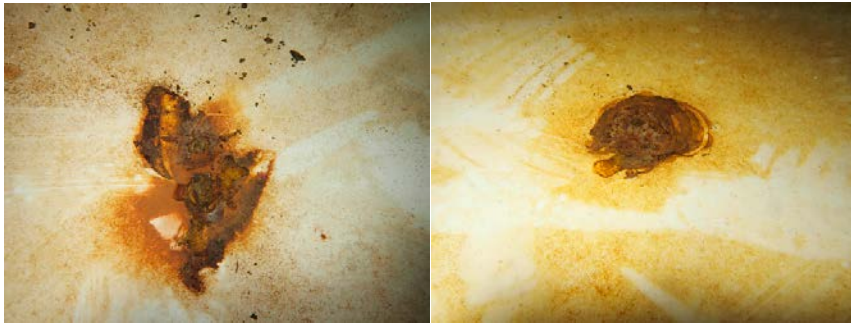
#### Photos of corrosion

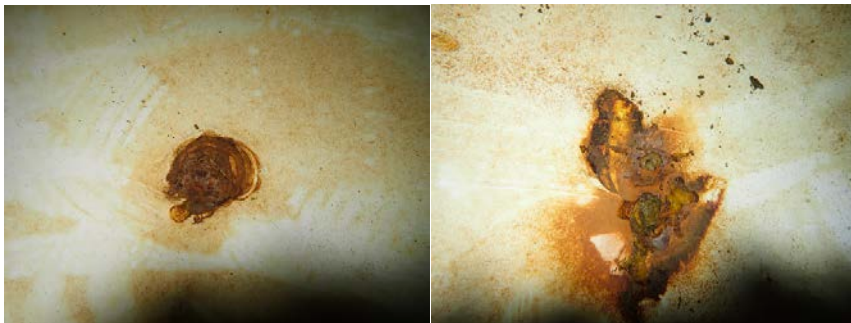
West Quadrant- Photo of welds

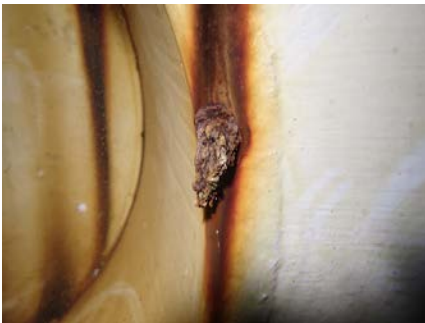
Interior Manway #1 Photo of corrosion

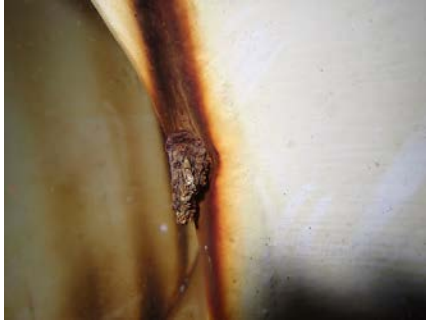
Interior Manway Photos

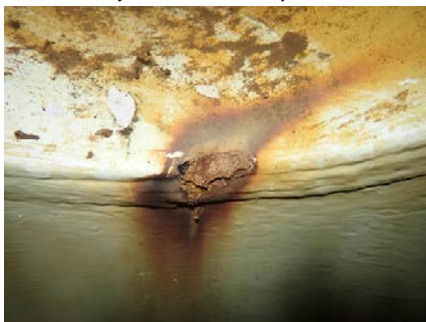
Interior Manway #2 Photo of corrosion

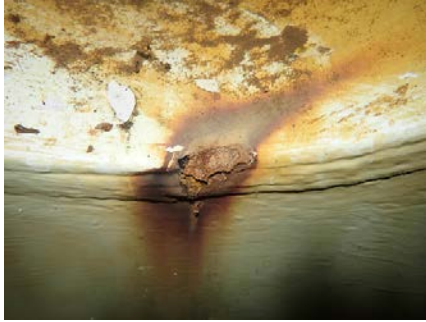
Interior Manway #2 Photos

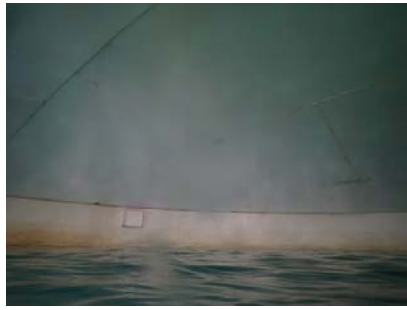
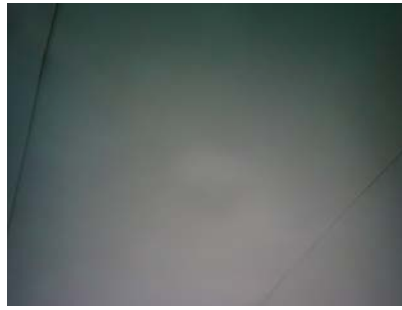
| SOUTH OVERHEAD AESTHETICS QUADRANT | |

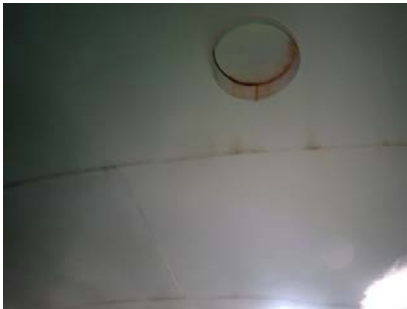
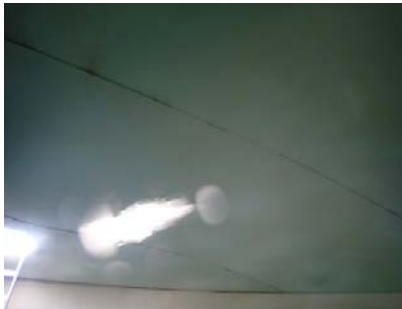
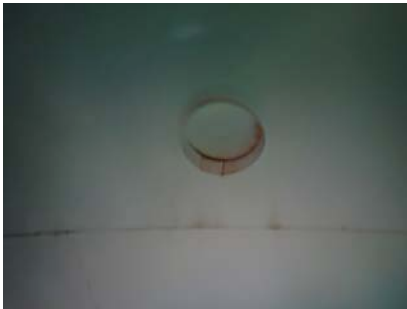
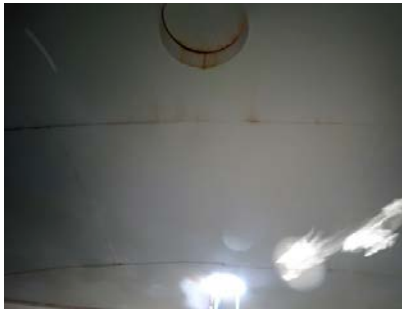
| EAST OVERHEAD AESTHETICS QUADRANT | |

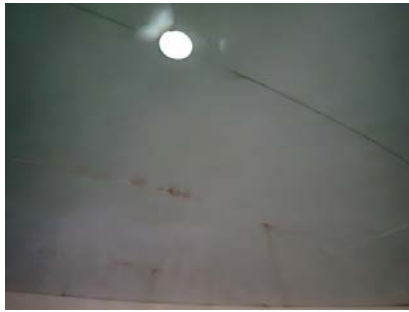
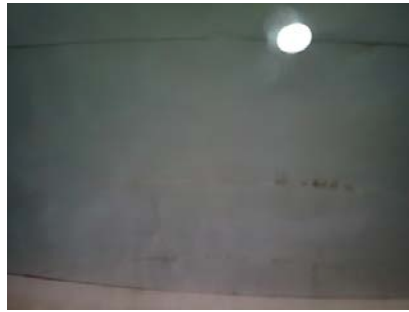
| WEST OVERHEAD AESTHETICS QUADRANT | |

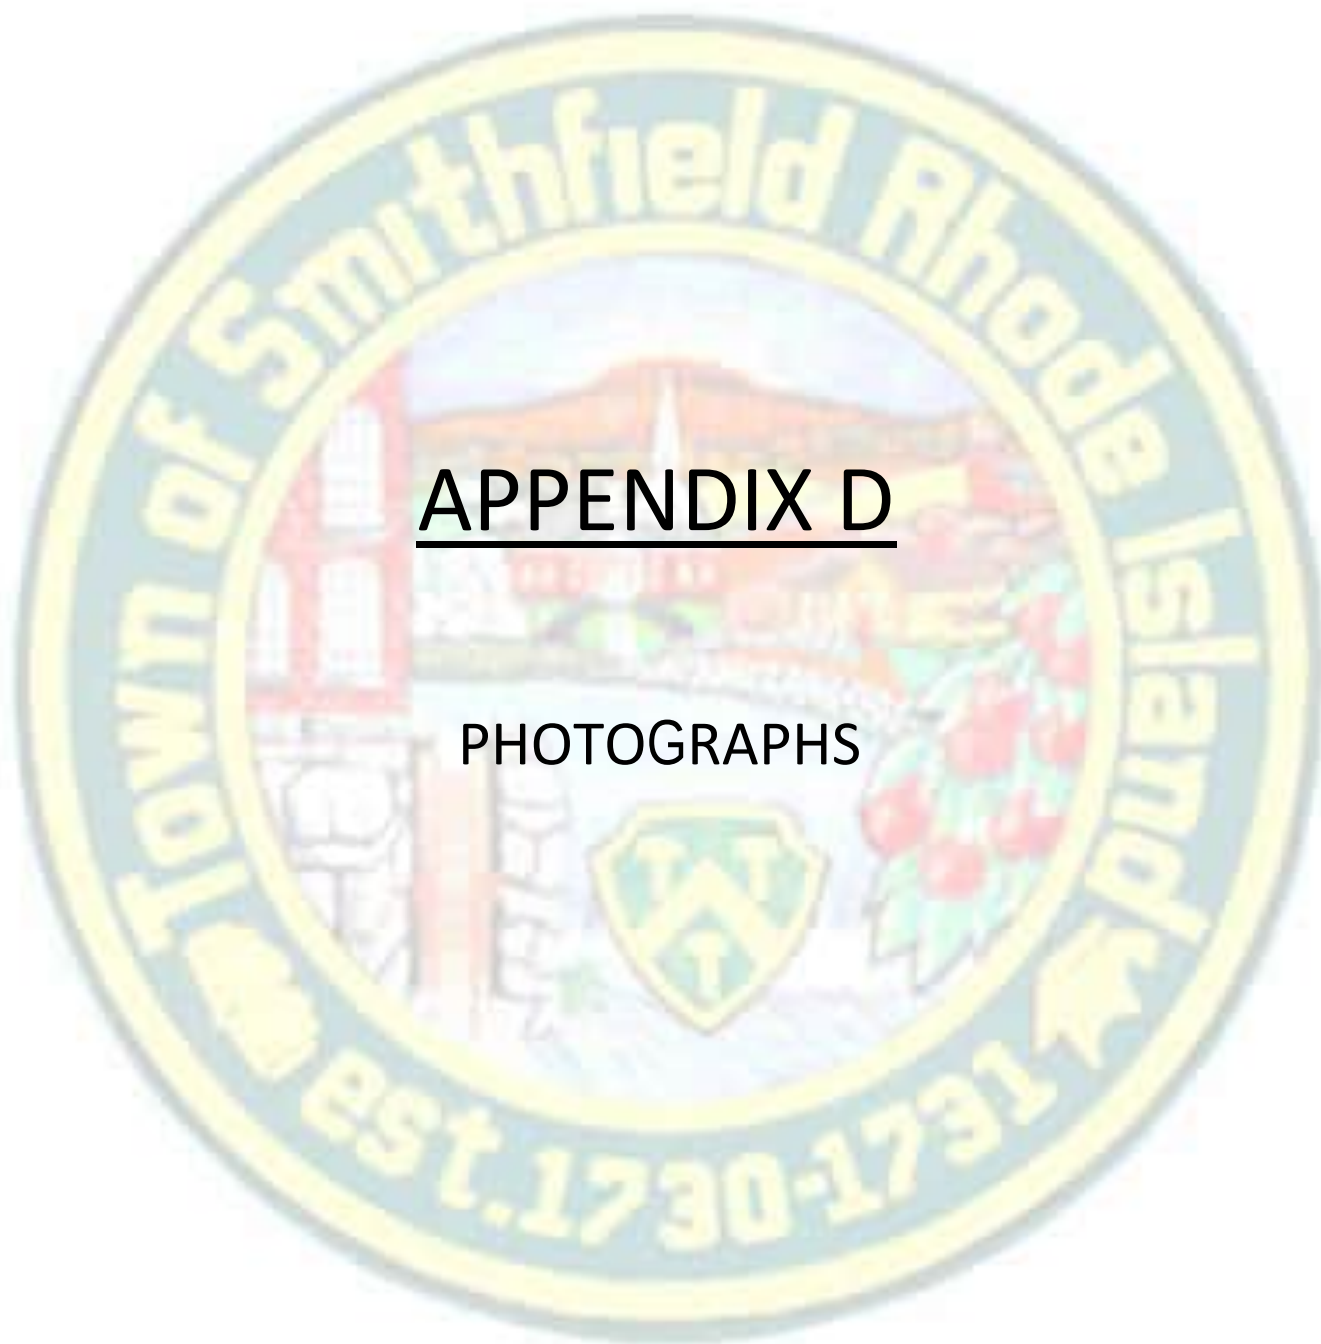
*Aqueous Infrastructure Management Co.'s recommendations, remedial action and infrastructure asset management plan is being processed and will be uploaded into your platform within 30 days for your review.*
