Effect of Partial Lead Service Line Replacement on Total Lead at the Tap

Prepared by Clay Commons
Senior Environmental Scientist
Office of Drinking Water Quality
April 2011

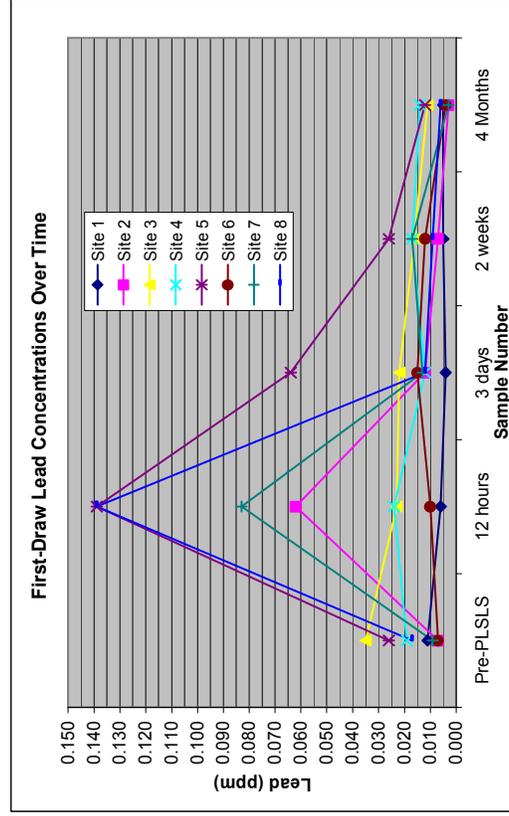
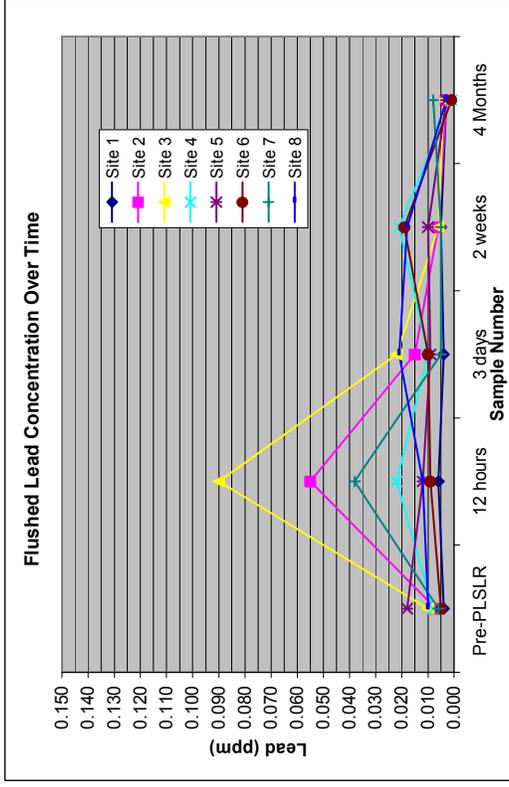
Pre-PLSLR and 4-month "Flushed" values were the lowest levels at which lead stabilized during sequential sampling. Other values were the results of samples taken by residents. Instructions were to "run water until cold", so some variability in location of water sample in pipe is to be expected and is unquantifiable.

The residents’ sampling showed the expected spike immediately following PLSLR. The three-day samples showed a decline in all cases, and by two weeks, levels were at or below the pre-PLSLR readings. After four months, in all cases but one, both first-draw and run-until-cold samples showed a reduction in lead concentration. (The one case, Site #7, demonstrated the long flushing time necessary; the site had very low lead to begin with and

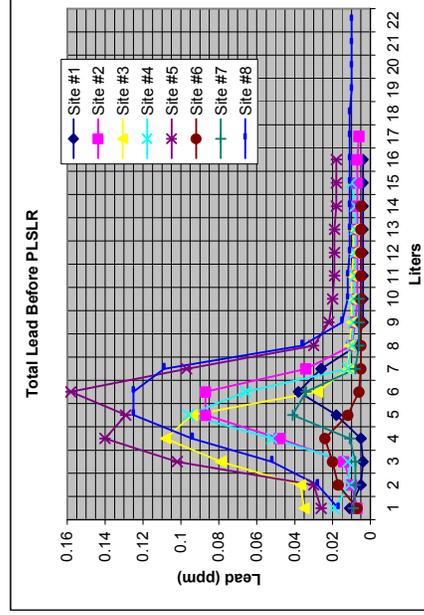
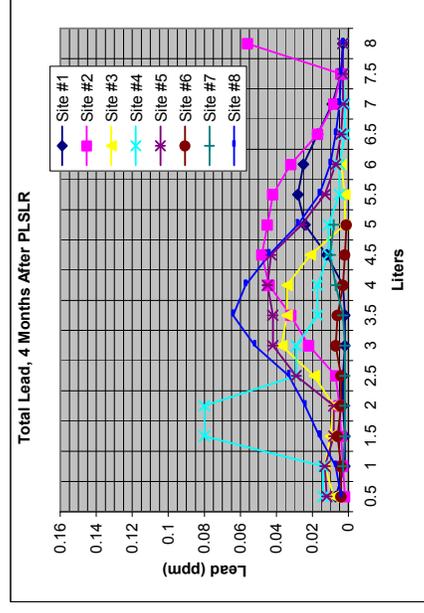
Table 3: Sequential sampling results before, and 4 months after, PLSLR

Sequential Sampling Results, Auburn neighborhood, Summer 2010										Sequential Sampling Results, Auburn neighborhood, Winter 2011 (500 mL samples, except Site #4)							
all results in parts per million																	
Year Built:	Site 1	Site 2	Site 3	Site 4	Site 5	Site 6	Site 7	Site 8	Liter #	Site 1	Site 2	Site 3	Site 4	Site 5	Site 6	Site 7	Site 8
1	0.011	0.007	0.035	0.019	0.026	0.007	0.009	0.017	0.5	0.007	0.002	0.008	0.014	0.012	0.004		0.004
2	0.005	0.01	0.037	0.011	0.030	0.017	0.008	0.028	1	0.002	0.003	0.013	0.014	0.013	0.004	0.003	0.007
3	0.004	0.014	0.079	0.012	0.102	0.020	0.008	0.052	1.5	0.002	0.004	0.010	0.080	0.008	0.006	0.002	0.016
4	0.005	0.048	0.108	0.052	0.140	0.024	0.011	0.094	2	0.003	0.005	0.008	0.080	0.008	0.004	0.002	0.024
5	0.018	0.087	0.094	0.096	0.129	0.012	0.041	0.125	2.5	0.003	0.007	0.019	0.029	0.029	0.004	0.002	0.033
6	0.038	0.087	0.028	0.066	0.158	0.006	0.034	0.125	3	0.002	0.022	0.037	0.029	0.042	0.007	0.002	0.052

The follow-up full sequential sampling, four months after PLSLR, showed a large decline in the total mass of lead delivered to the tap (Table 1), as well as a greatly reduced flushing time necessary to move all stagnant lead-containing water out of the internal plumbing. All sites showed both first-draw and flushed samples to be below the action level of 15 parts per billion. It should be noted that six sites out of eight still had at least some samples with concentrations above the action level, probably due to the remaining lead portion of the service line. The average reduction of total mass of lead at the tap (in comparable volumes of water) was 62%, with a low of 36% and a high of 79%. The average mass reduction was 210 micrograms, with a minimum reduction of 41 micrograms and a maximum reduction of 562 micrograms. The two sites with the highest mass of lead, and the longest flushing times, Sites #5 and #8, showed the most dramatic reduction in both mass and flushing time.
