PASCOAG UTILITY DISTRICT

CLEAN WATER INFRASTRUCTURE REPLACEMENT PLAN

Five (5) Year Update

May 11, 2022

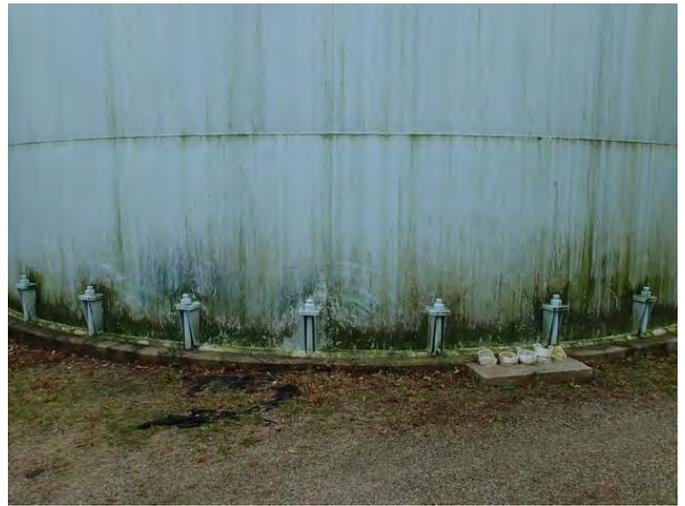
1 *Exterior Wall With Mild To Moderate Mildew*

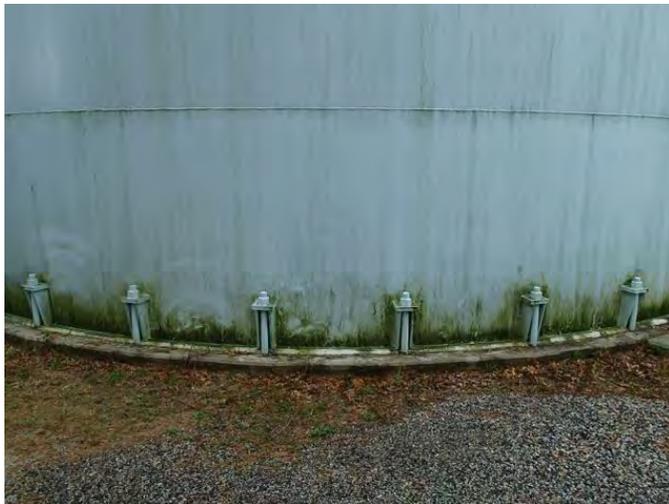
2 *Exterior Wall With Mild To Moderate Mildew*

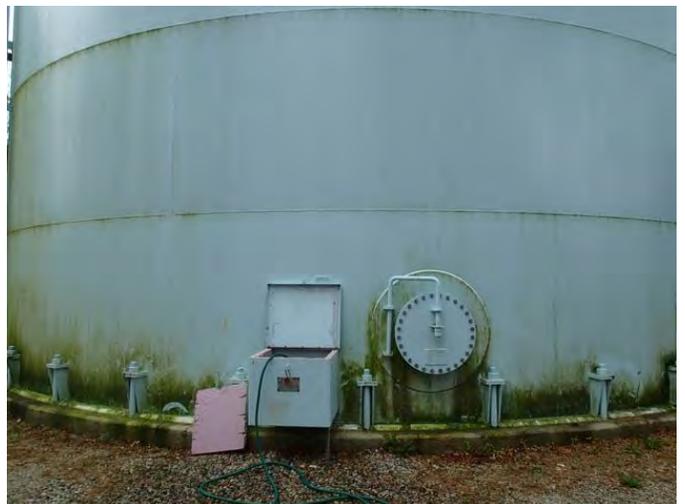
3 *Exterior Wall With Mild To Moderate Mildew*

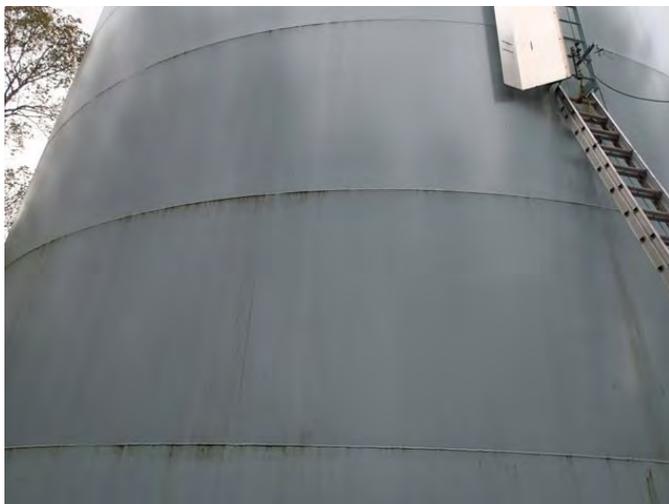
4 *Exterior Wall With Mild To Moderate Mildew*

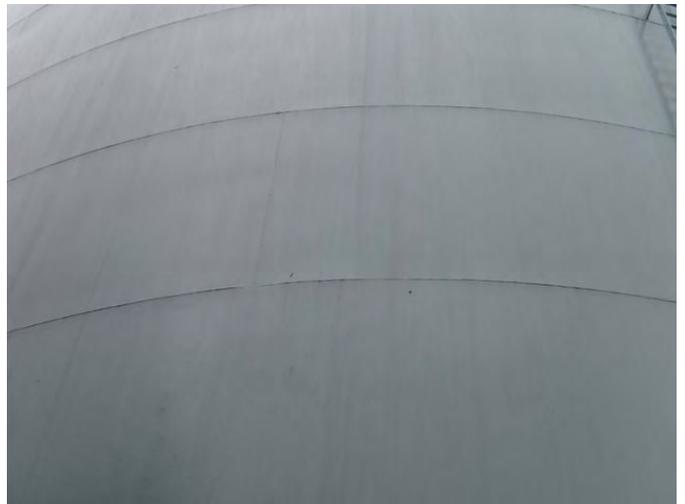
5 *Exterior Wall With Mild To Moderate Mildew*

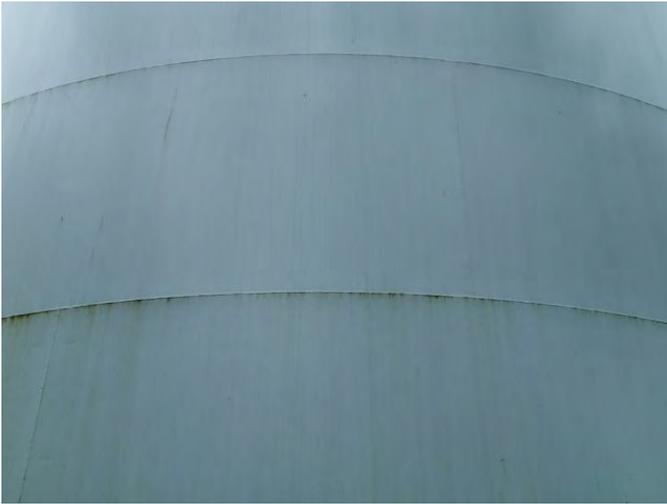
6 *Exterior Wall With Mild To Moderate Mildew*

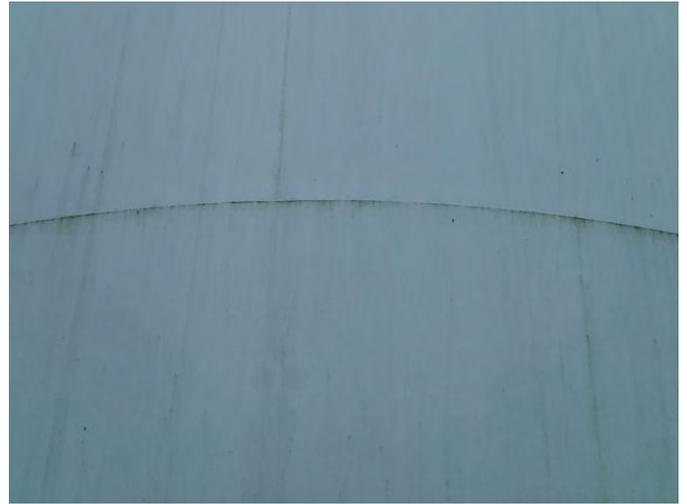
7 *Exterior Wall With Mild To Moderate Mildew*

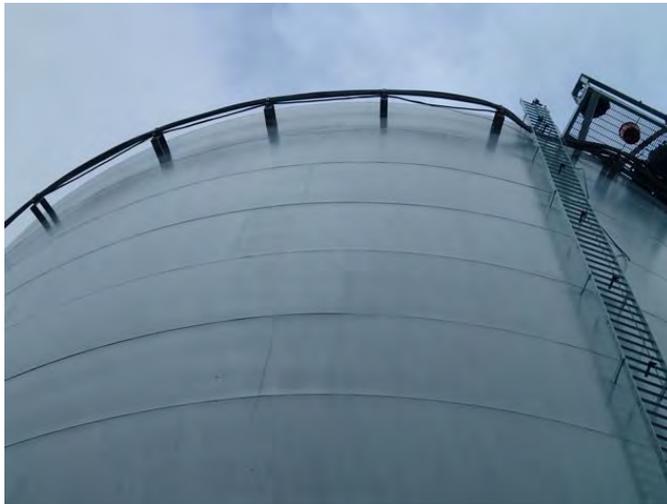
8 *Exterior Wall With Mild To Moderate Mildew*

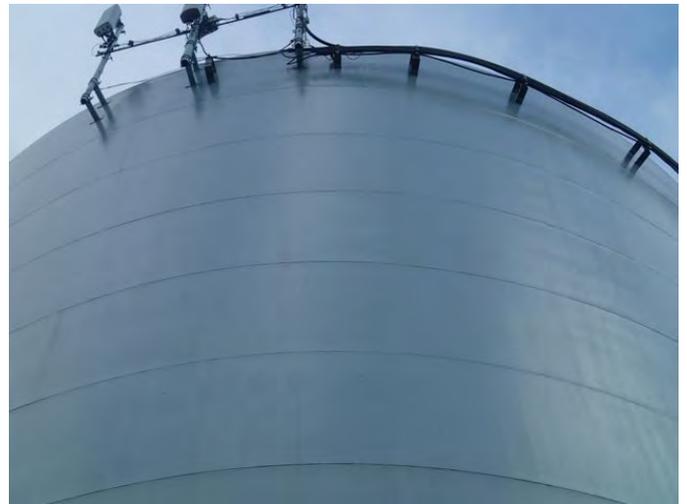
9 *Exterior Wall With Mild To Moderate Mildew*

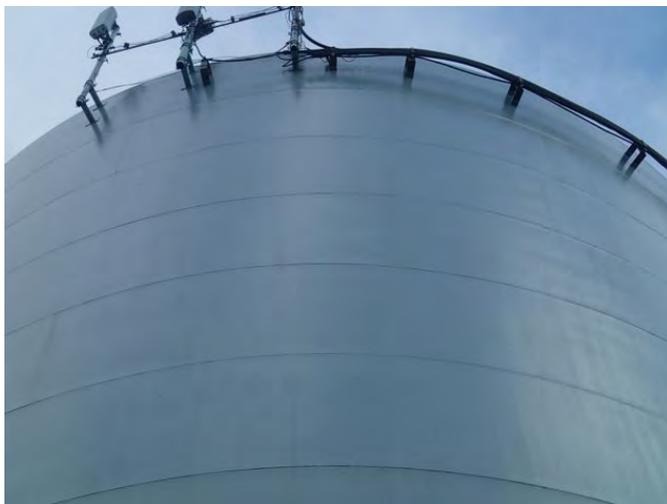
10 *Exterior Wall With Mild To Moderate Mildew*

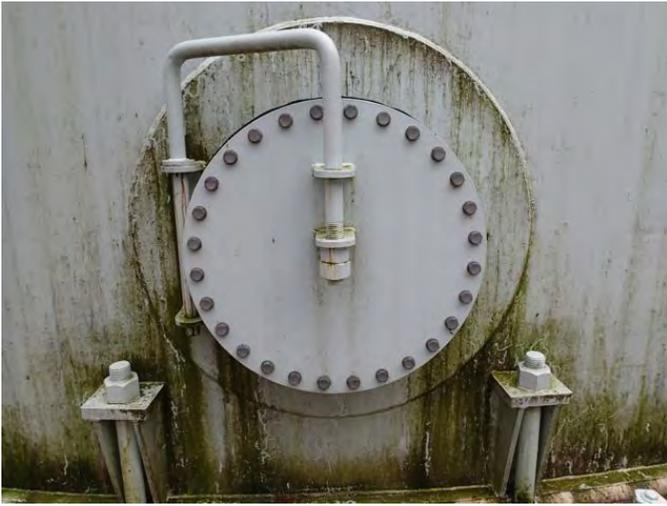
12 *Exterior Wall With Mild To Moderate Mildew*

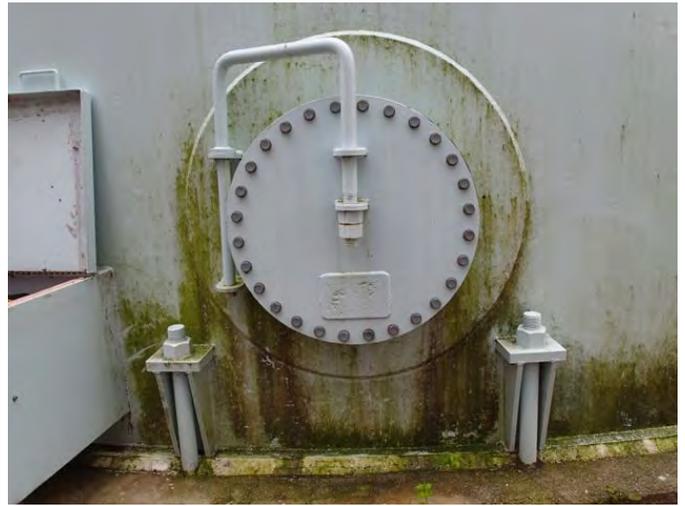
13 *Secure Easternmost Manway*

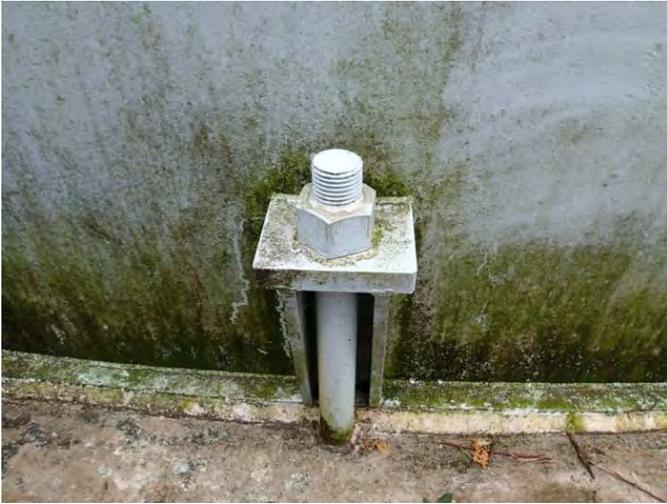
14 *Secure Westernmost Manway*

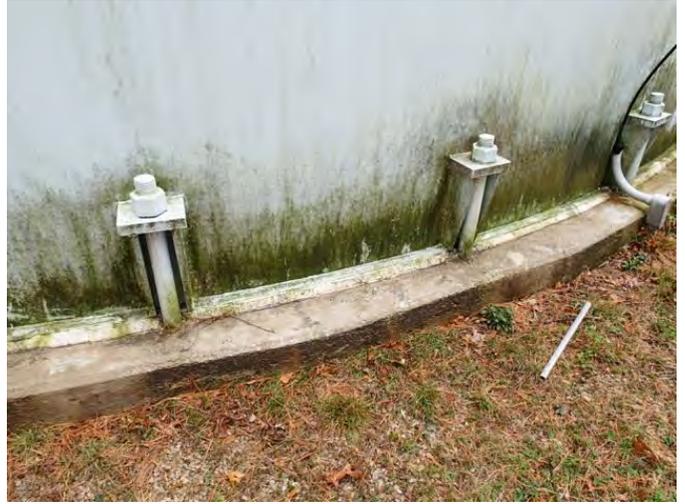
15 *Secure Anchor Bolt*

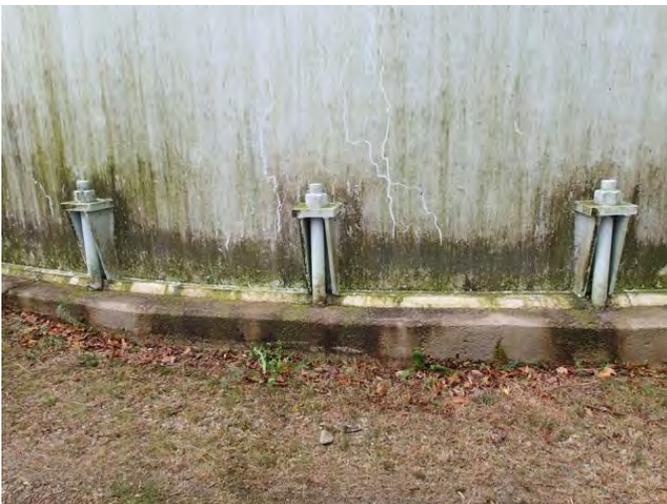
16 *Secure Anchor Bolt*

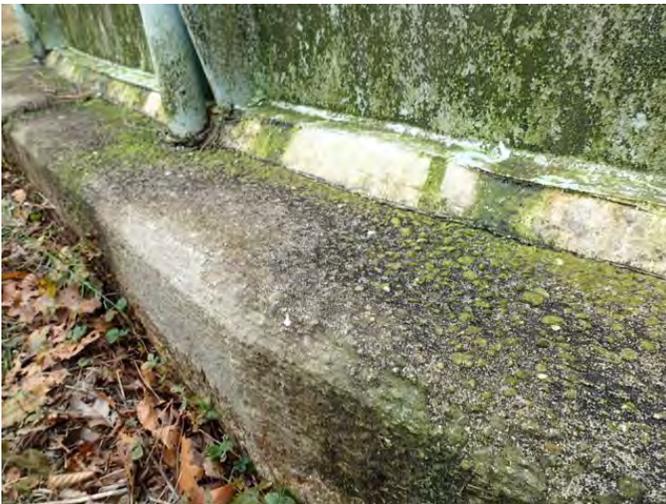
20 *Concrete Foundation With Tight Cracks*

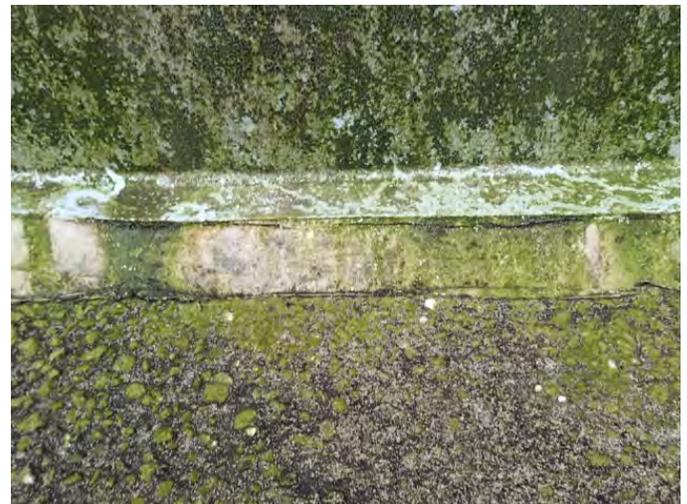
21 *Concrete Foundation With Sealant Applied At The Junction Of The Concrete Foundation And Tank Base*

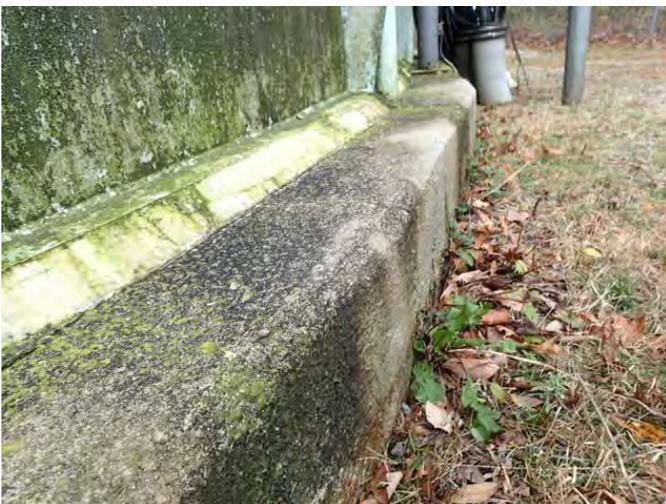
22 *Concrete Foundation With Sealant Applied At The Junction Of The Concrete Foundation And Tank Base*

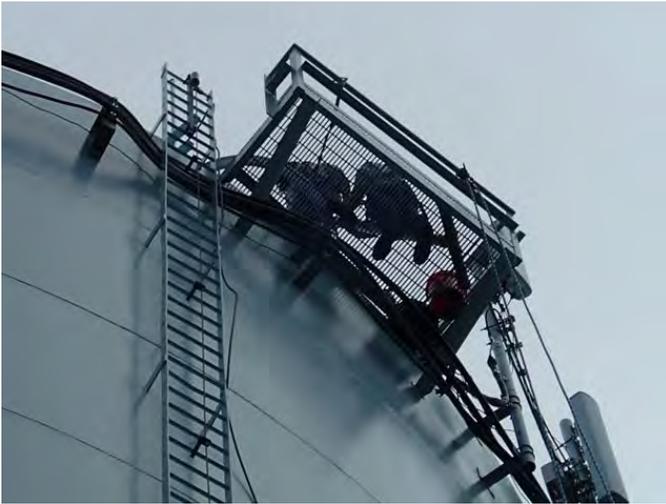
24 *Ladder With A Fall Prevention Device And Platform*

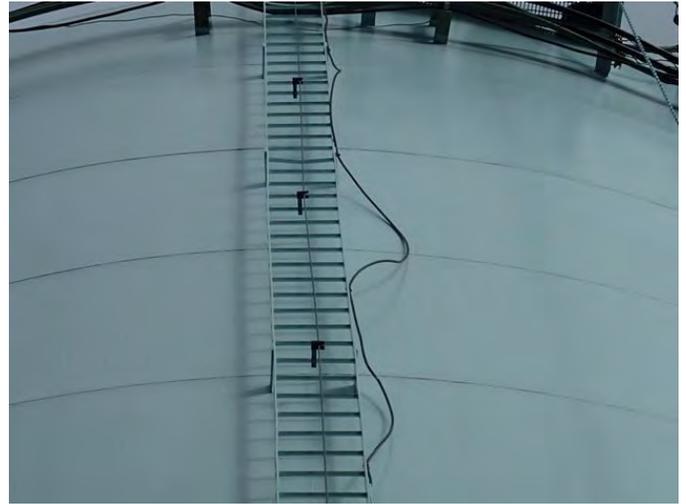
25 *Ladder With A Fall Prevention Device And Platform*

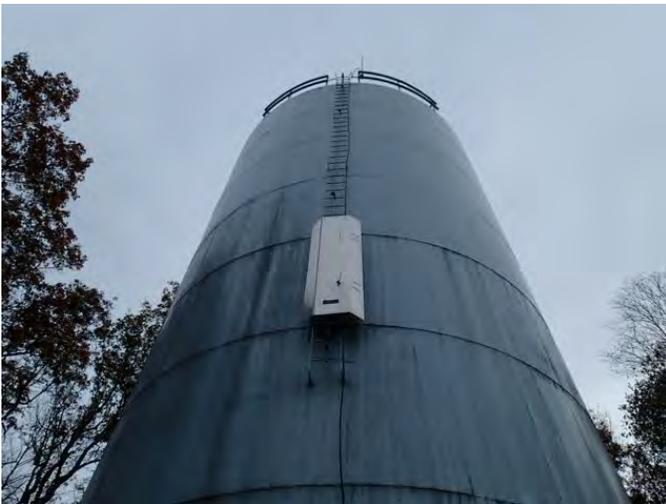
26 *Communication Cable Installed On The Ladder Having Slack*

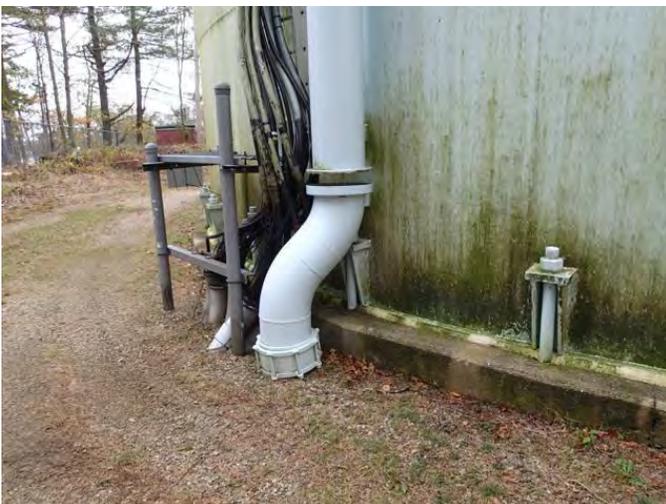
28 *Overflow Weir Box And Overflow Pipe*

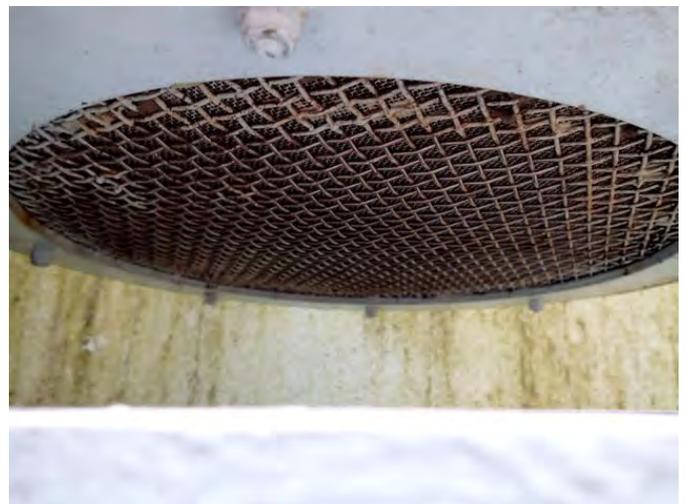
29 *Overflow Pipe With An Air Gap*

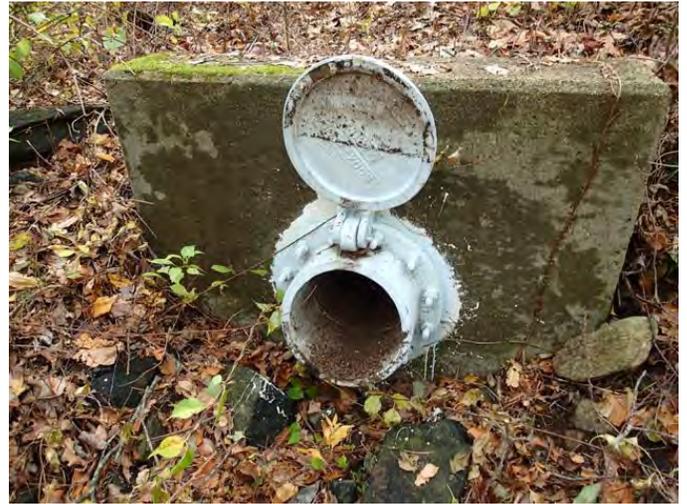
31 *Pipe Below The Overflow Pipe Without A Screen*

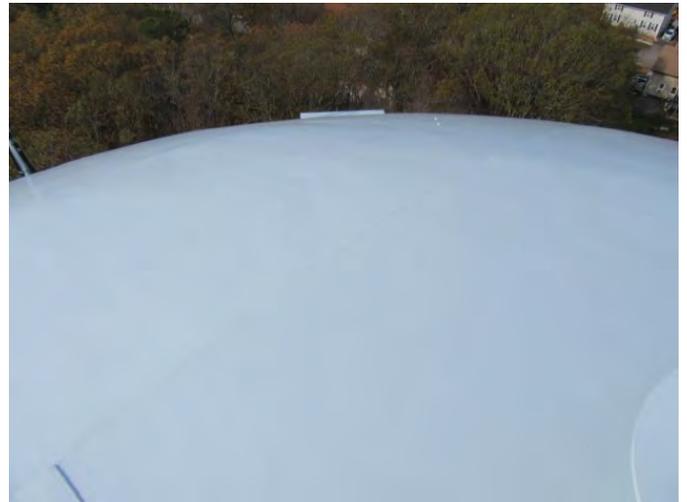
33 *Roof Panels*

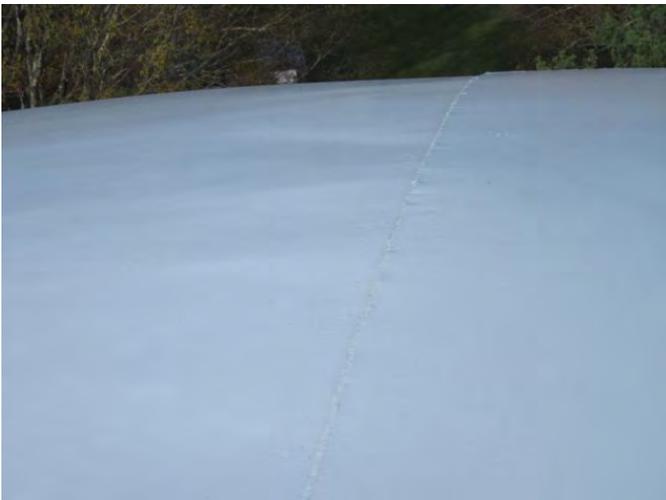
34 *Roof Panels*

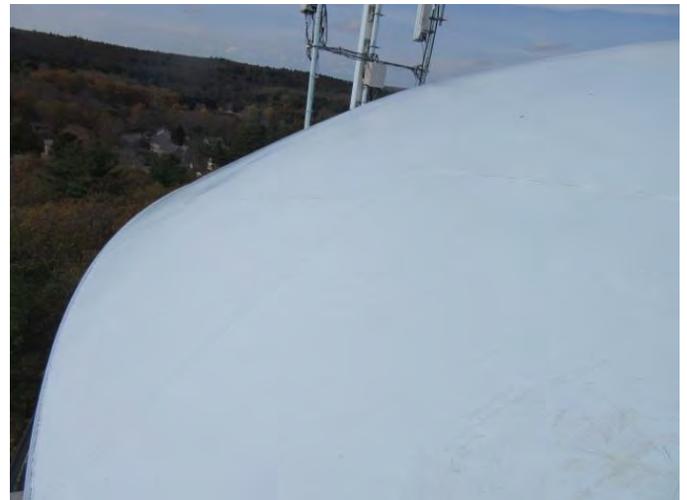
35 *Roof Panels*

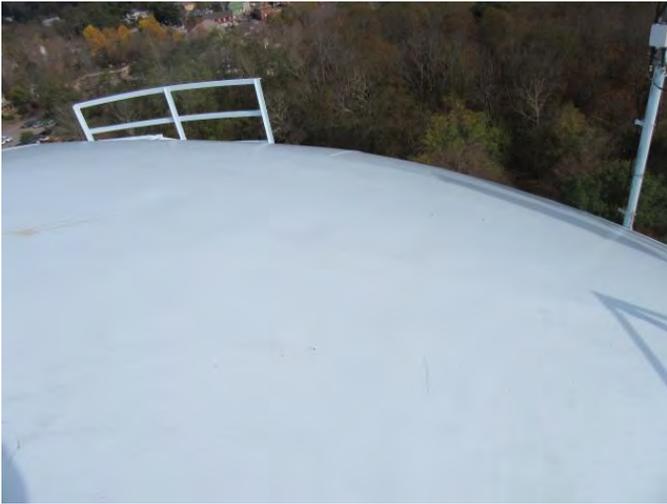
36 *Roof Panels*

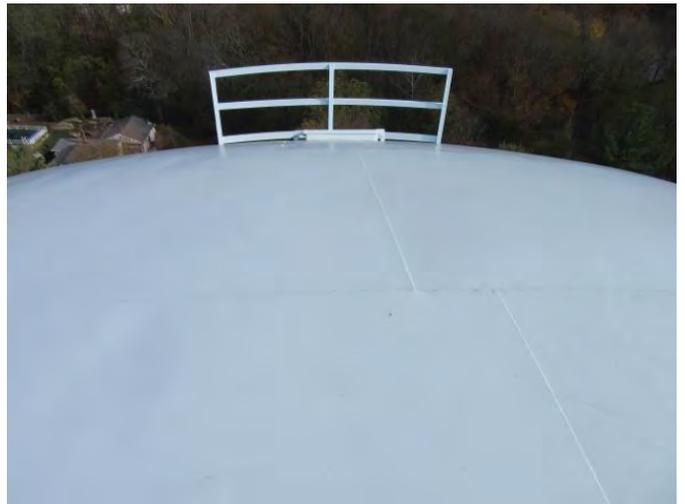
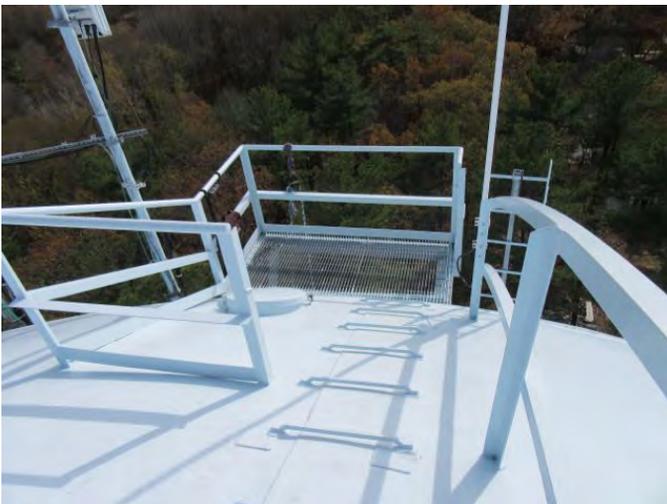
38 *Roof Panels*

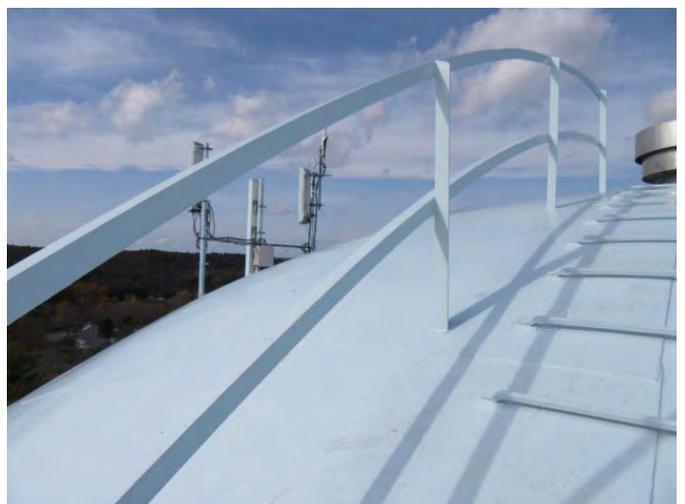
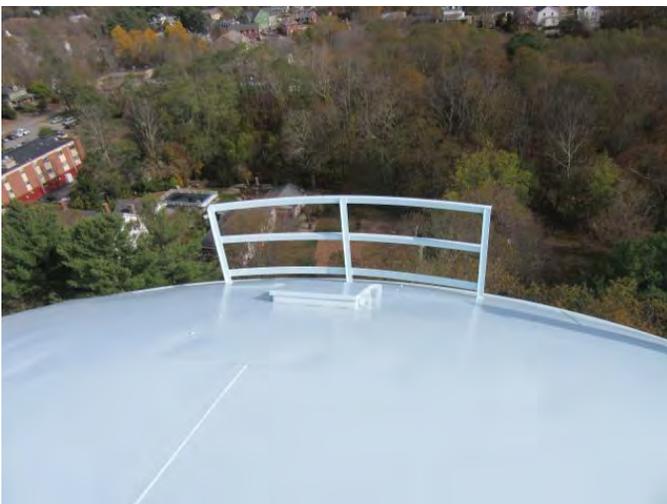
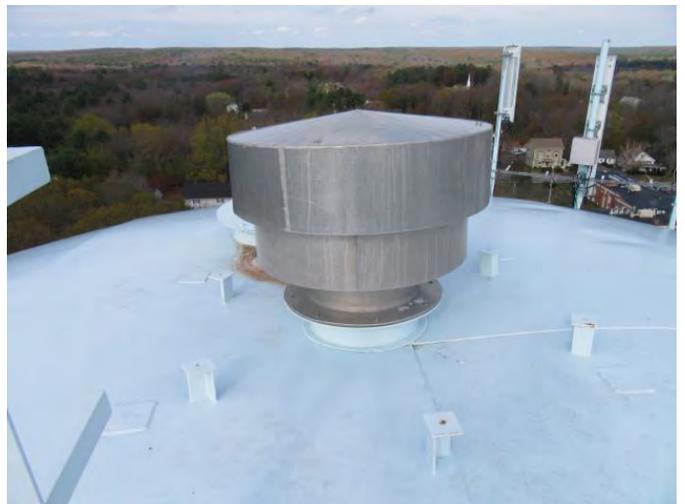
39 *Secure Safety Railings*

40 *Secure Safety Railings*

41 *Secure Safety Railings*

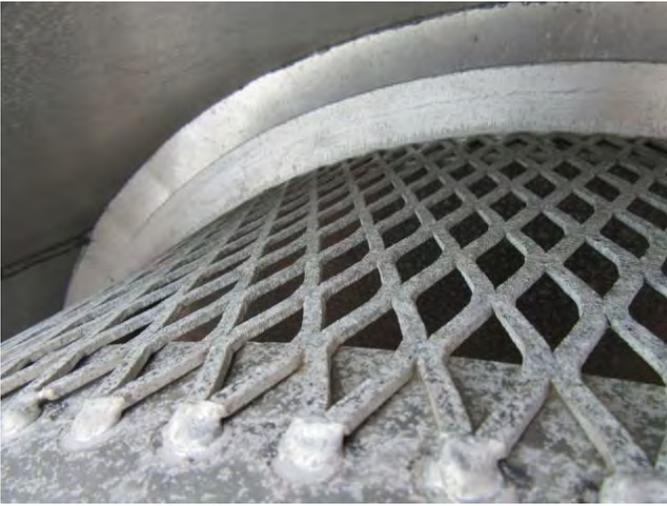
42 *Secure Frost Proof Vent*

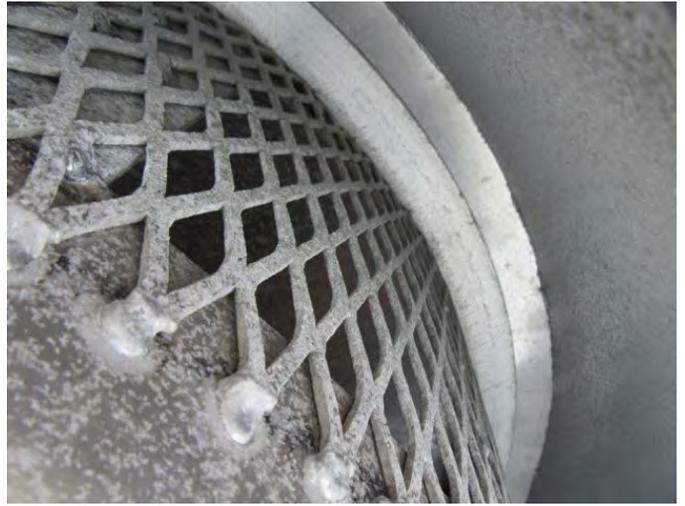
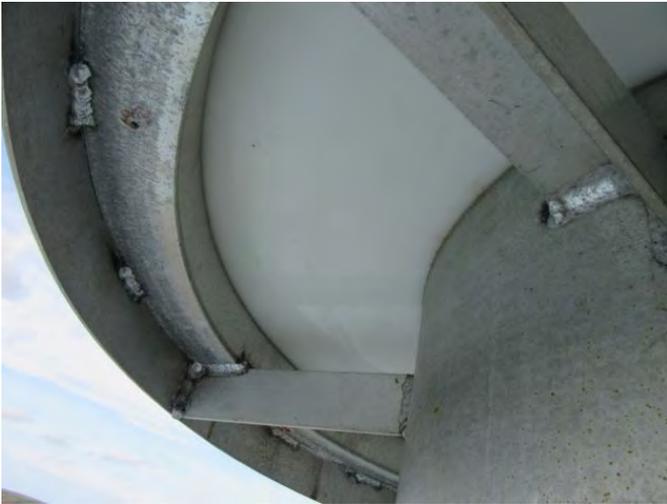
43 *Secure Vent Screen*

44 *Secure Vent Screen*

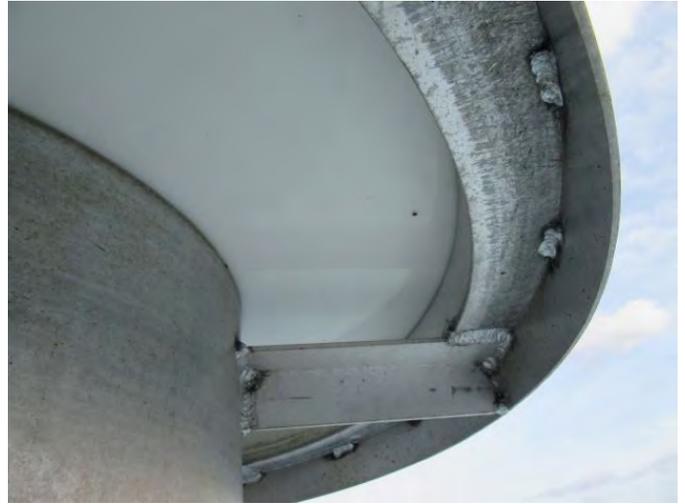
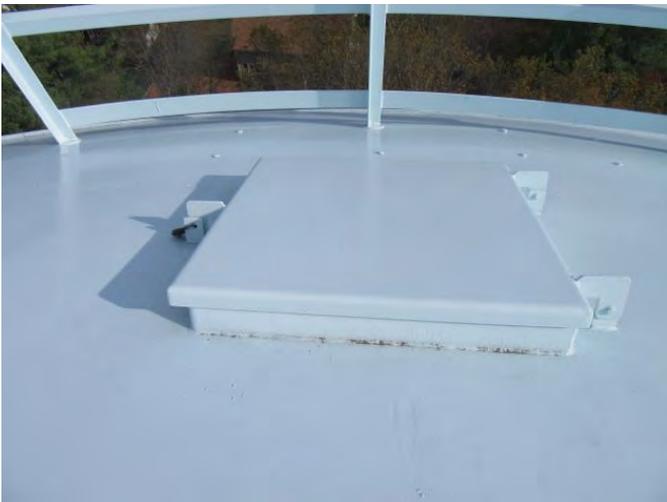
45 *Secure Vacuum Release Plate*

46 *Secure Vacuum Release Plate*

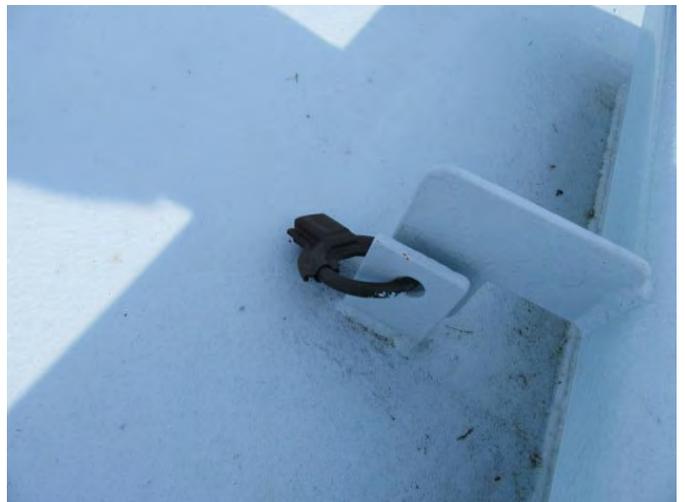
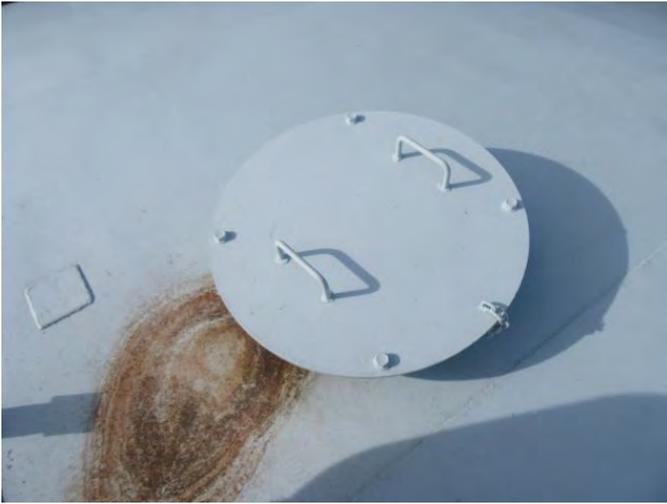
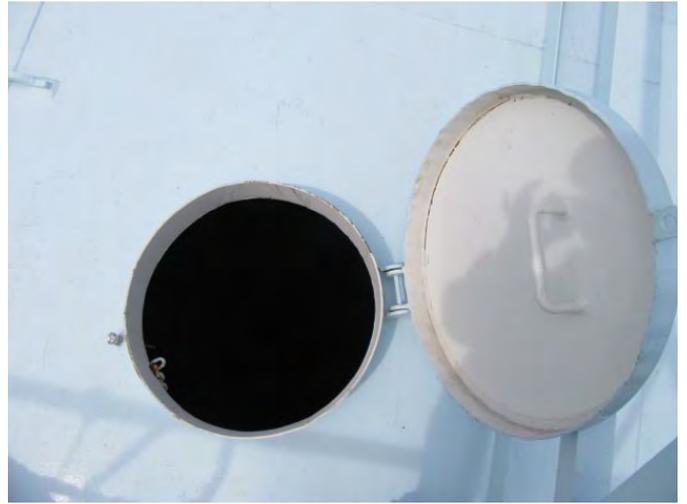
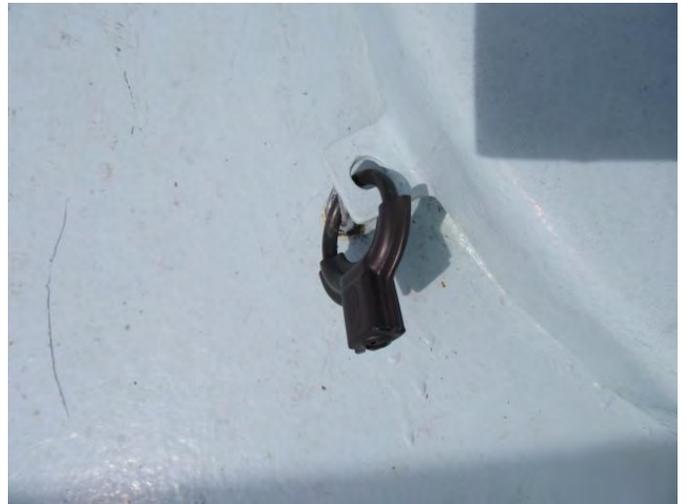
47 *Closed Easternmost Access Hatch*

48 *Secure Easternmost Access Hatch*

49 *Secure Access Hatch*

50 *Southernmost Open Access Hatch*

51 *Southernmost Closed Access Hatch*

52 *Southernmost Secure Access Hatch*

Each hatch was opened during this inspection and were found in good working condition.

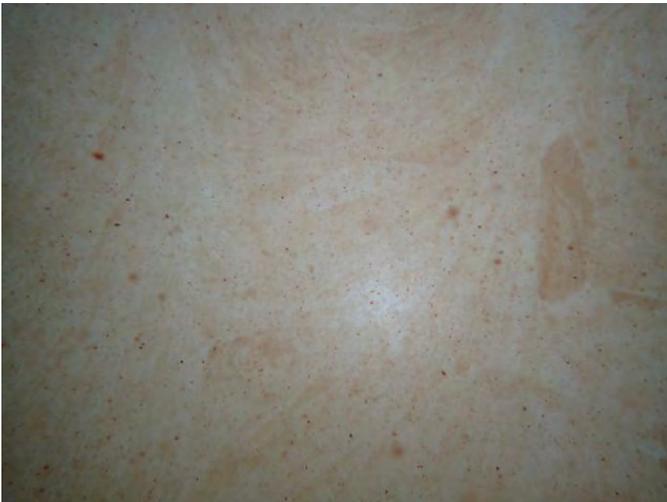
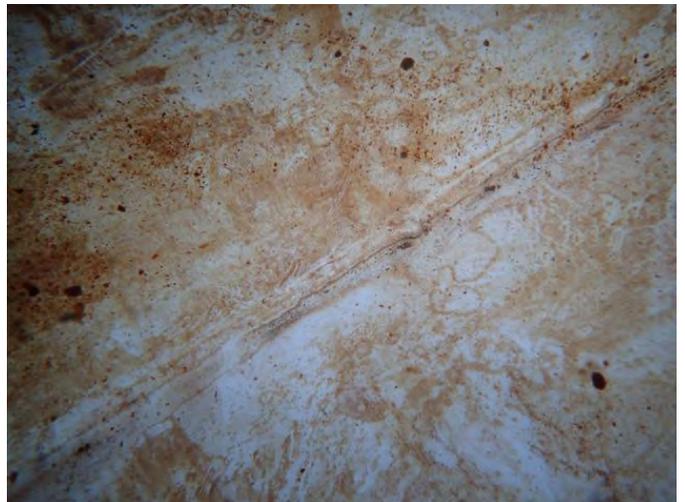
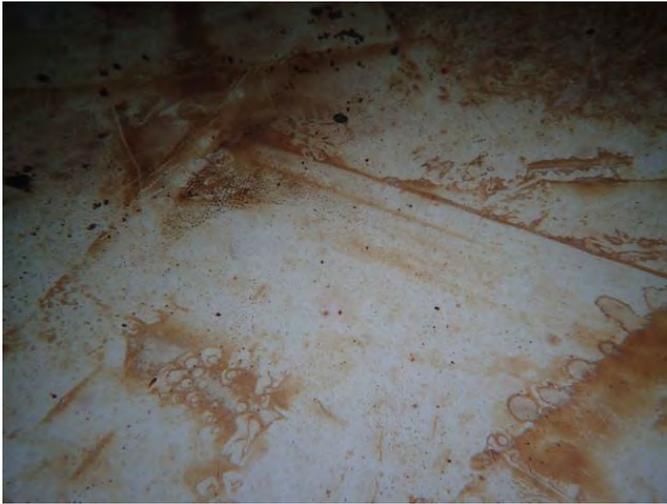
58 *Floor With Mild To Moderate Staining*

59 *Floor With Mild To Moderate Staining*

60 *Floor With Mild To Moderate Staining*

61 *Floor With Mild To Moderate Staining*

62 *Floor With Mild To Moderate Staining*

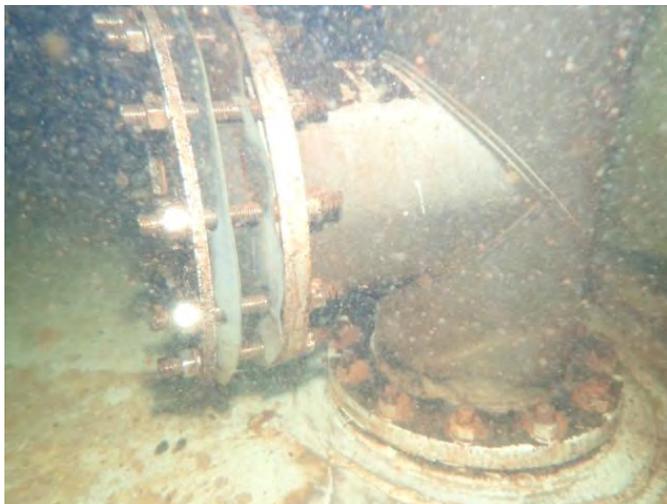
64 *Westernmost Manway*

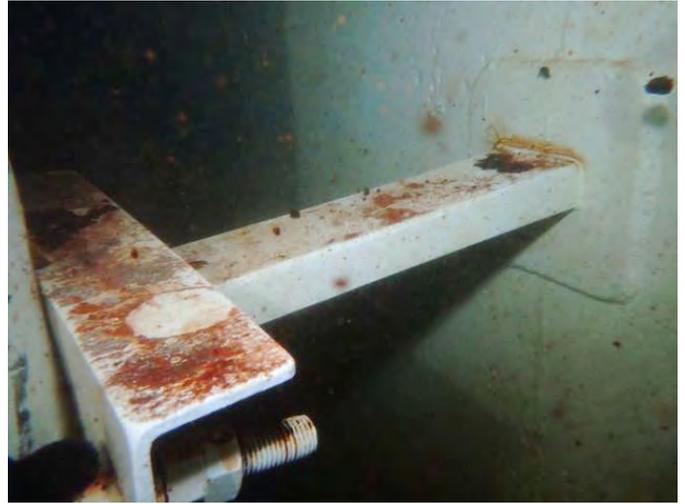
66 *Effluent Steel Grate*

67 *Effluent Steel Grate*

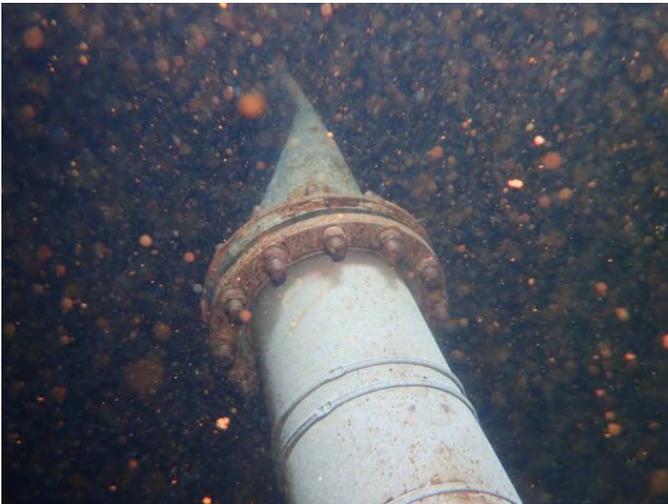
68 *Influent/Effluent Mixing System Pipe Supported To The Wall*

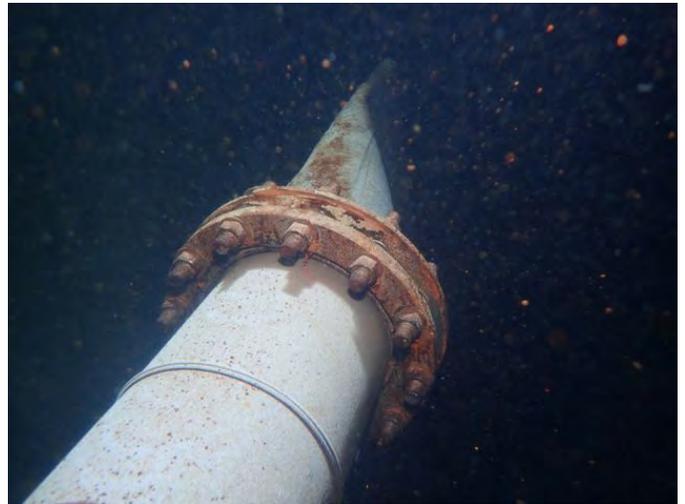
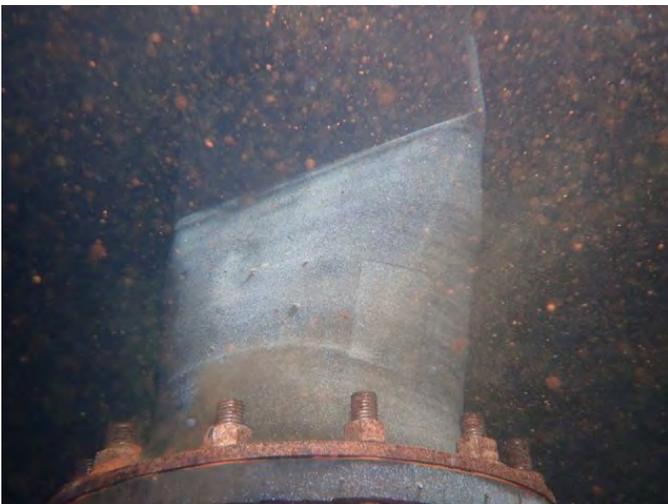
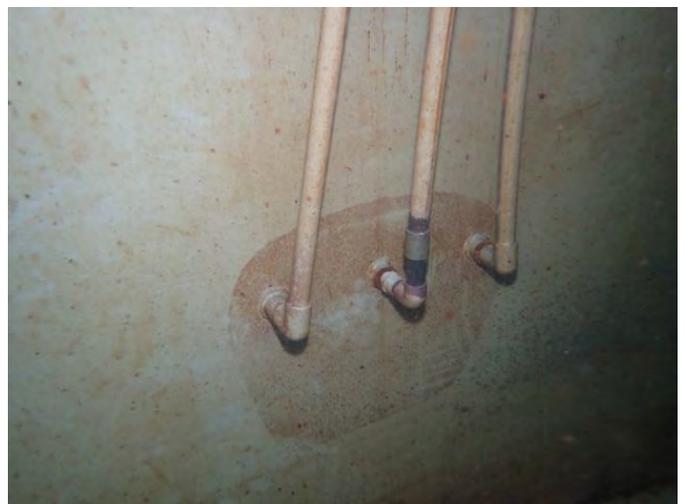
69 *Rubber Influent Check Valve*

70 *Rubber Influent Check Valve*

71 *Rubber Influent Check Valve*

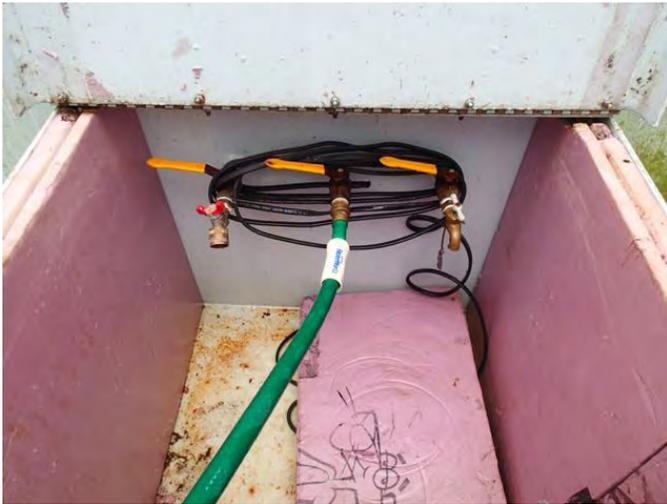
72 *Sample Pipes Penetrating The Wall (Interior Of The Tank)*

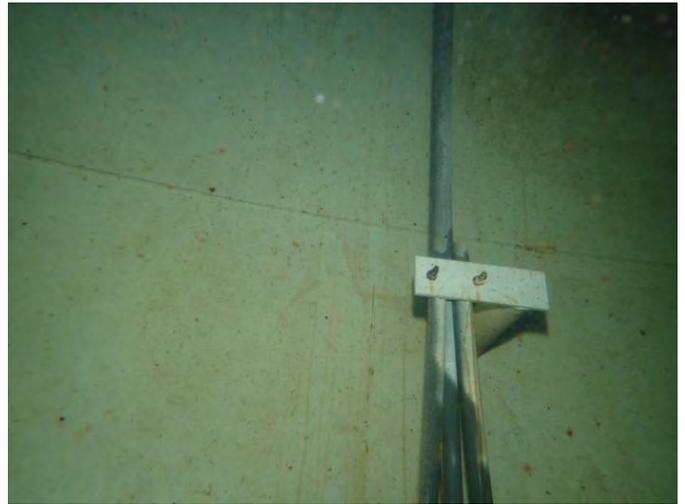
73 *Sample Pipe Box On The Exterior Of The Tank*

A steel box welded to the lowest wall panel on the westernmost side of the tank provides a housing for the sample pipes. This steel box was found secured with a lock, preventing unwanted access.

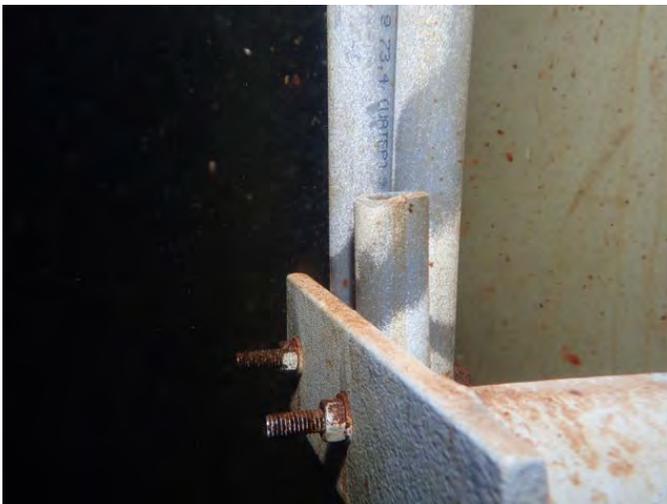
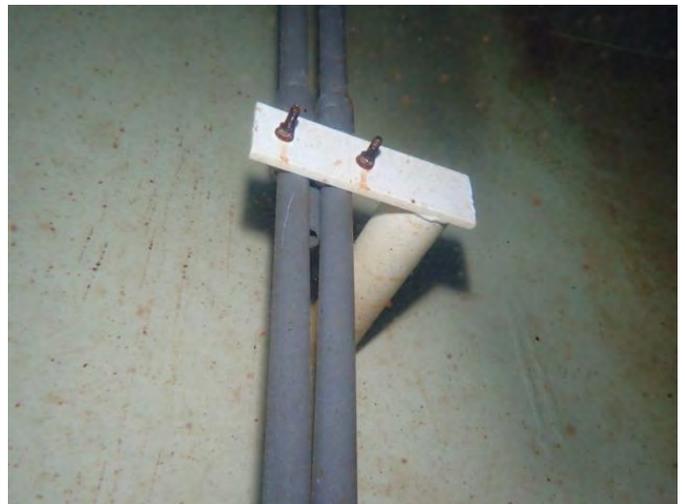
74 *Sample Pipes Supported To The Wall*

75 *Sample Pipes Supported To The Wall*

76 *Sample Pipes Supported To The Wall*

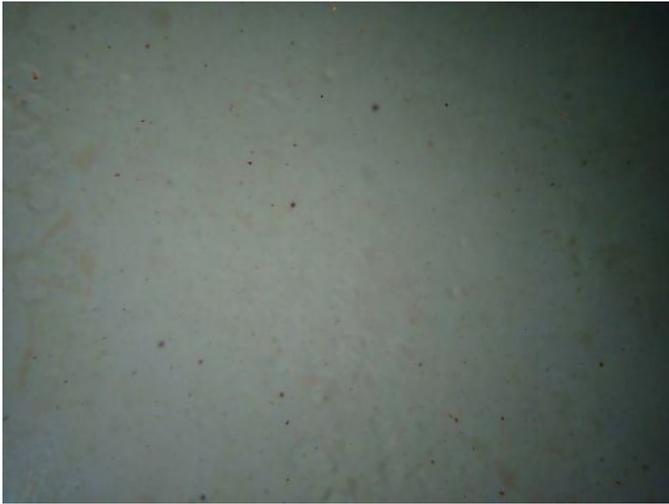
78 *Interior Wall With Mild Staining*

79 *Interior Wall With Mild Staining*

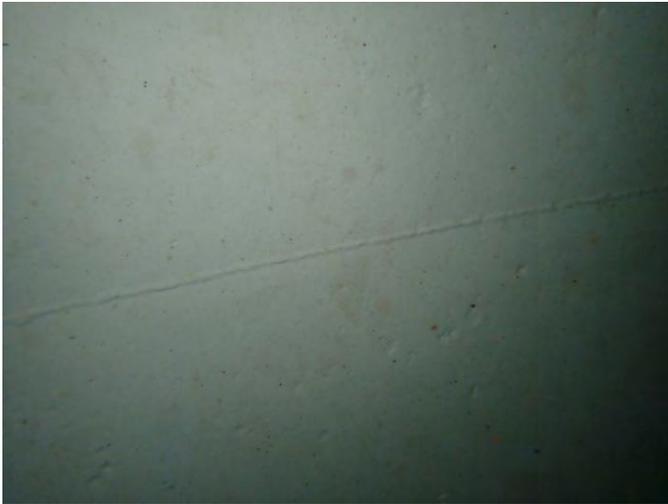
81 *Interior Wall With Mild Staining*

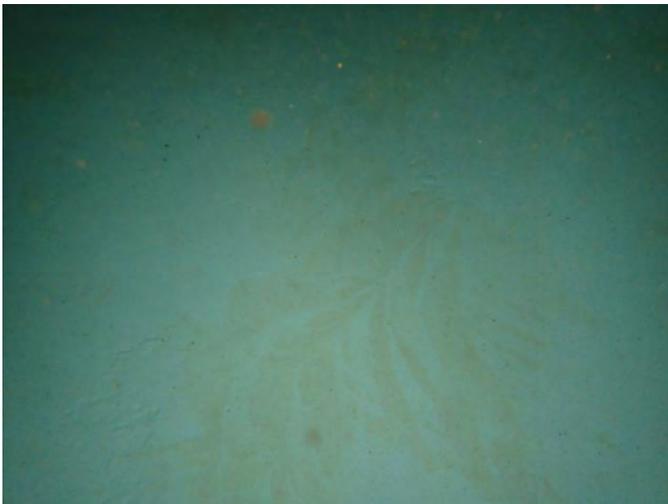
83 *Interior Wall With Mild Staining*

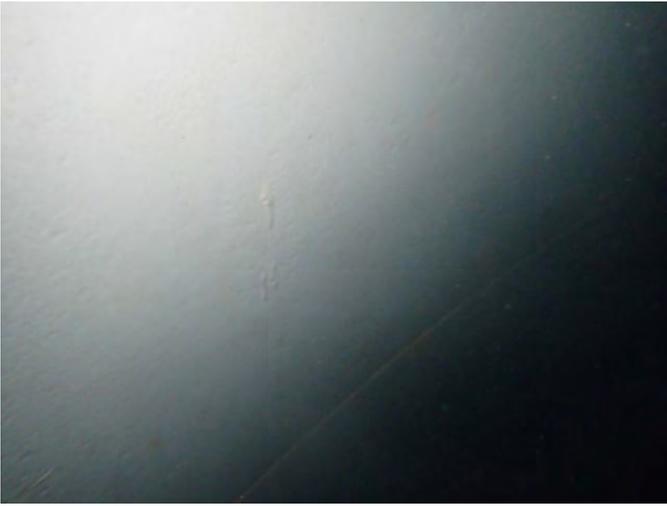
85 *Interior Wall With Mild Staining*

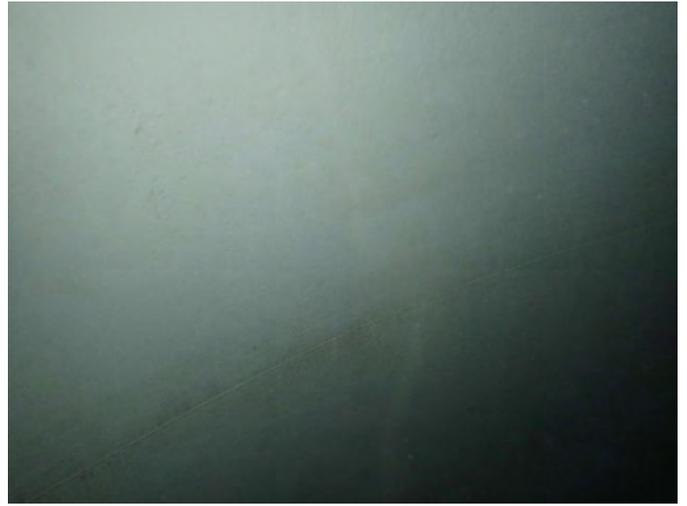
86 *Interior Wall With Mild Staining*

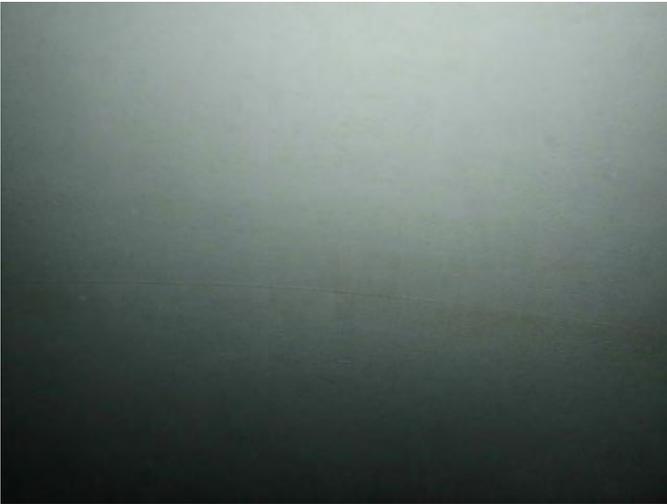
87 *Interior Wall With Mild Staining*

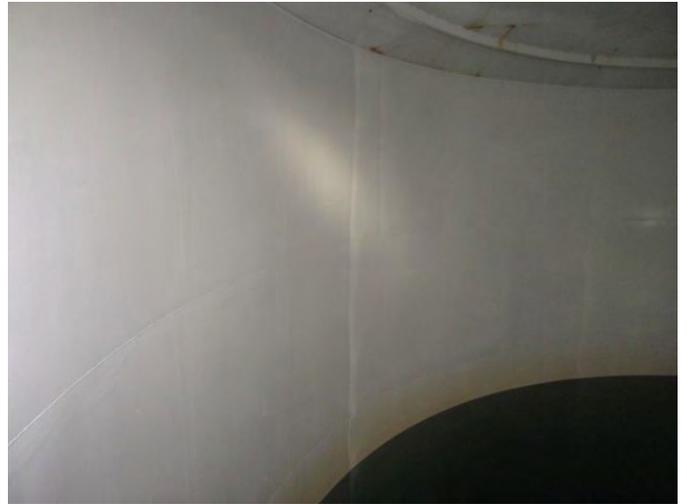
88 *Interior Wall With Mild Staining*

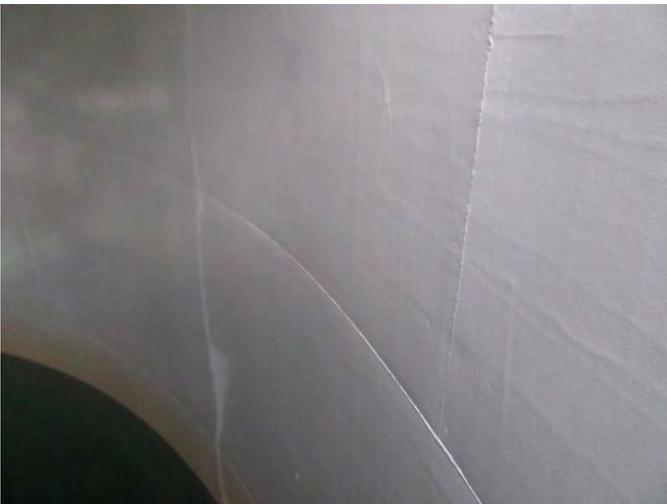
89 *Interior Wall With Mild Staining*

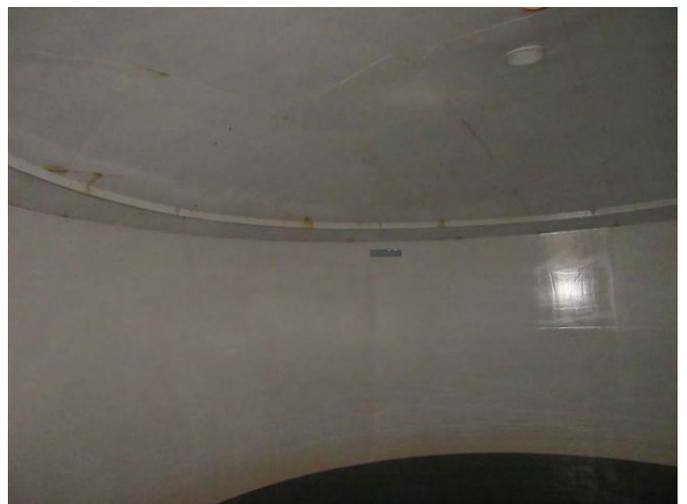
90 *Interior Wall With Mild Staining*

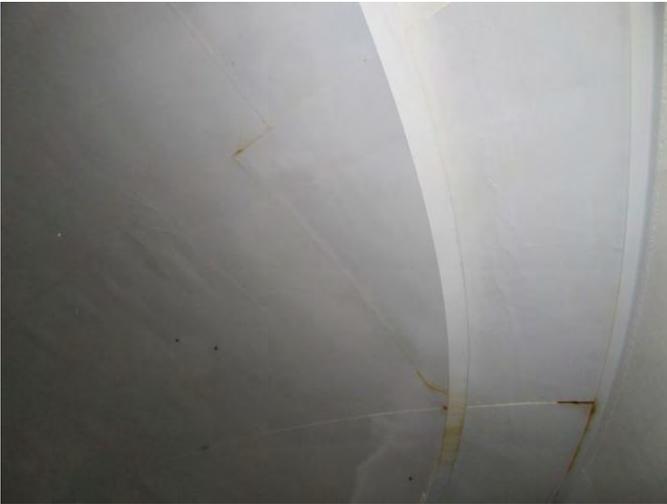
93 *Overhead With Mild Rust Staining*
