PASCOAG UTILITY DISTRICT

CLEAN WATER INFRASTRUCTURE REPLACEMENT PLAN

Five (5) Year Update

May 11, 2022

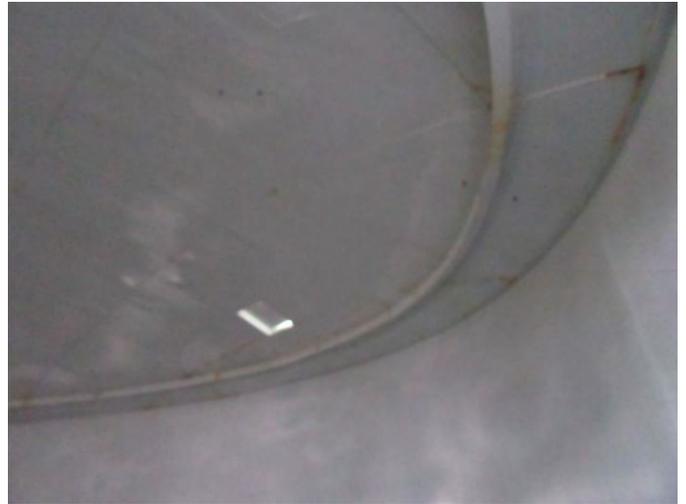
94 *Overhead With Mild Rust Staining*

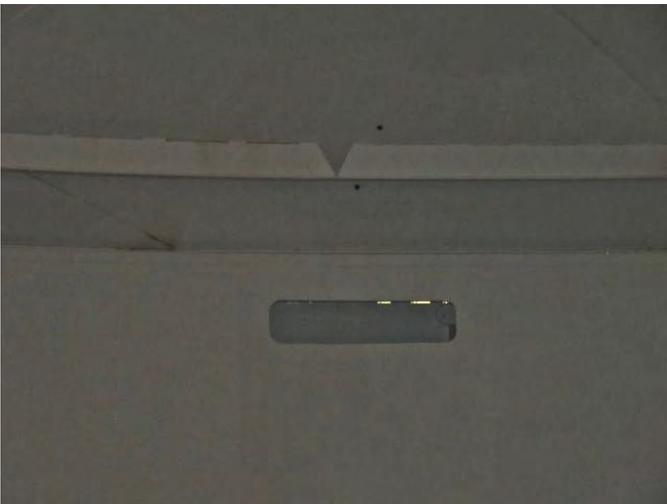
95 *Overflow Cutout*

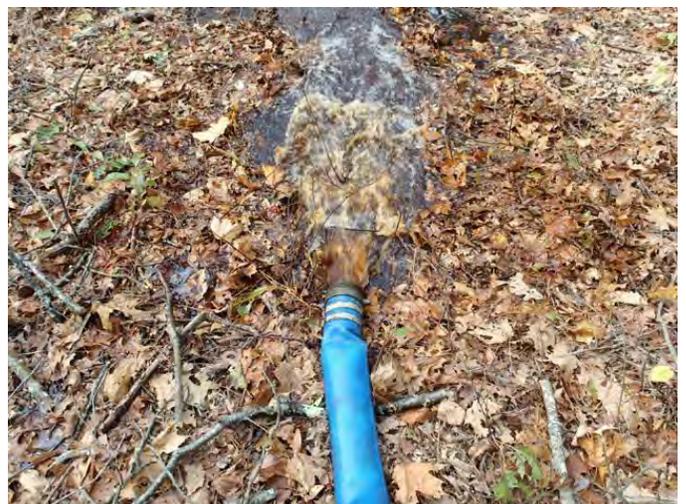
96 *Discharge During Cleaning*

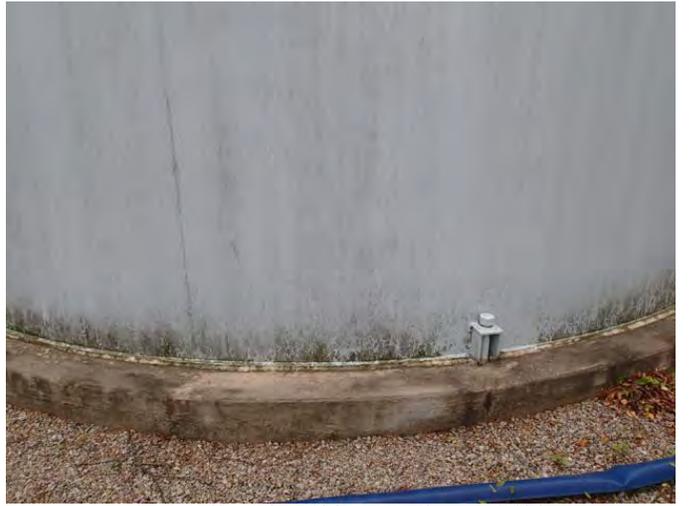
2 *Exterior Wall With Mild To Moderate Mildew*

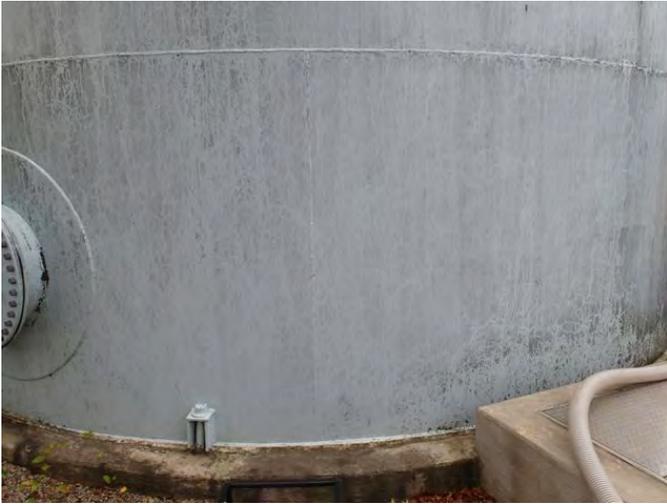
3 *Exterior Wall With Mild To Moderate Mildew*

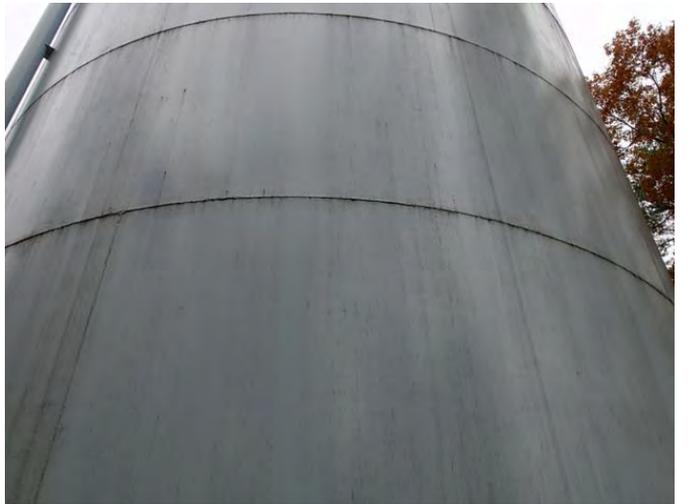
4 *Exterior Wall With Mild To Moderate Mildew*

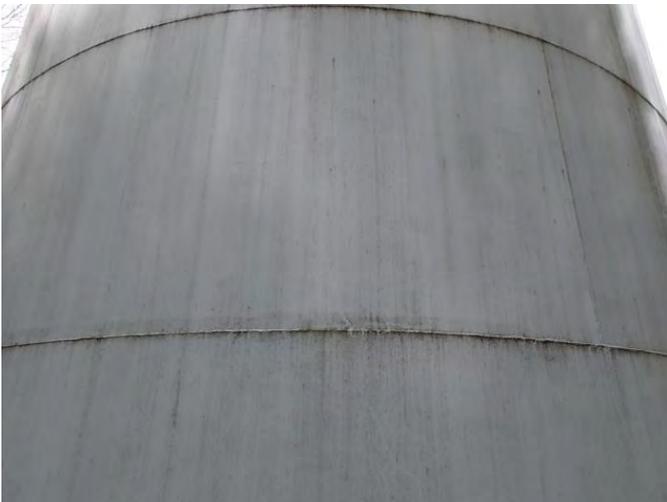
5 *Exterior Wall With Mild To Moderate Mildew*

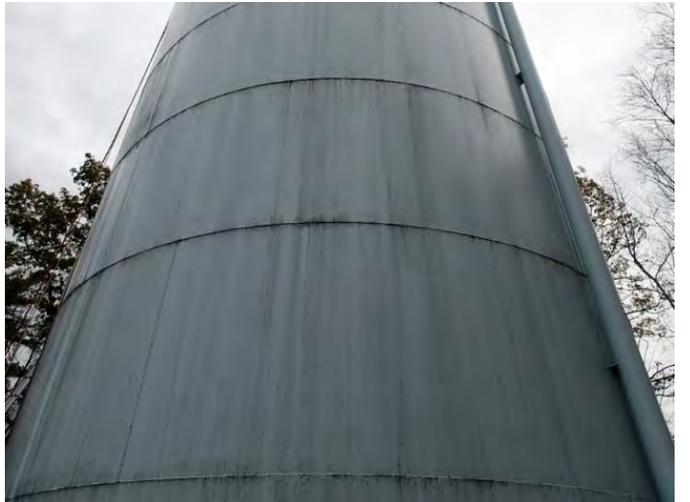
6 *Exterior Wall With Mild To Moderate Mildew*

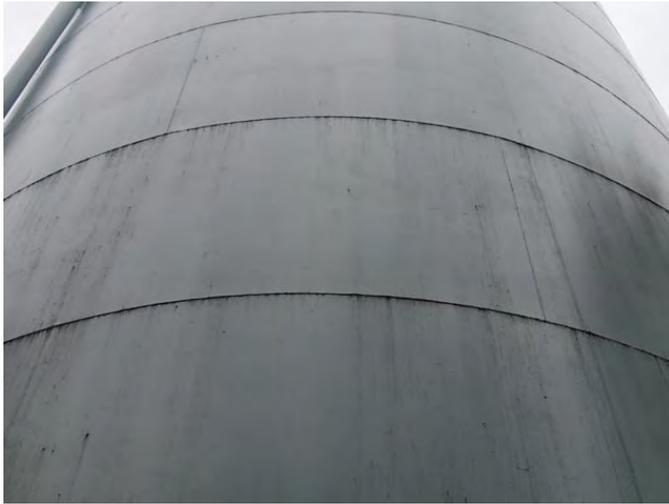
7 *Exterior Wall With Mild To Moderate Mildew*

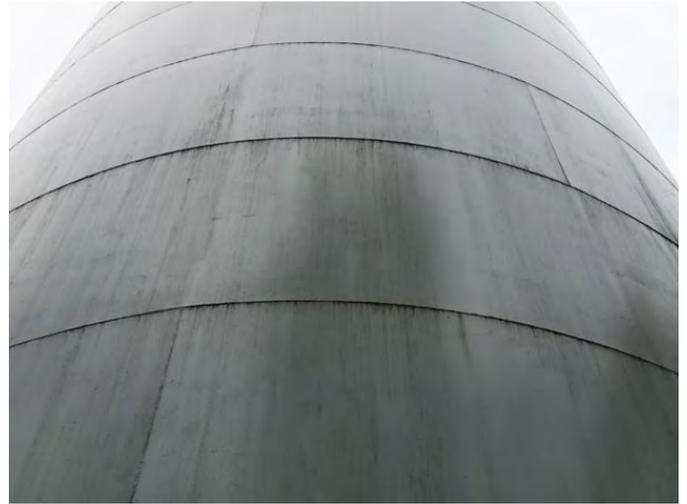
8 *Exterior Wall With Mild To Moderate Mildew*

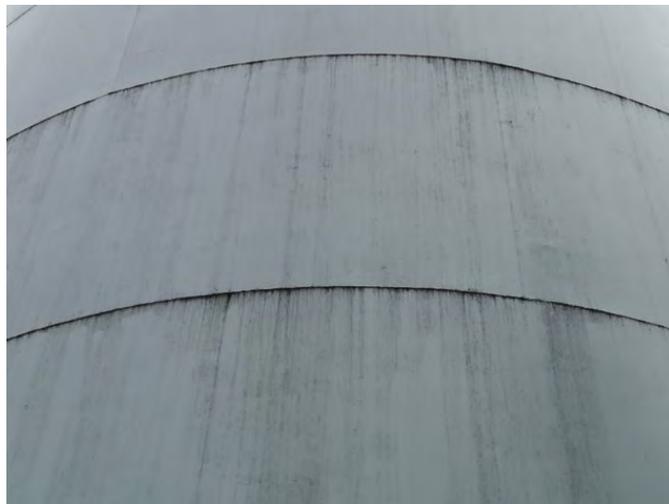
9 *Exterior Wall With Mild To Moderate Mildew*

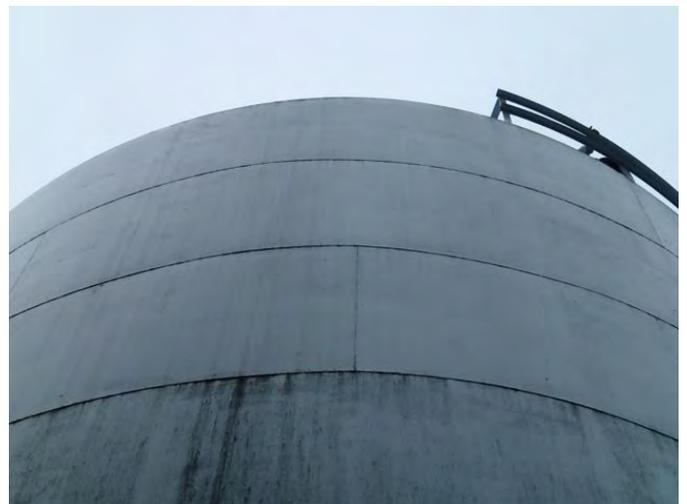
10 *Exterior Wall With Mild To Moderate Mildew*

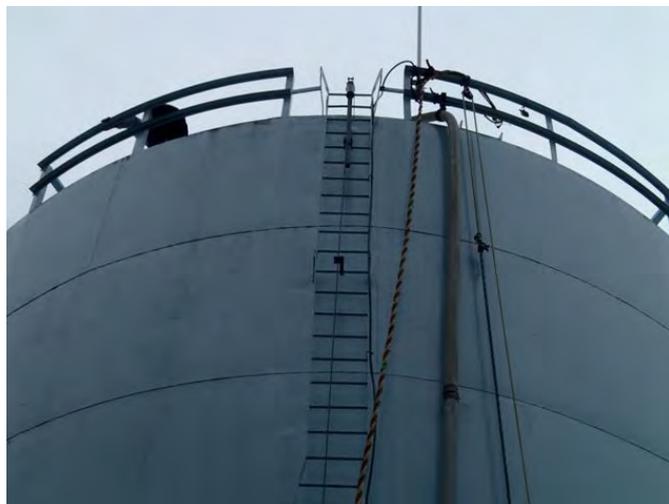
11 *Exterior Wall With Mild To Moderate Mildew*

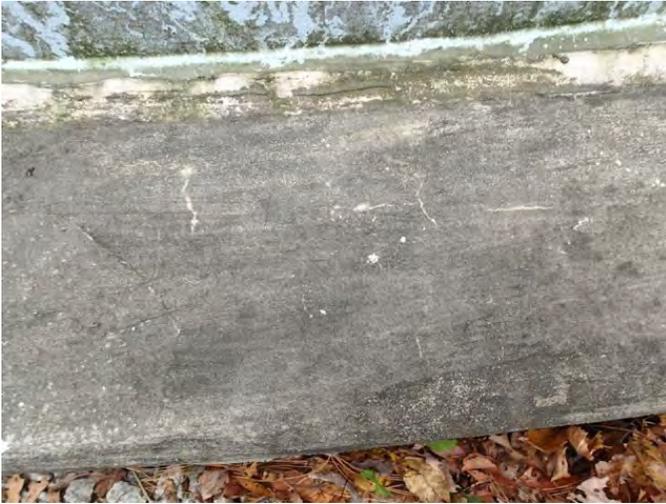
The exposed surfaces of the 10” wide concrete foundation averages 7” in height and was found to be un-coated, yet appeared mostly sound. Tight cracks were observed throughout less than 5% of these exposed surfaces. These cracks were sounded and appeared to be limited to the surface of the concrete and free of voids or spalls at this time.

15 *Concrete Foundation With Tight Surface Cracks*

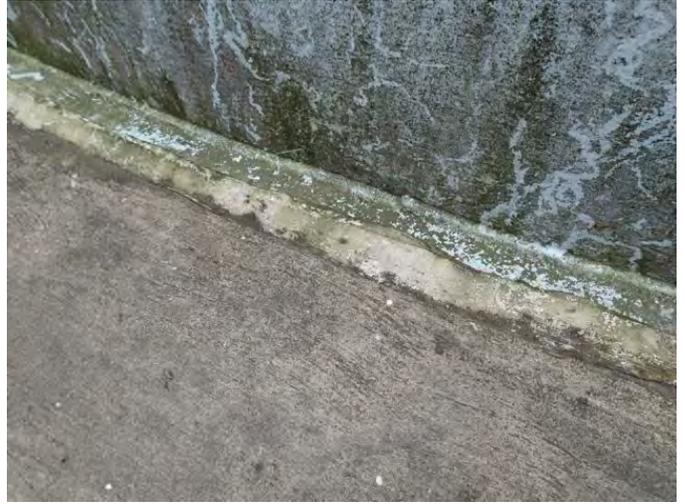
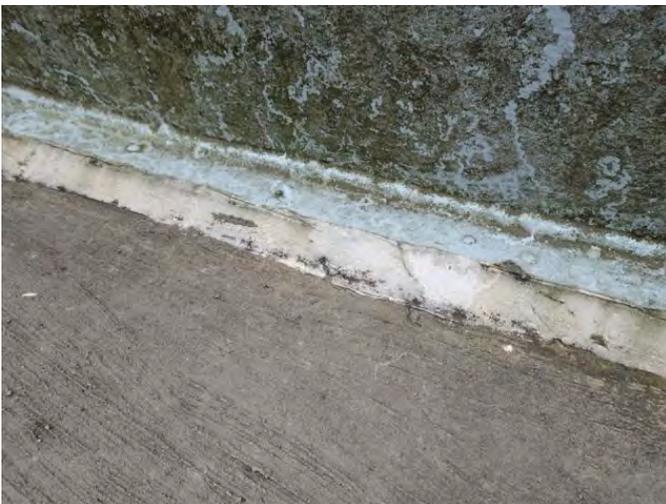
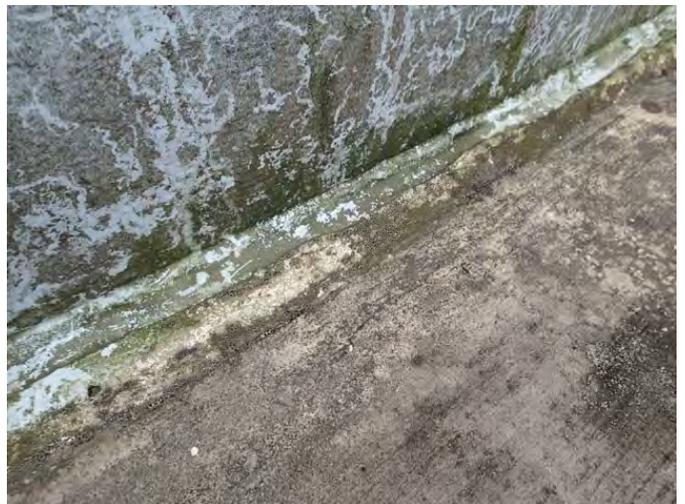
The sealant applied throughout the circumference of the tank at the junction of where the foundation and tank base meet was found having good adhesion value, preventing moisture from penetrating and accumulating beneath the tank.

16 *Concrete Foundation With Sealant Applied At The Junction Of The Concrete Foundation And Tank Base*

17 *Concrete Foundation With Sealant Applied At The Junction Of The Concrete Foundation And Tank Base*

18 *Concrete Foundation With Sealant Applied At The Junction Of The Concrete Foundation And Tank Base*

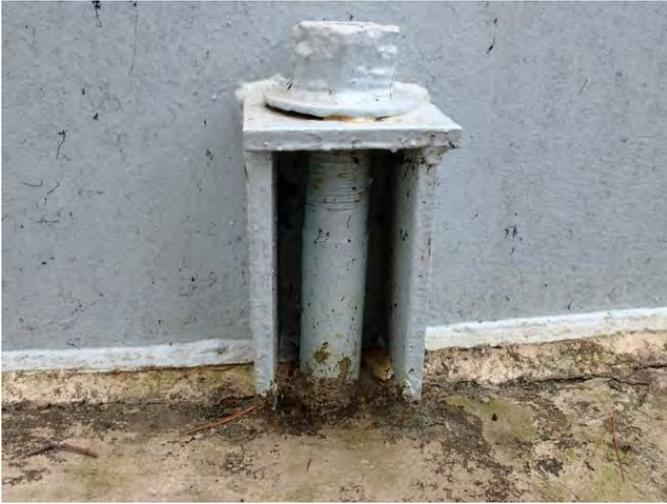
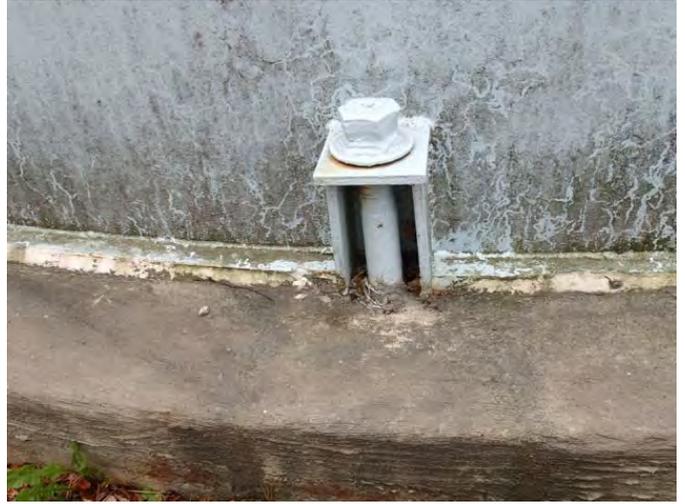
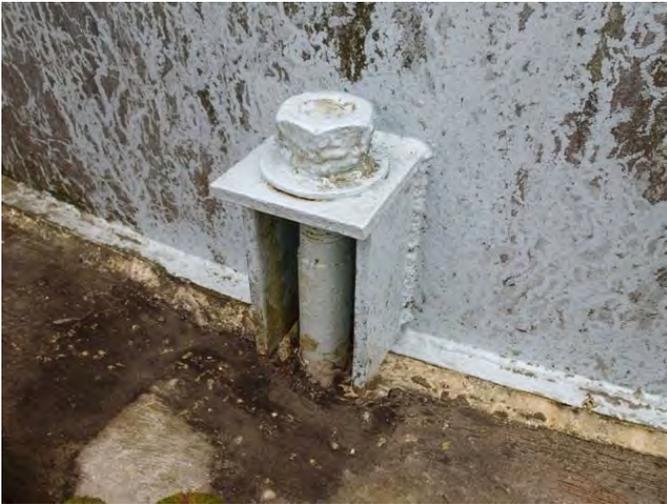
Six, 1-3/4" diameter anchor bolts extend up from the foundation into steel support chairs welded to the lowest row of wall panels. Each anchor bolt has a nut securely installed, while the protective coating applied to this steel support hardware was found having good adhesion value at this time.

19 *Secure Anchor Bolt*

20 *Secure Anchor Bolt*

21 *Secure Anchor Bolt*

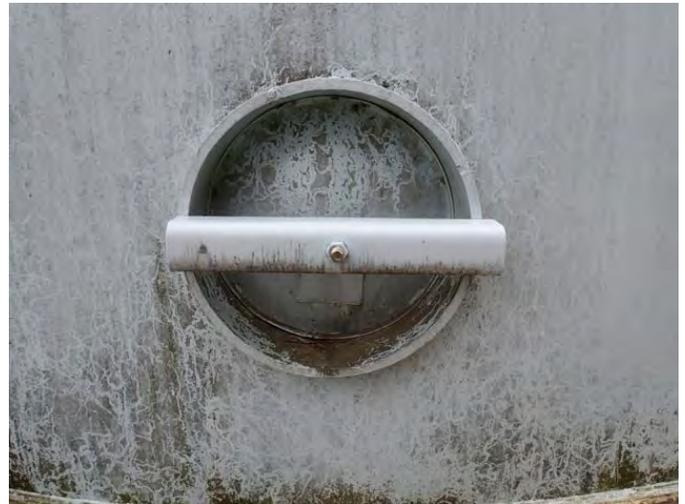
One 24" inside diameter manway penetrates the lowest wall panel on the westernmost side of the tank, located approximately 17" above the tank base and is securely installed and free of obvious leakage. The protective coating applied to the steel manway lid, trunk and securing hardware was found having good adhesion value at this time.

22 *Secure Westernmost Manway*

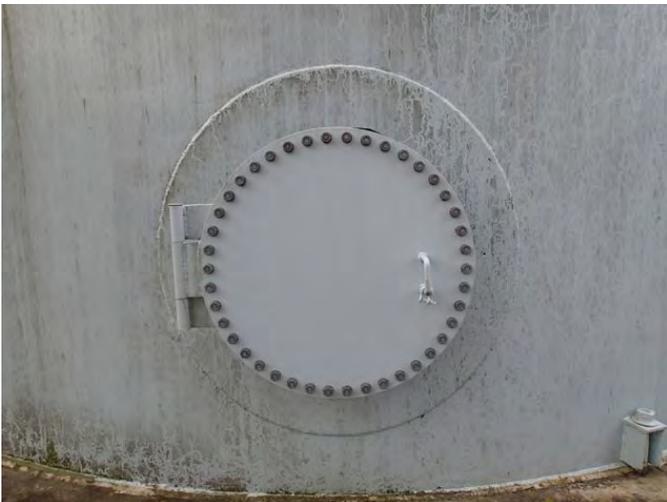
One, 30" inside diameter manway penetrates the lowest wall panel on the easternmost side of the tank, located approximately 25" above the tank base and is securely installed and free of obvious leakage. The protective coating applied to the steel manway lid and trunk was found having good adhesion value, while the galvanized steel nuts and bolts that secures this manway are not coated at this time.

23 *Secure Easternmost Manway*

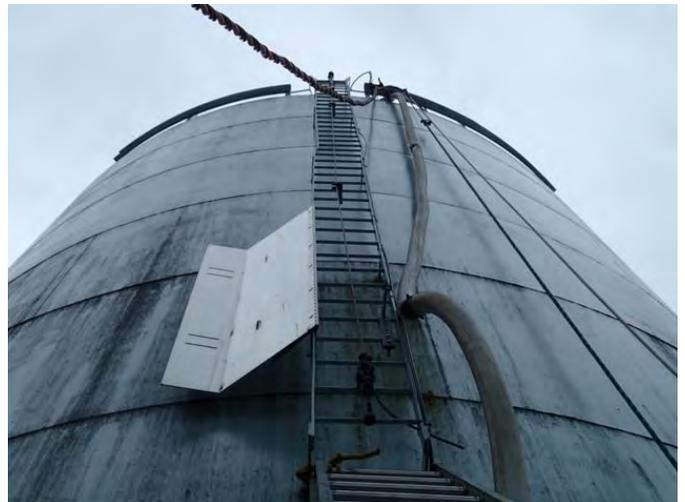
A welded steel ladder extends from 20' above the ground up to the roof and is supported to the tank wall with five sets of welded standoffs, having a galvanized steel fall prevention device installed throughout its length and providing safe access to the roof. The protective coating applied to this steel ladder and support standoffs was found having good adhesion value, while the galvanized steel fall prevention device is not coated at this time.

24 *Ladder And Safety Cage With A Fall Prevention Device*

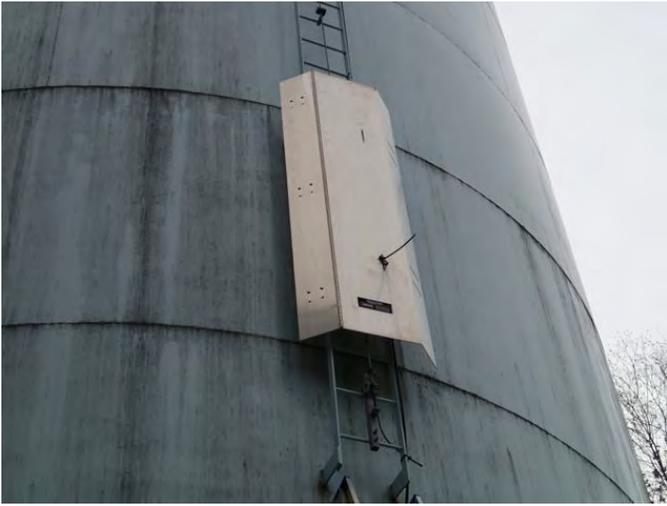
An aluminum ladder guard installed on the base of the ladder was found secured with nut and bolt at this time.

25 *Secure Ladder Guard*

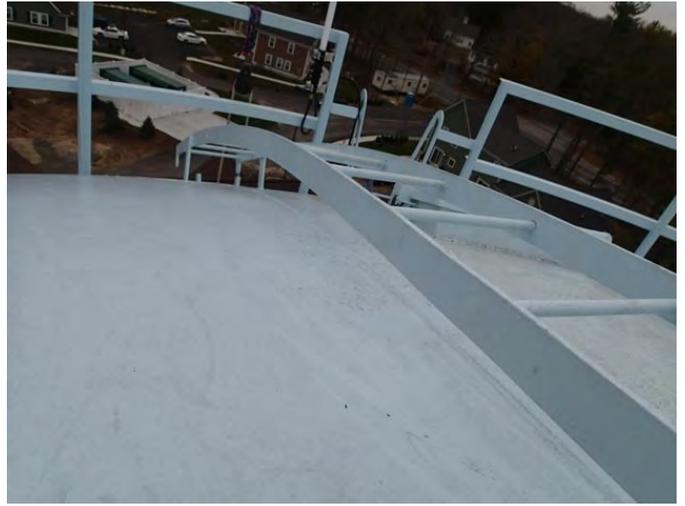
26 *Vent Access Ladder*

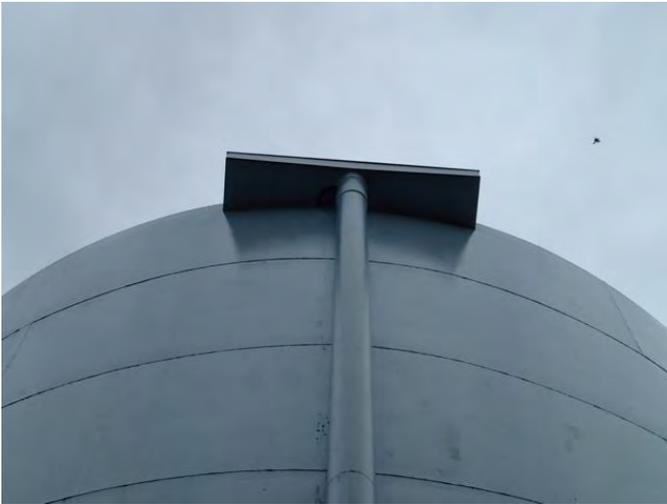
27 *Overflow Weir Box And Overflow Pipe*

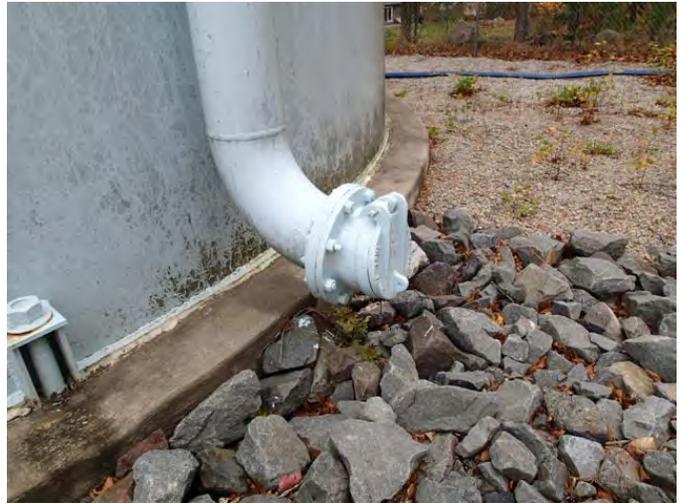
28 *Overflow Pipe With A Flap-Valve*

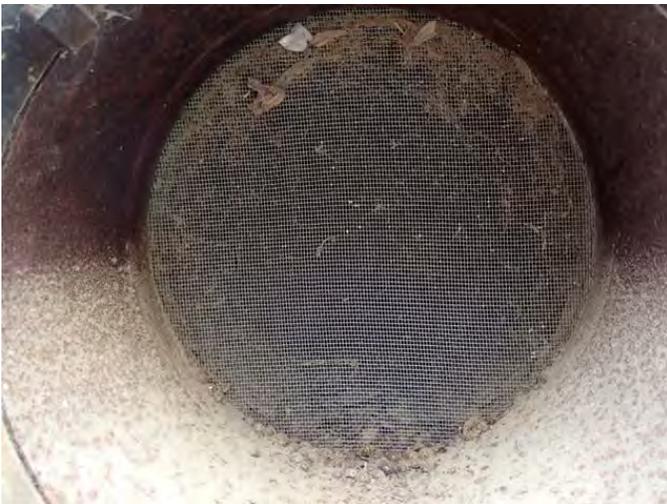
29 *Secure Overflow Pipe Screen*

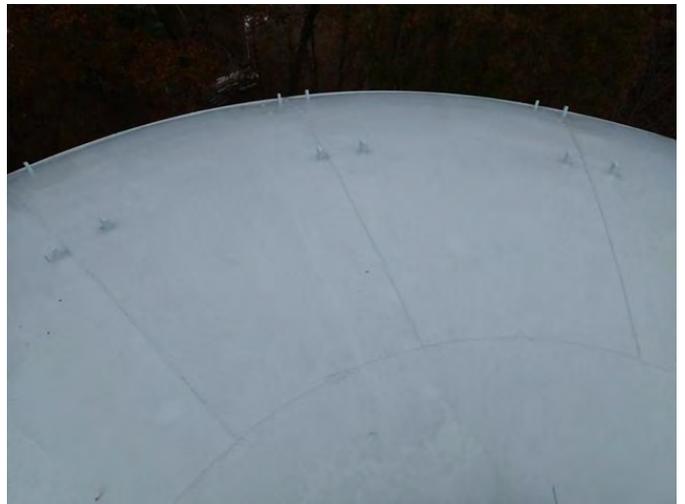
30 *Roof Panels With Mildew*

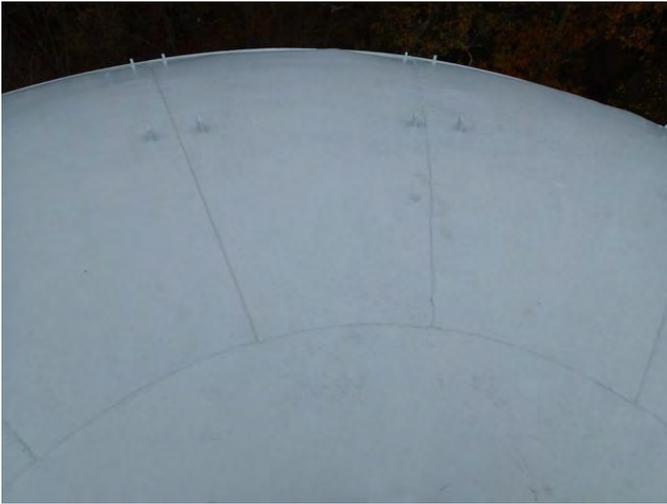
31 *Roof Panels With Mildew*

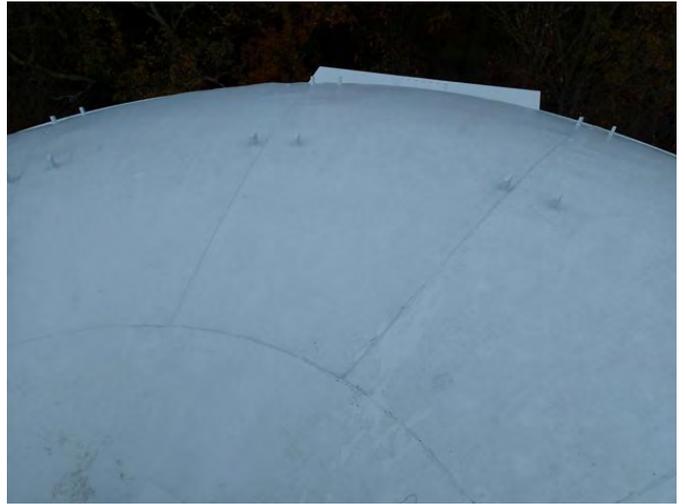
32 *Roof Panels With Mildew*

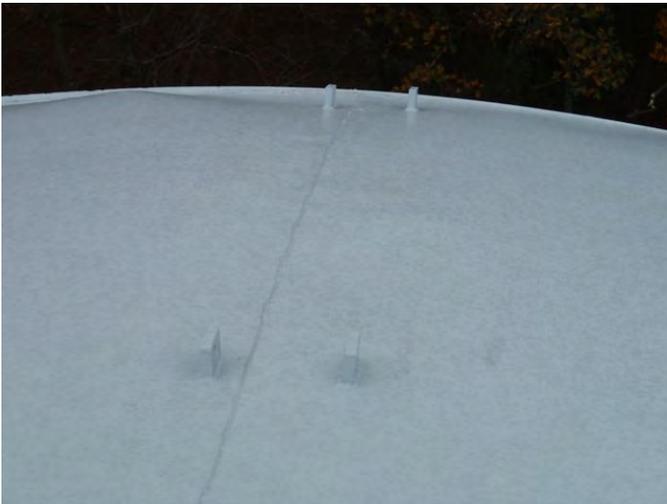
33 *Roof Panels With Mildew*

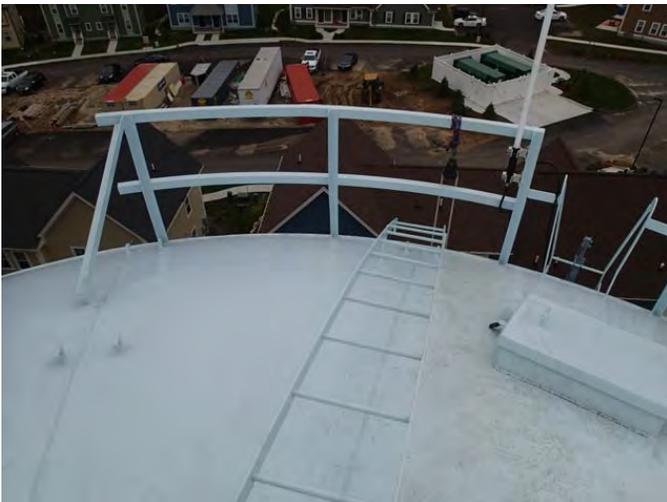
35 *Secure Safety Railings*

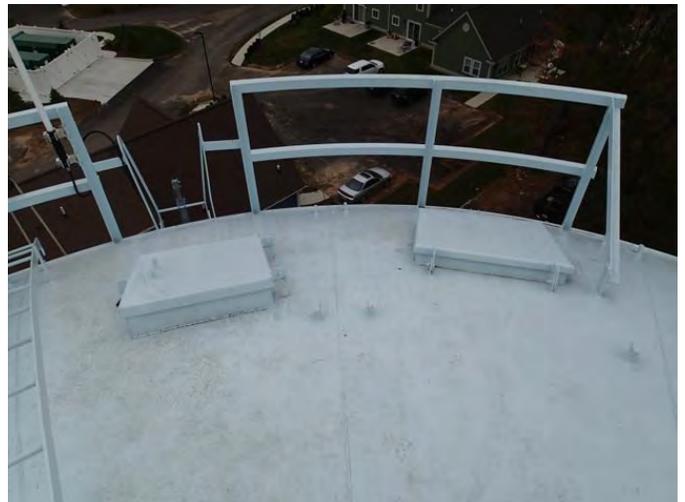
36 *Secure Safety Railings*

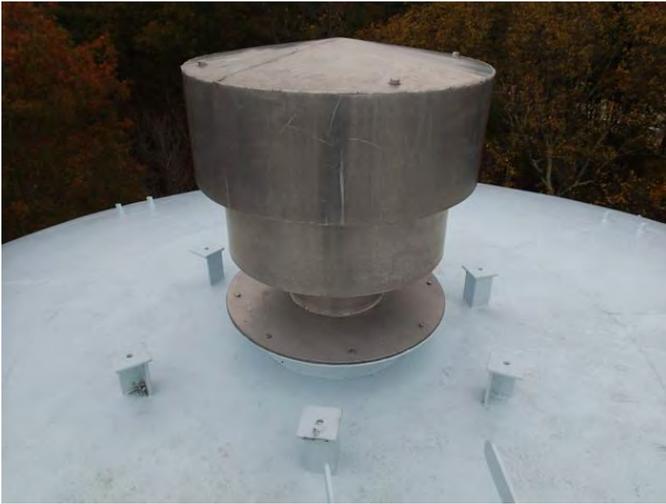
37 *Secure Frost Proof Vent*

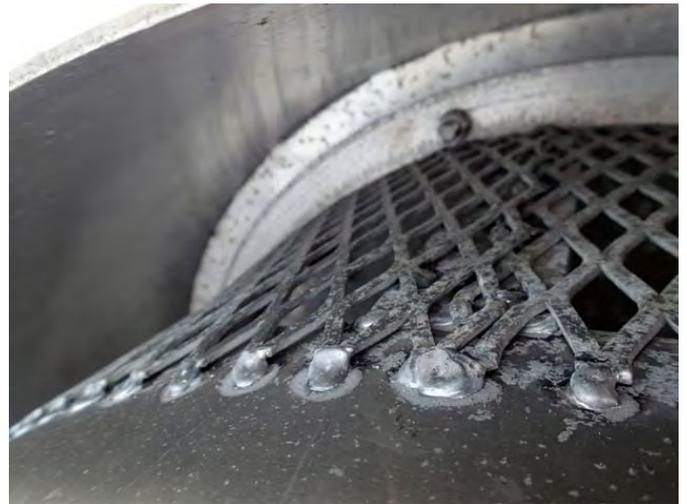
38 *Secure Vent Screen*

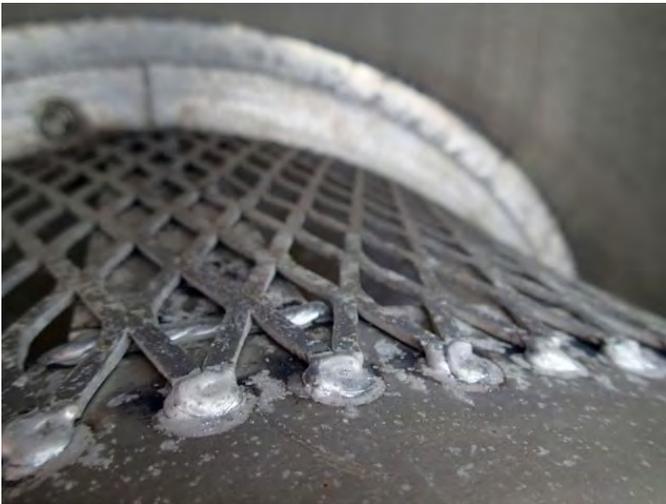
39 *Secure Vent Screen*

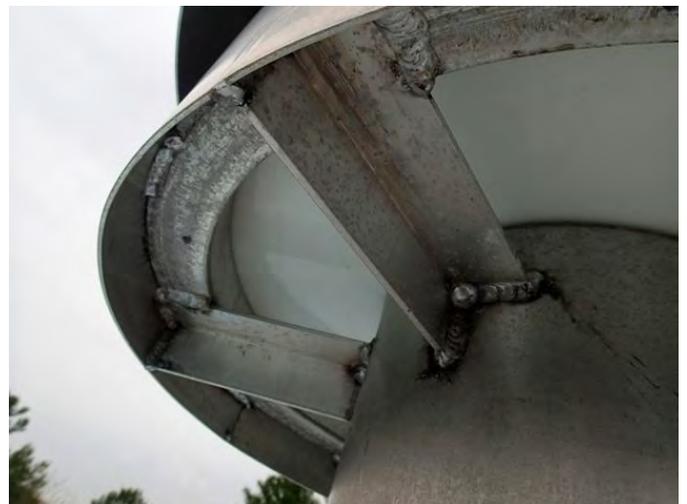
40 *Secure Vacuum Release Plate*

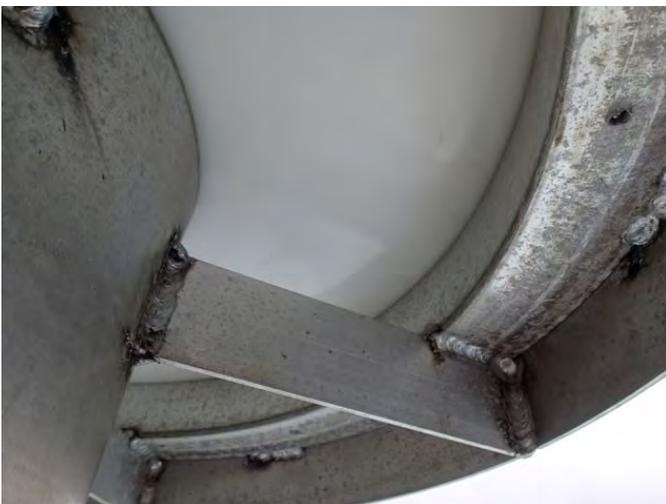
41 *Secure Vacuum Release Plate*

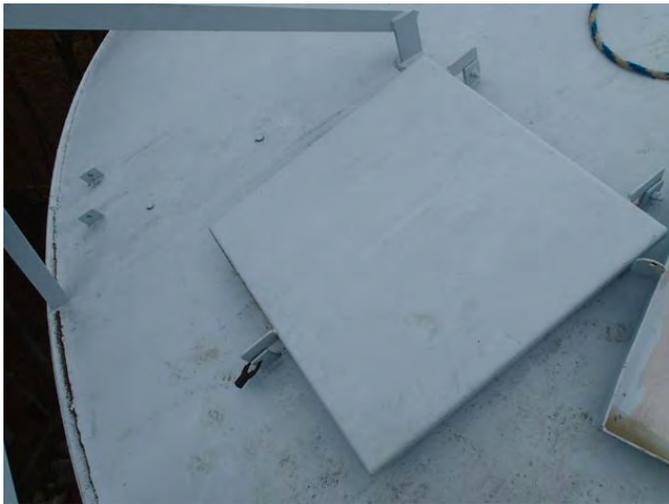
43 *Closed Access Hatch*

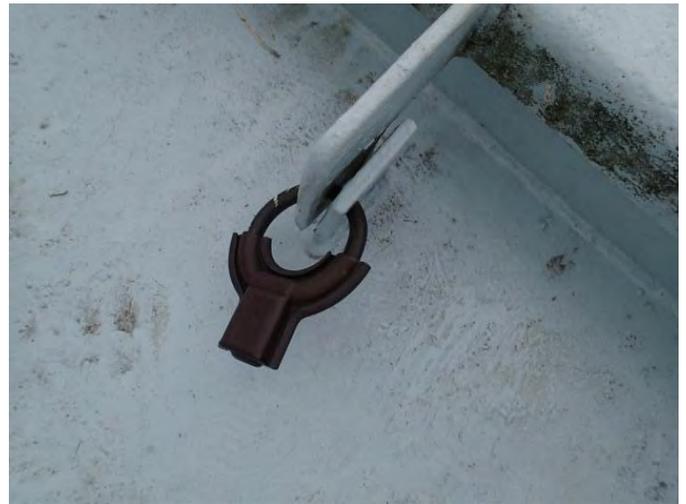
44 *Secure Access Hatch*

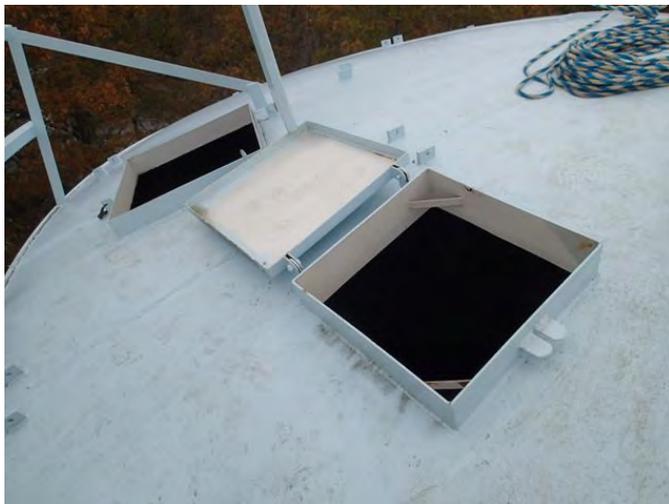
45 *Open Access Hatch*

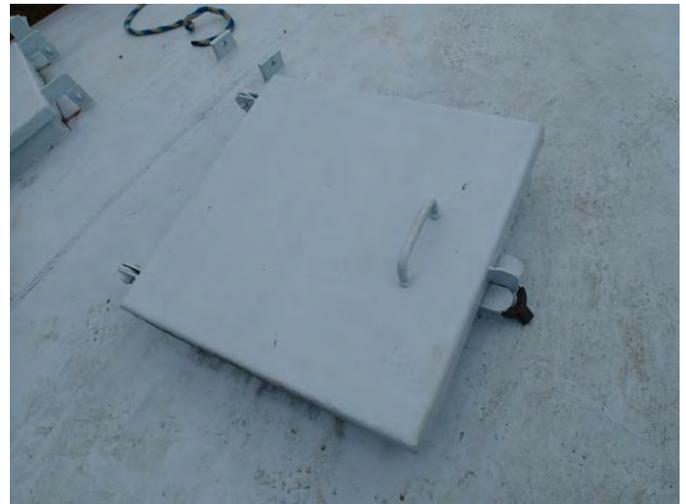
46 *Closed Access Hatch*

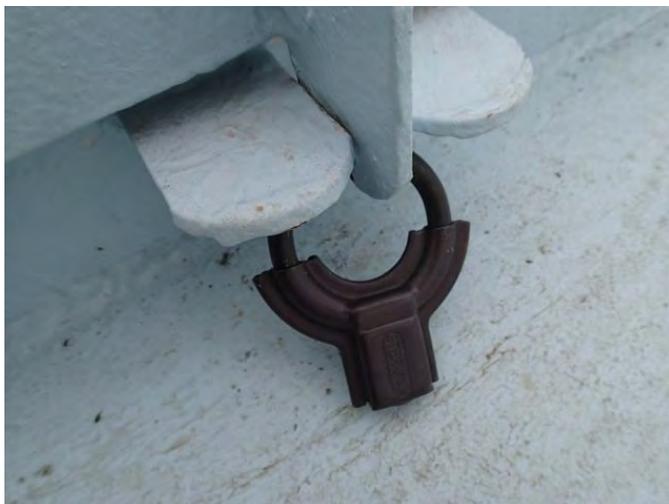
47 *Secure Access Hatch*

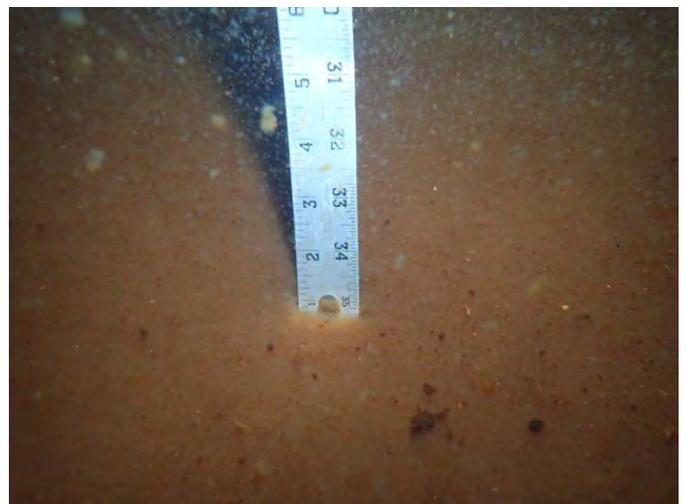
48 *Layer Of Precipitate*

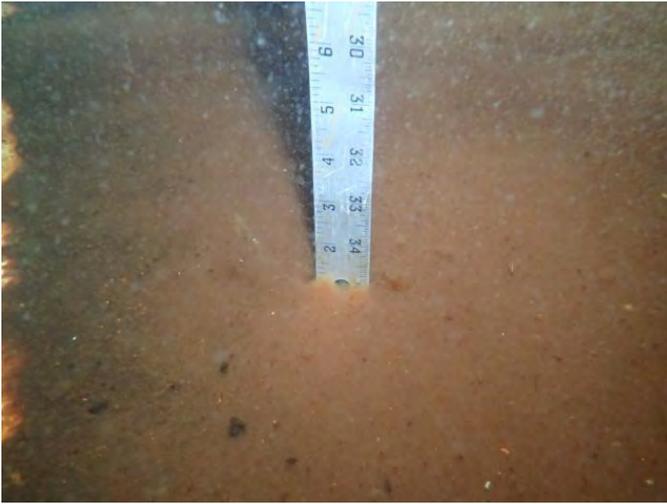
49 *Layer Of Precipitate*

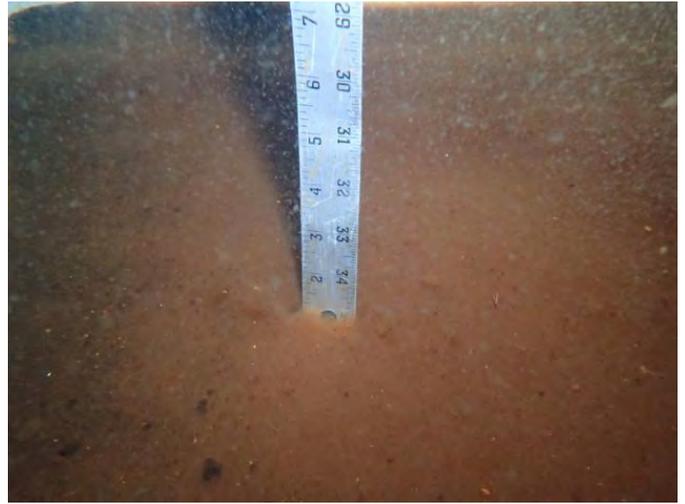
50 *Layer Of Precipitate*

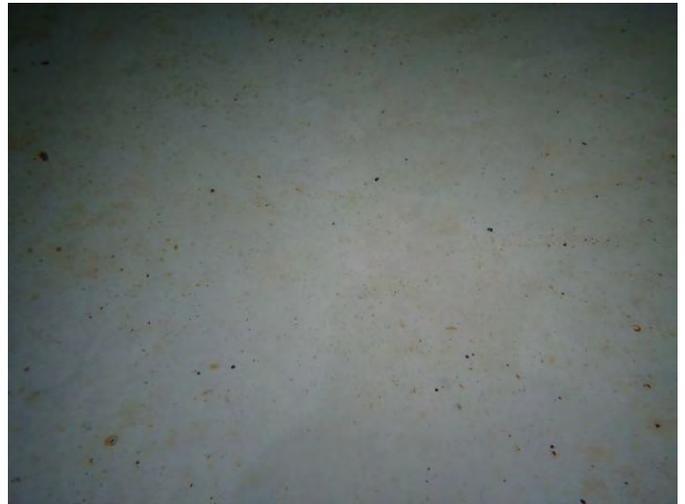
52 *Floor With Mild Staining*

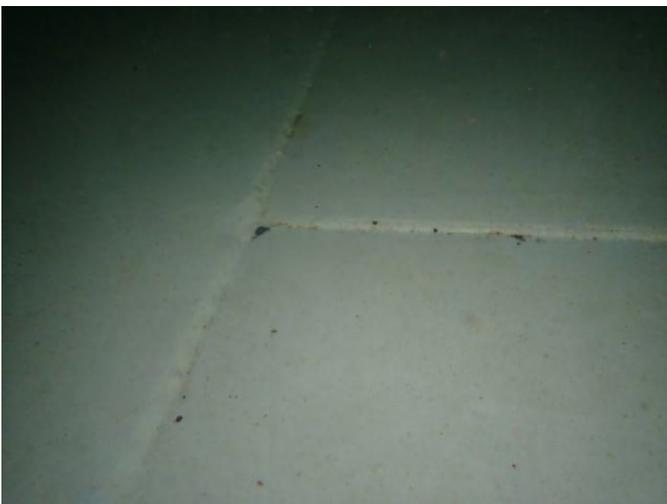
53 *Floor With Mild Staining*

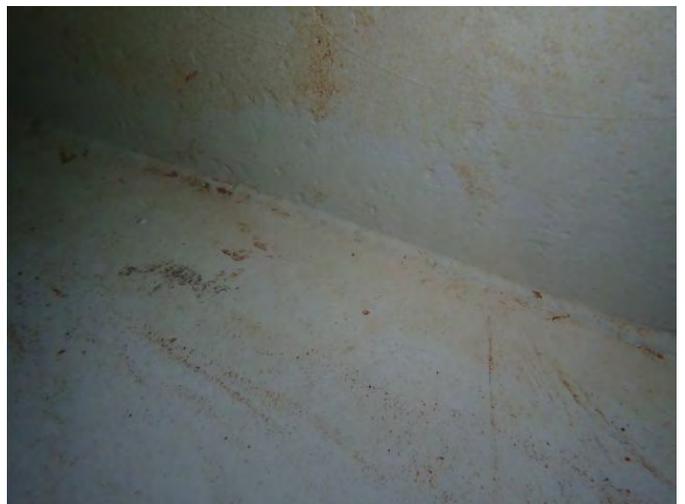
54 *Floor With Mild Staining*

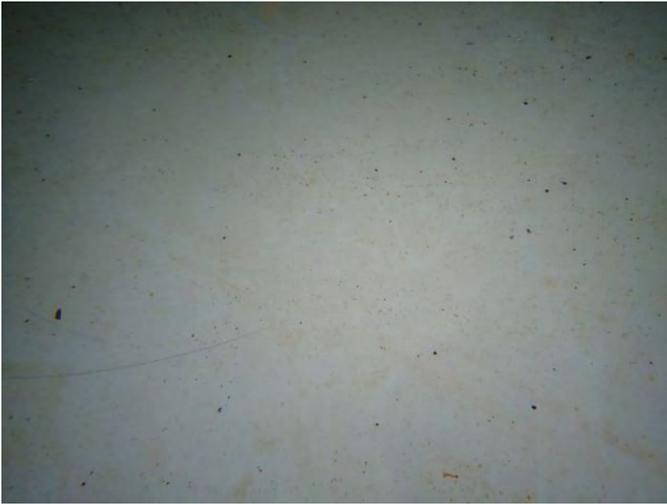
55 *Floor With Mild Staining*

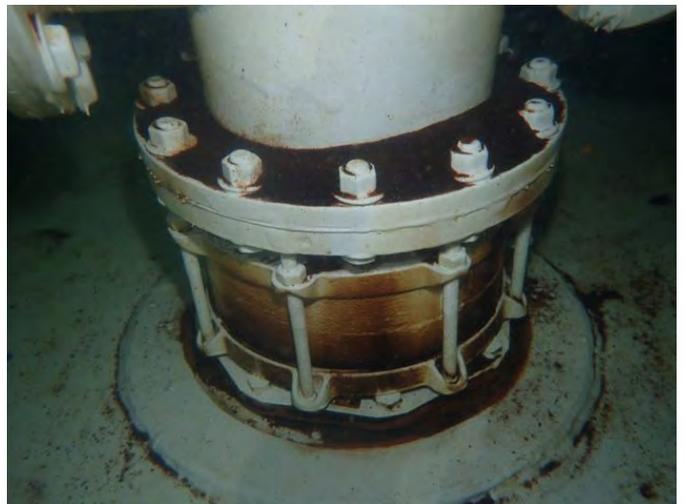
58 *Influent/Effluent Mixing System Piping Penetrating The Tank Floor*

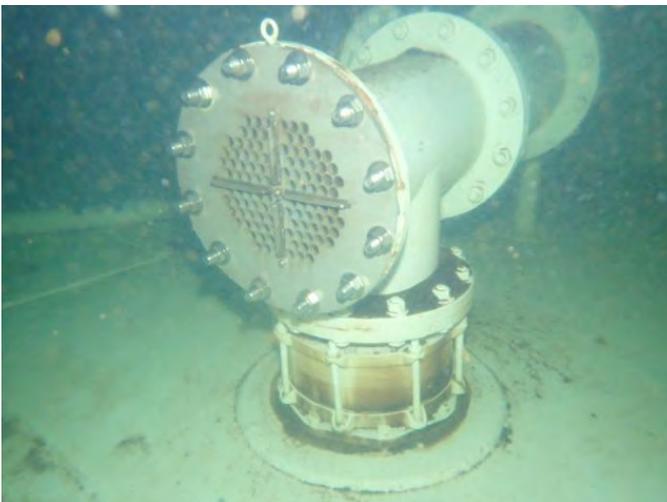
59 *Effluent Steel Grate*

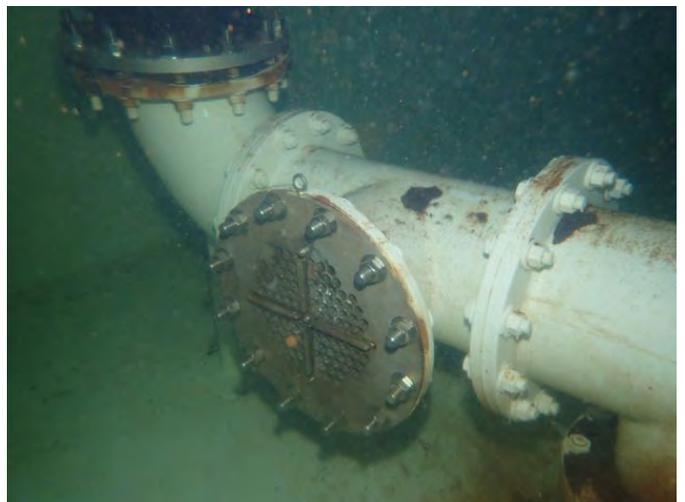
60 *Effluent Steel Grate*

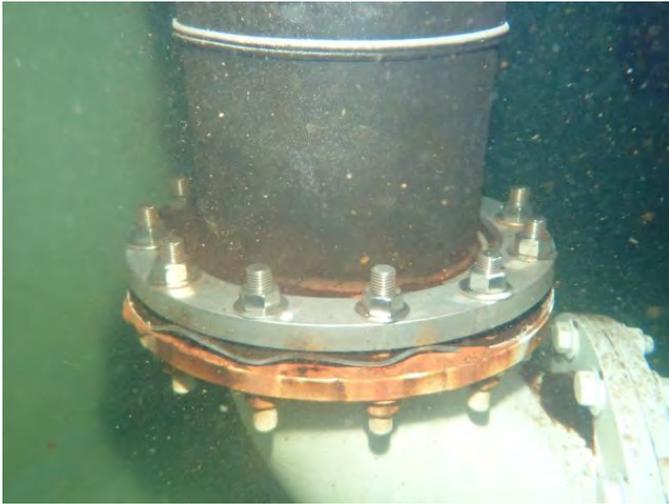
61 *Influent/Effluent Mixing System Extending Upward Into The Tank*

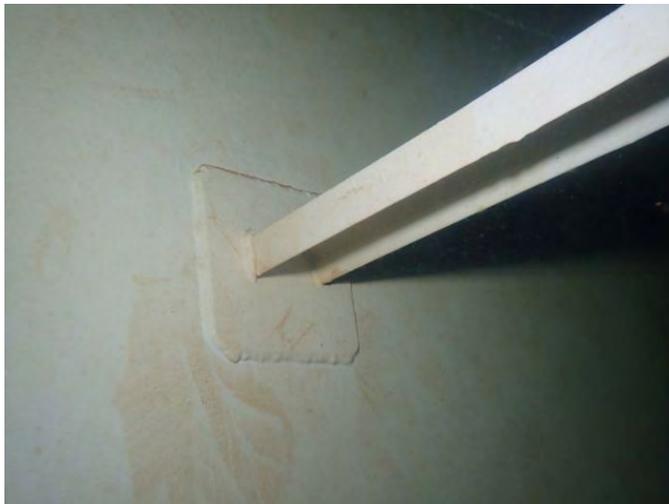
63 *Influent/Effluent Mixing System Pipe Supported To The Wall*

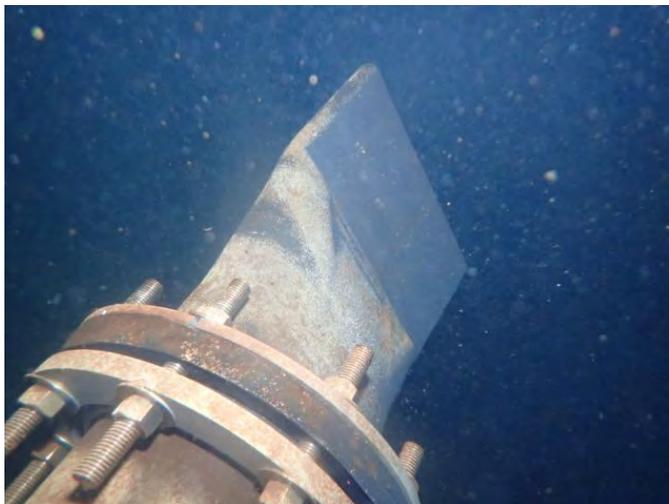
65 *Rubber Influent Check Valve*

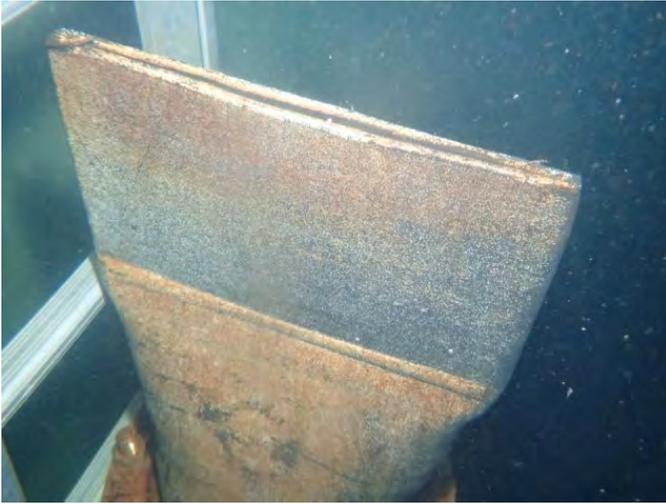
67 *Rubber Influent Check Valve*

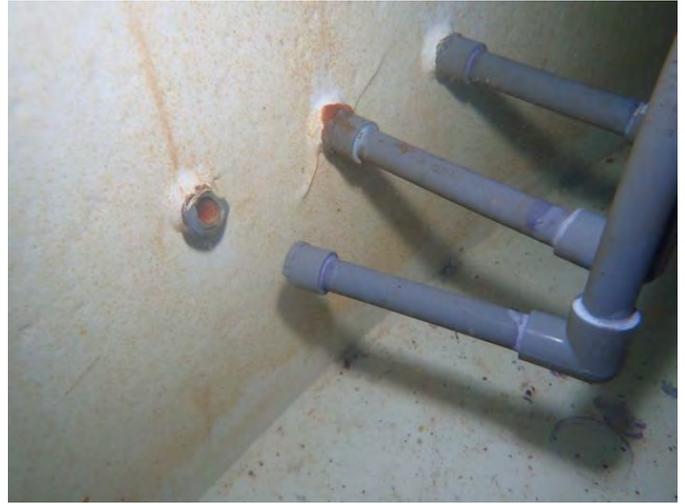
68 *Sample Pipes Penetrating The Wall (Interior Of The Tank)*

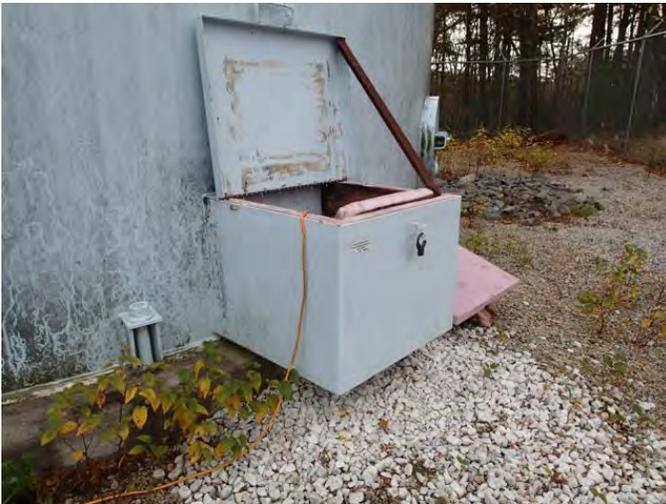
69 *Sample Pipe Box On The Exterior Of The Tank*

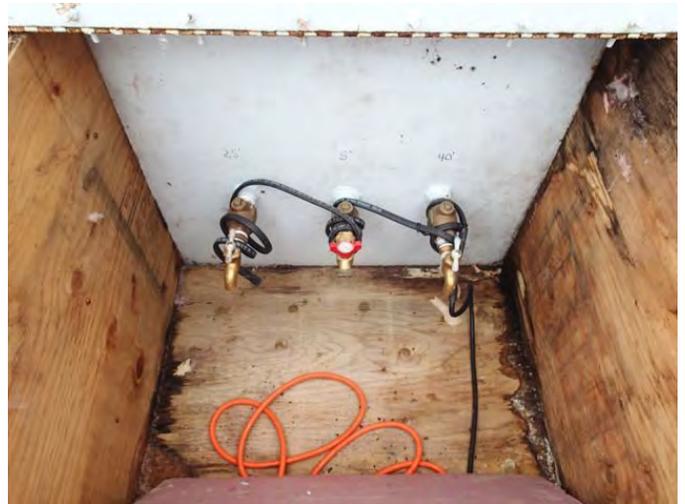
70 *Sample Pipes Penetrating The Wall (Exterior Of The Tank)*

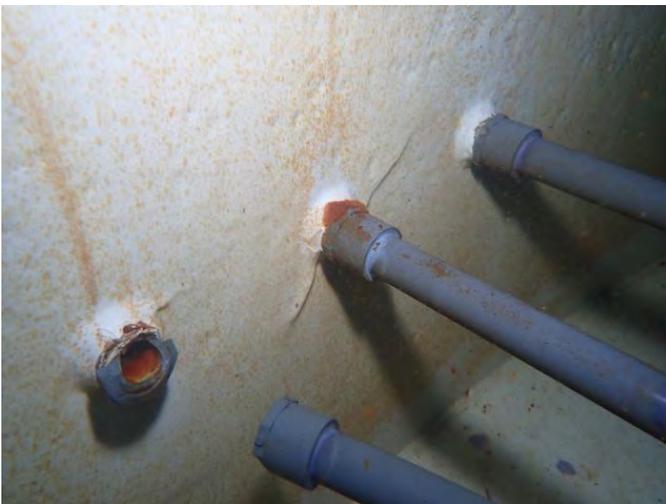
71 *Sample Pipe Snapped At The Wall Penetration*

It is our recommendation that the next time this tank is removed from service and de-watered, that the failed sample pipe be repaired/replaced to allow for sampling at the proper elevations. We recommend then re-securing the failed support standoff located approximately 40' above the floor and to re-coat the repaired standoff using an A.N.S.I./N.S.F.61 approved coating for use in structures containing potable water in an effort to halt corrosion, prevent steel fatigue and to provide good protection for this steel support and to provide good protection for the wall panel that this support is welded to.

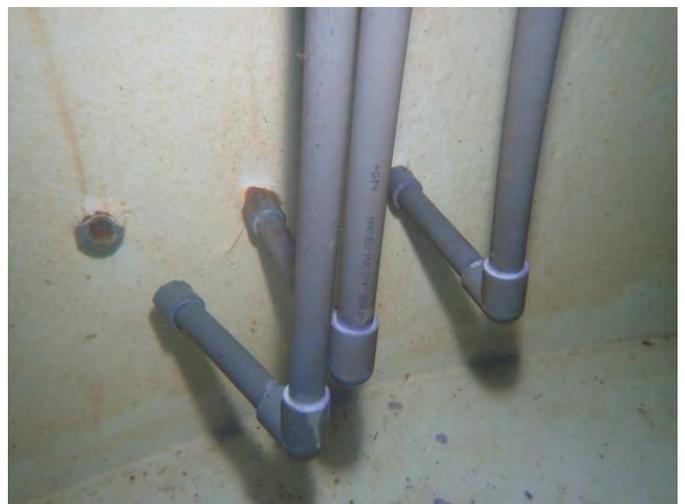
72 *Sample Pipe Securely Installed*
