PASCOAG UTILITY DISTRICT

CLEAN WATER INFRASTRUCTURE REPLACEMENT PLAN

Five (5) Year Update

May 11, 2022

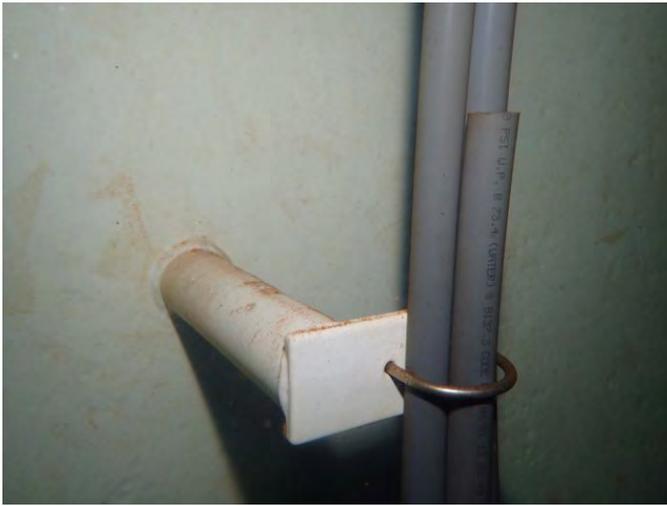
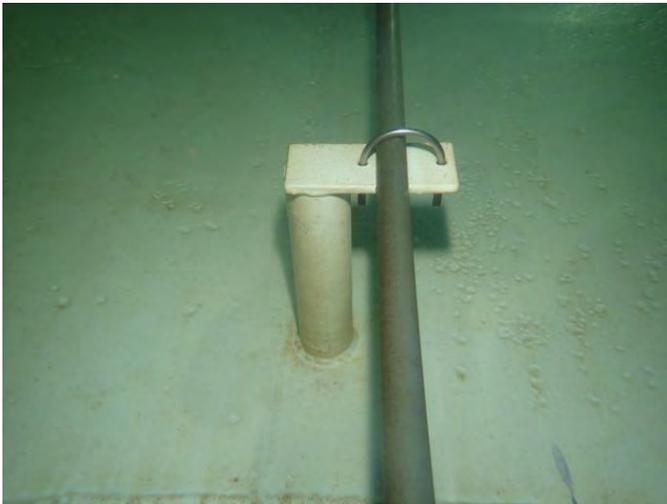
The two remaining 3/4" inside diameter P.V.C. pipes that provide sampling at the 5' and 25' elevations above the floor were found securely supported within welded steel standoffs and free of obvious obstructions at this time.

73 *Sample Pipes Supported To The Wall*

74 *Sample Pipes Supported To The Wall*

75 *Sample Pipes Supported To The Wall*

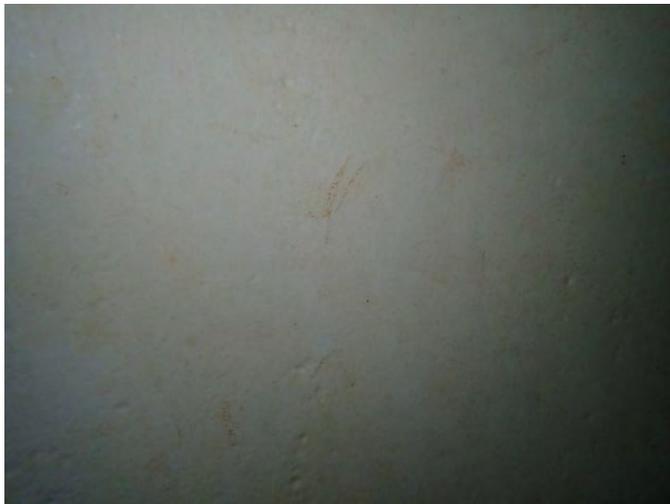
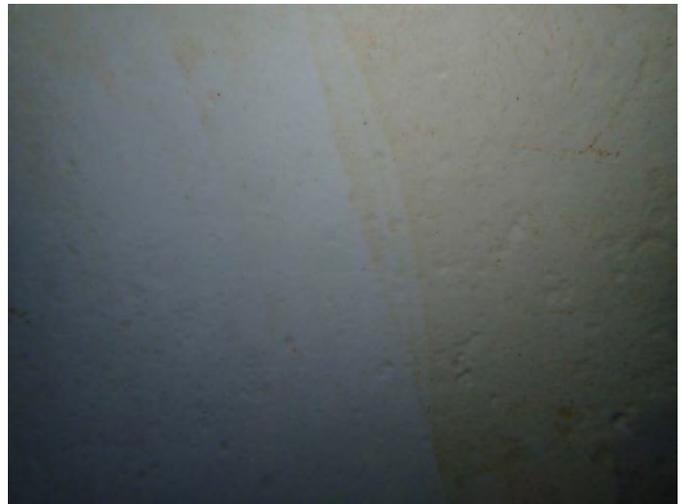
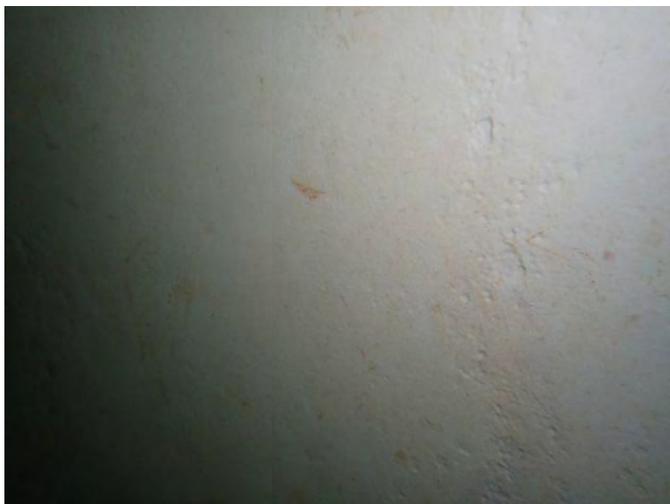
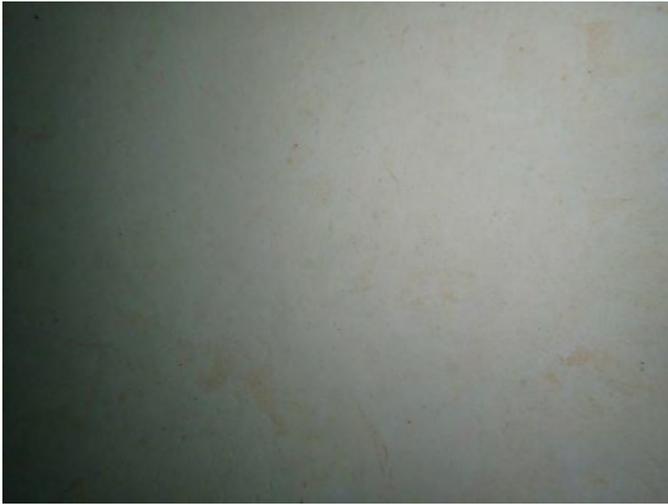
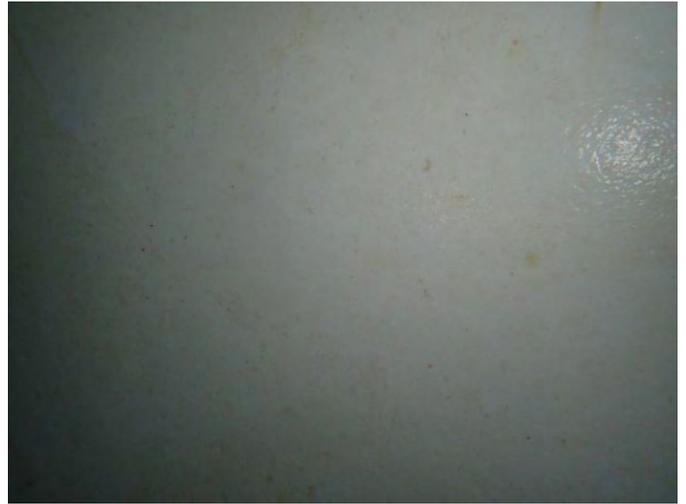
The interior steel wall panels and associated welds appeared sound and free of obvious fatigue or failures of the steel at this time.

81 *Interior Wall With Mild Staining*

82 *Interior Wall With Mild Staining*

83 *Interior Wall With Mild Staining*

84 *Interior Wall With Mild Staining*

85 *Interior Wall With Mild Staining*

86 *Interior Wall With Mild Staining*

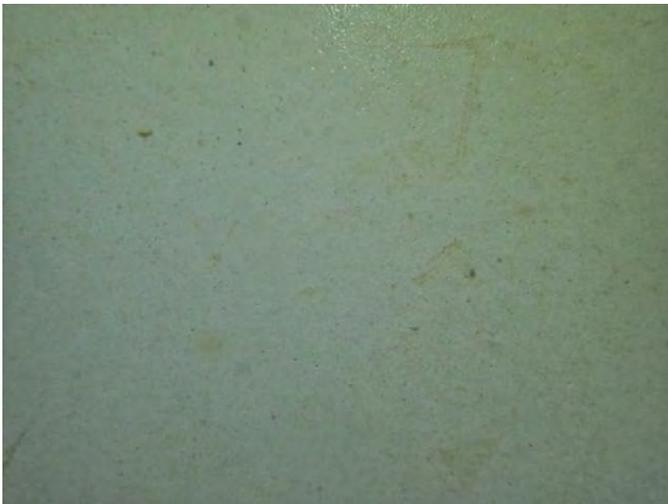
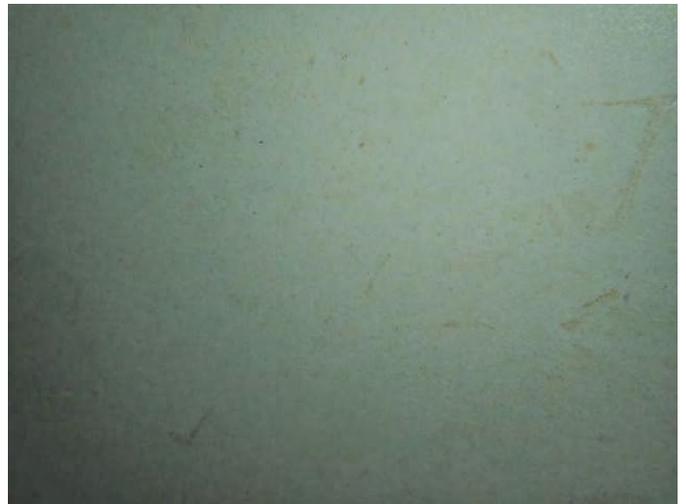
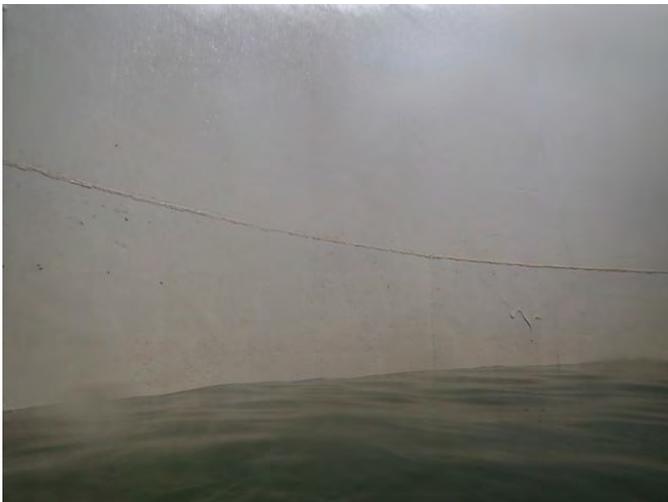
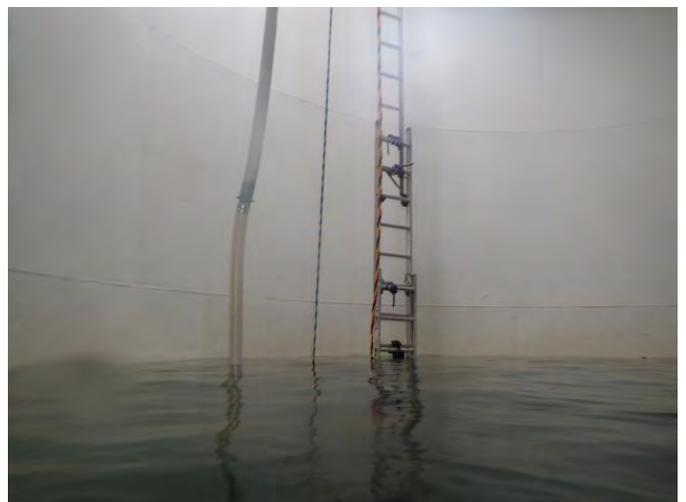
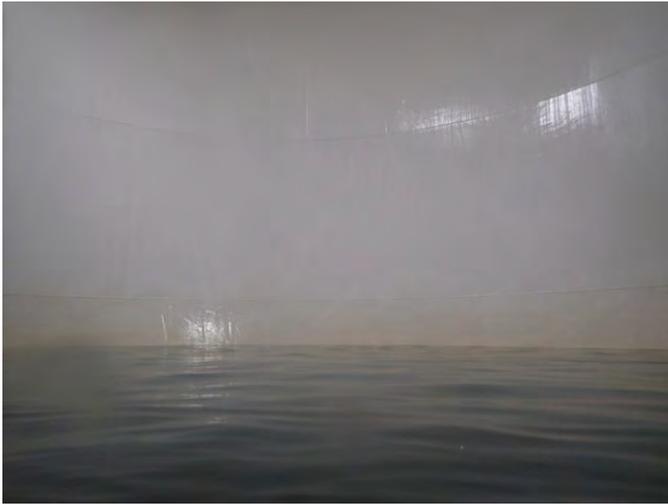
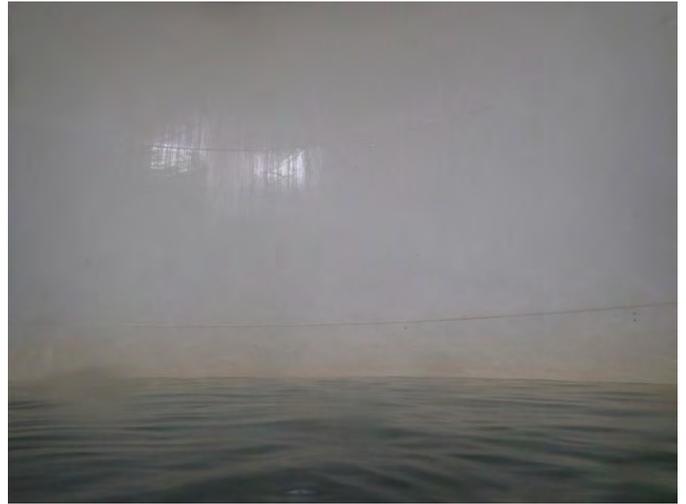
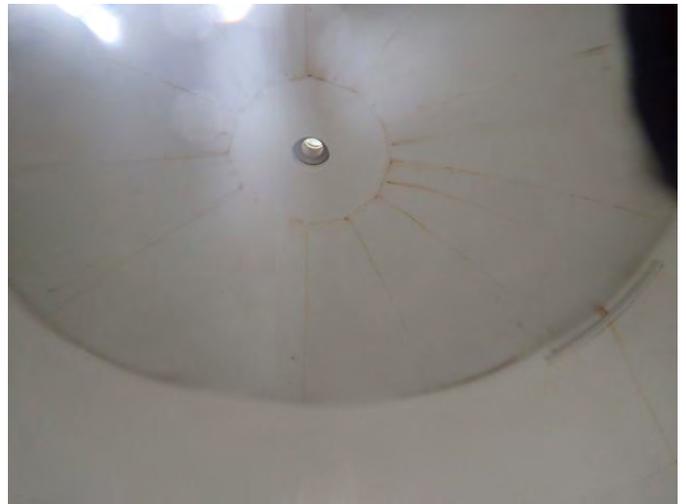
87 *Interior Wall With Mild Staining*

88 *Interior Wall With Mild Staining*

89 *Interior Wall With Mild Staining*

90 *Interior Wall With Mild Staining*

91 *Interior Wall With Mild Staining*

92 *Interior Wall With Mild Staining*

93 *Interior Wall With Mild Staining*

94 *Overhead With Mild Rust Staining*

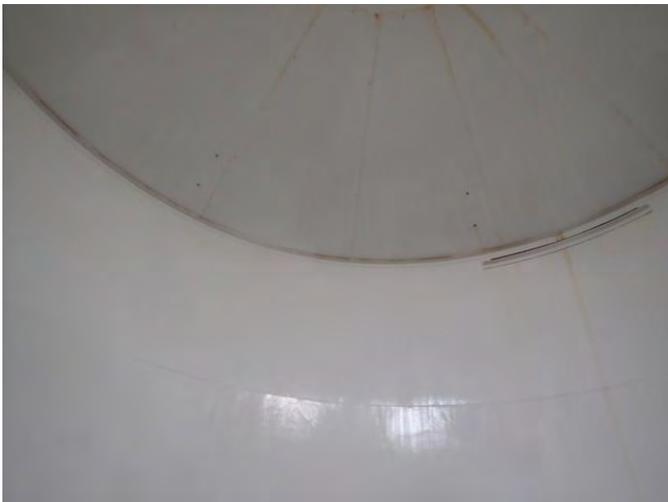
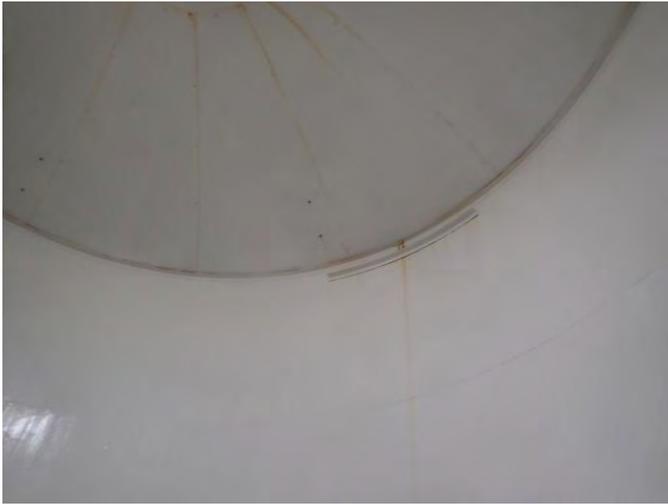
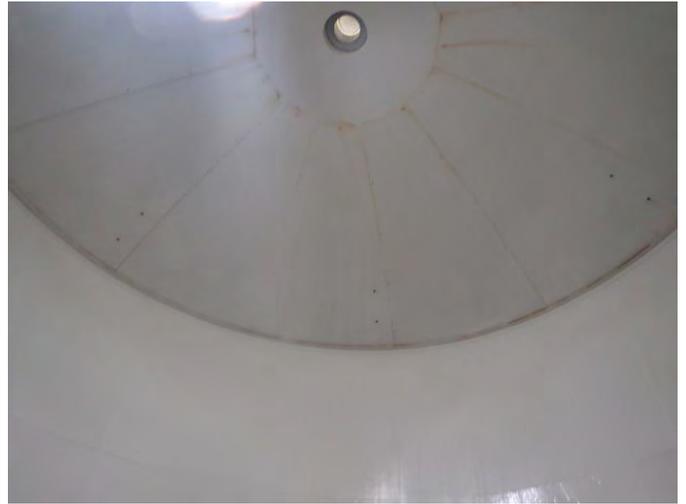
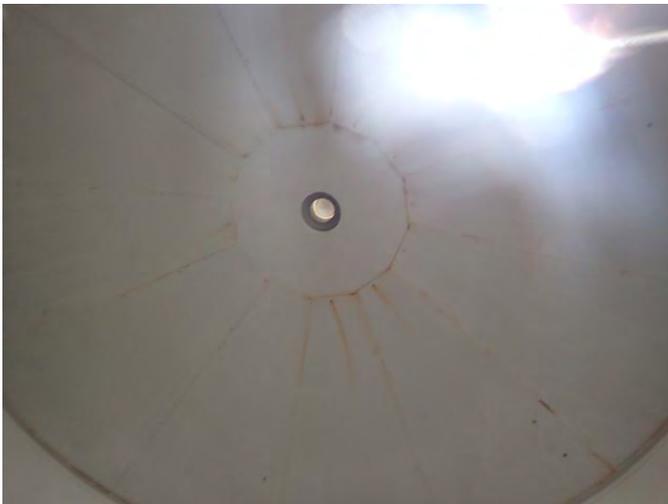
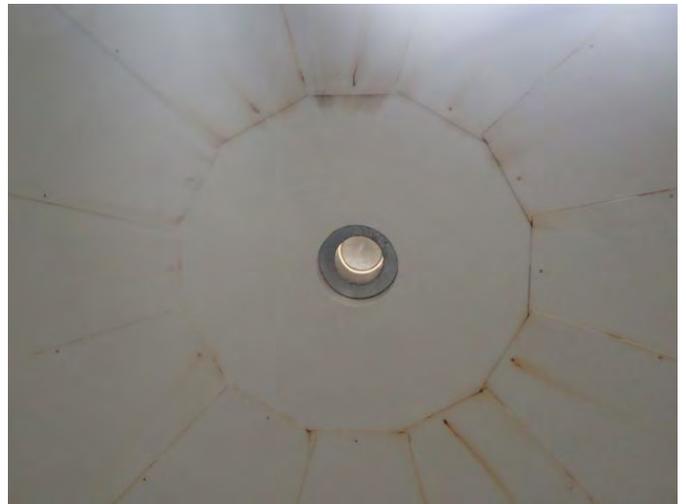
The steel overhead panels and associated welds appeared sound and free of obvious fatigue or failures of the steel at this time. The protective coating applied to these welded steel surfaces appeared to have been applied uniformly, meets the specifications set by the AWWA and was found having good adhesion value. Mild rust staining was observed throughout the edges of the steel panels, yet no obvious exposure of the underlying steel was evident at this time.

95 *Overhead With Mild Rust Staining*

97 *Overhead With Mild Rust Staining*

98 *Overhead With Mild Rust Staining*

99 *Overhead With Mild Rust Staining*

100 *Vent Penetration*

It is our recommendation to monitor these overhead surfaces through future scheduled inspections to ensure that adhesion loss of the protective coating does not occur, which could result in exposure of the underlying steel.

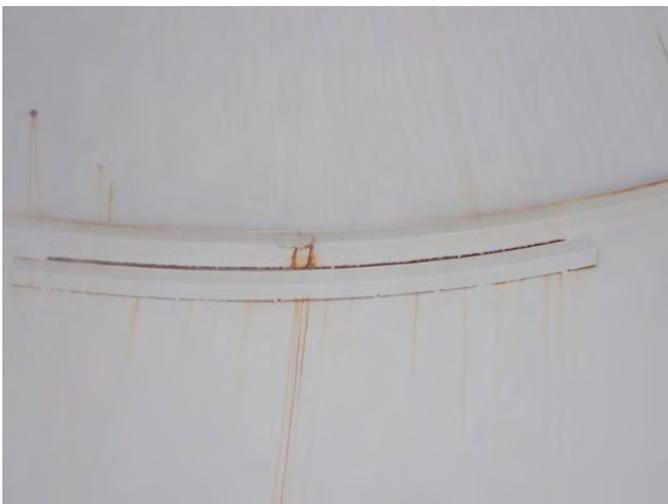
101 *Overflow Cutout*
